# Service Bulletin

Bulletin No.: 17-NA-166

**Subject:** Rough Idle in Drive

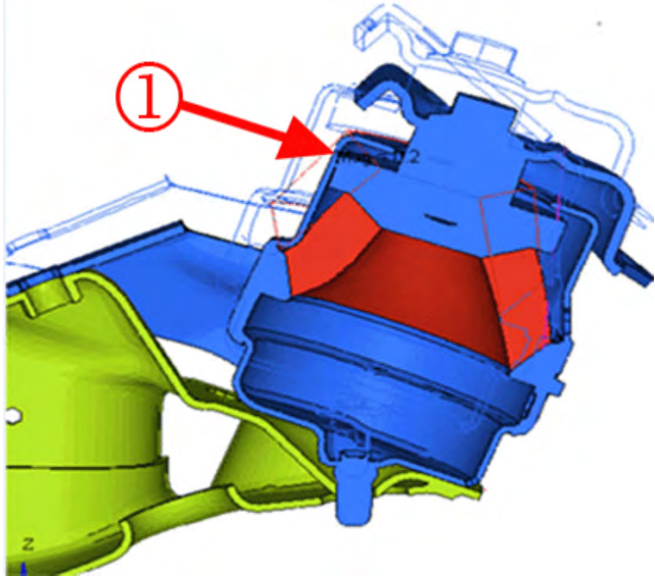
<p style="text-align: right;">4787059</p> <p>This concern may be caused by ground out (1) within one or both engine mounts.</p>
<p><b>Correction</b></p>	<p><b>Important:</b> Familiarize yourself with this entire bulletin before proceeding to ensure you are diagnosing and focusing on the correct issue by frequency measured with Pico scope.</p> <p>Perform PICO analysis, refer to the Service Procedure section below.</p> <p>⇒ If the rough idle / vibration concern frequency is E1.5 in the horizontal / lateral direction with Pico sensor mounted in seat track as indicated below – continue with steps to install updated design engine mounts and settle both engine and trans mounts to reduce amplitude (mg) / eliminate ground out within the engine mounts for vehicles built prior to engine mount breakpoint. For vehicles built after breakpoint, follow Shimming Procedure for Engine Mount Vibration/Grounding after Mount Replacement.</p> <p><b>Important:</b> The updated engine mounts are designed to reduce internal ground out, primarily E1.5. These mounts along with engine and trans mount settling will typically reduce amplitude at the seat track to 2 mg or less.</p> <p><b>Note:</b> The 6.2L engine has a characteristic E1 which can be felt and may be described as a lopey idle. V-8 engine firing frequency produces E4 which will typically be very low frequency at the seat track. Do not confuse 6.2L E1 characteristic (not caused by mount ground-out), with E1.5 normal idle characteristics being transmitted into the truck via ground-out through the engine mounts.</p>

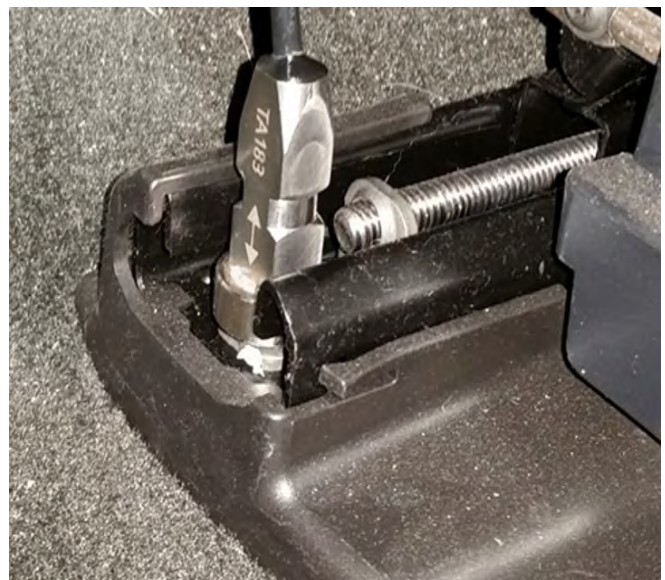
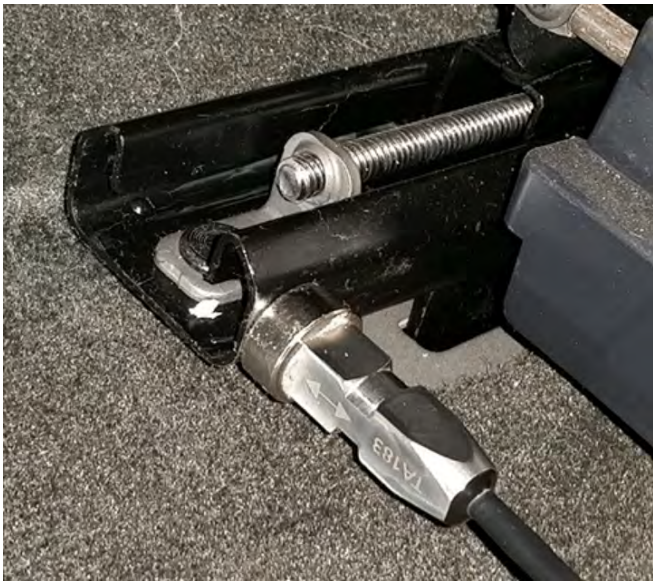
4532456

**Note:** If using a single-axis pico sensor, mount and test both vertically and horizontally – E1.5 rough idle vibration will usually be horizontal / lateral at the seat track.

(TA183 single axis pico sensor shown / TA143 is tri-axis sensor)

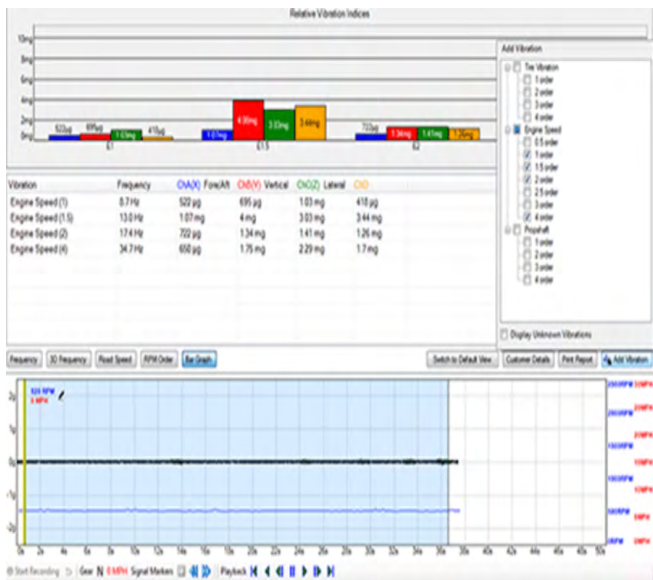
4534309

Add E1.5 to the displayed data and turn Off T and P related data (under Add Vibration in Pico) since issue occurs with vehicle stationary.

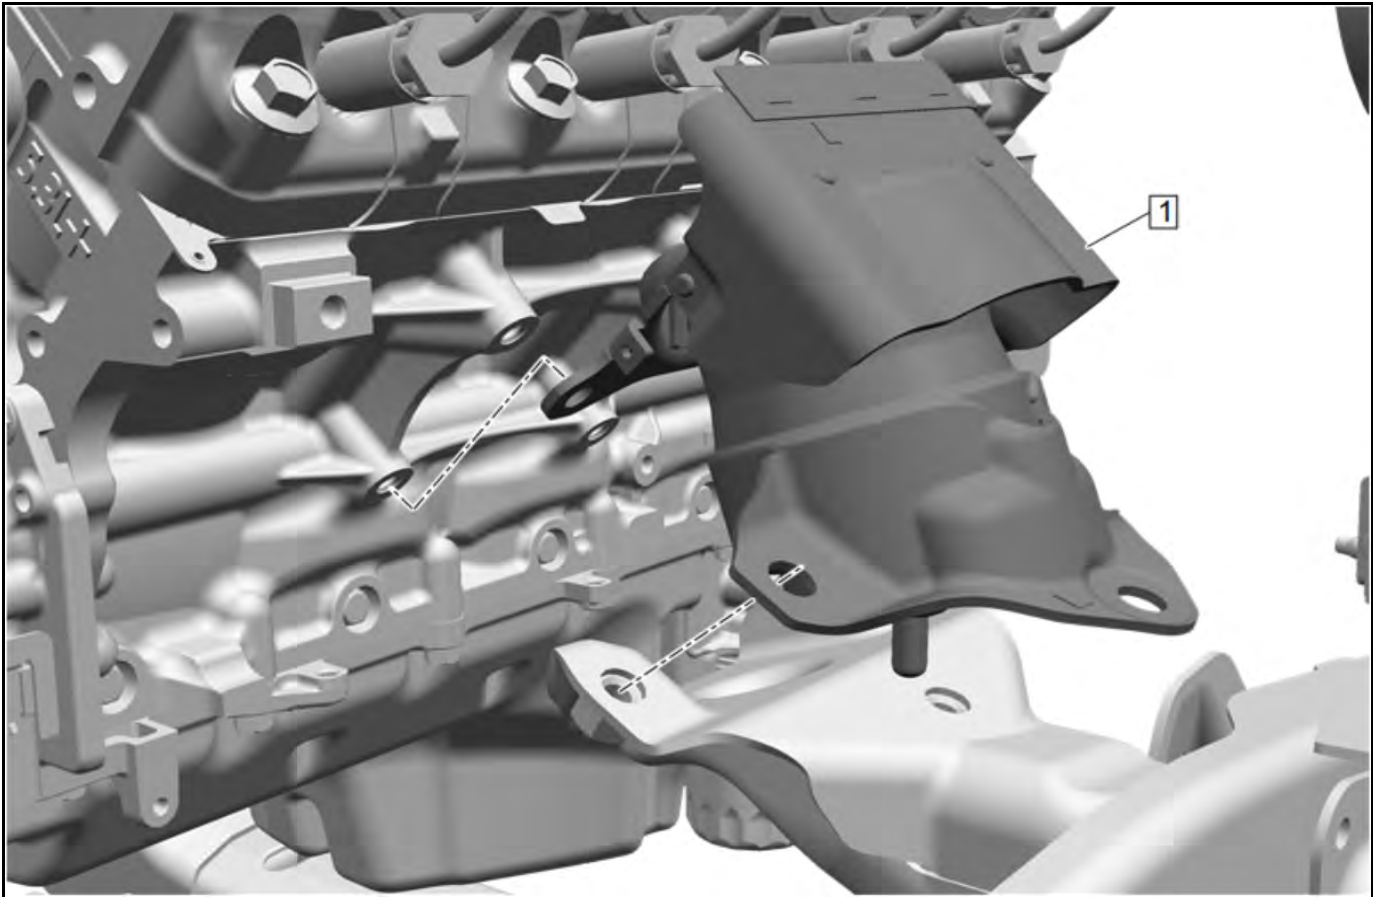
5030893

**Note:** Initial removal of the engine mounts will require the removal of the exhaust manifolds.

1. Replace both engine mounts (1). Refer to *Engine Mount Replacement – Left and Right Engine Mount Replacement* in SI.
2. Install but do **NOT** tighten the mount to frame bolts.
3. Settle all mounts as follows:
  - 3.1. Ensure the engine mount to frame bolts on both LH and RH sides are loosened a couple turns.
  - 3.2. Ensure, the transmission/transfer case mount to frame crossmember nuts are loosened a couple of turns.
  - 3.3. Have assistant set park brake and apply base brake.
  - 3.4. Have assistant turn Traction Control Off, and brake torque in Drive and Reverse with the engine at operating temperature, then place in Neutral and turn engine Off.
