Service Bulletin

Bulletin No.: 17-NA-308

Subject: Carpet Damage, Seat Mounting Stud Wear Through, Hole in Second Row (Intermediate) Carpet

Brand:	Model:	Model Year:		VIN:		Engine:	Transmission:
		from	to	from	to		
Cadillac	Escalade Models	2011	2020			All	All
Chevrolet	Suburban Tahoe	2011	2020				
GMC	Yukon Models	2011	2020

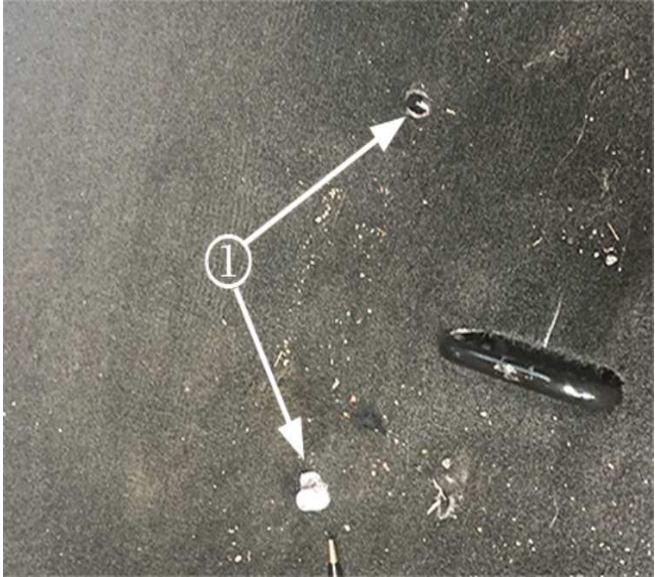
<p style="text-align: right;">4867790</p> <p>Some customers may comment that studs are wearing through (1) the second row (intermediate) carpet, around the base of the second row seats. This may be most noticeable on vehicles with second row bucket seats.</p>
Cause	This condition may be due to the interface design of the intermediate carpet to the seat studs, which may allow the studs to wear holes in the carpet.
Correction	Replace the intermediate carpet and add protective hose to the seat studs, following the steps in the Service Procedure below.

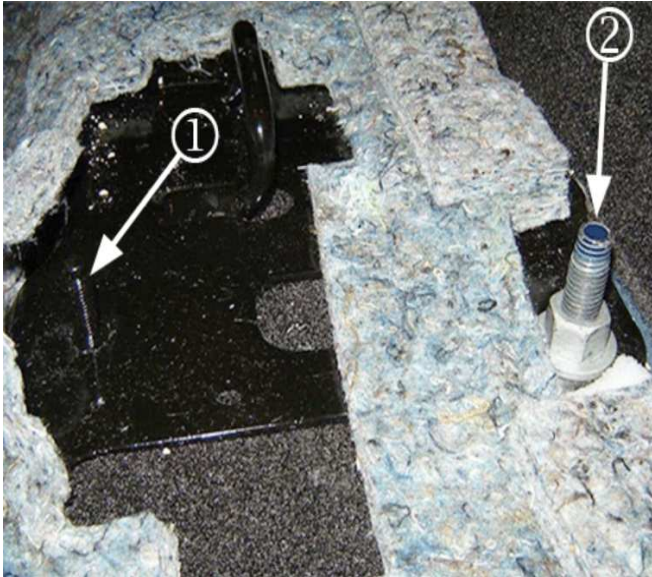
4867792

Note: There are two different size seat studs; 8 mm (1) used for long side bench to short side bench seat attachment (present on right side bucket seat), and 12 mm (2) used for seat to floor attachment.

1. Inspect the intermediate carpet for wear through from seat studs and mark the affected stud locations.
