Service Bulletin

Bulletin No.: 19-NA-107

Subject: Extended Cab Rear Door Ajar Indicator Displayed Intermittently, Rear Door Hard to Close and/or Rattle Noise from Lower Rear Door

Brand:	Model:	Model Year:		VIN:		Engine:	Transmission:
		from	to	from	to		
Chevrolet	Colorado (VIN S, VIN T) (Extended Cab)	2015	2021			All	All
GMC	Canyon (Extended Cab)

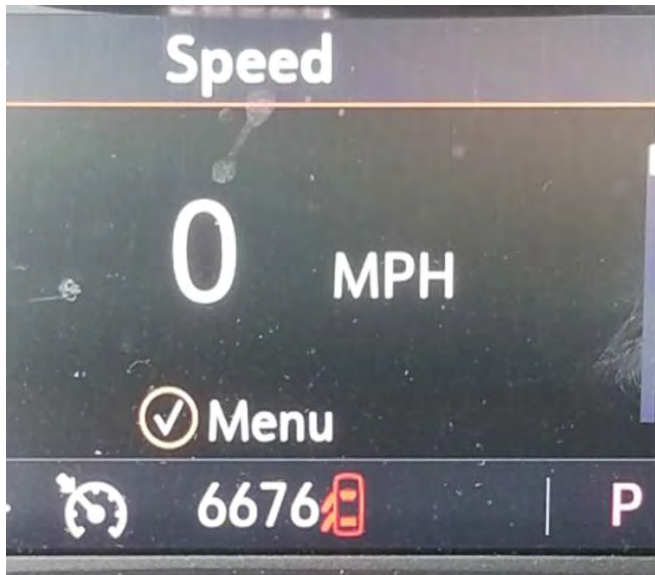
5335735

3. Open the same side extended rear door so now, as shown in the graphic above, the extended cab door should also appear **ajar** on the dash.
4. Starting with a low force, shut the extended cab door several times. The first few tries should show the door is still **ajar**.

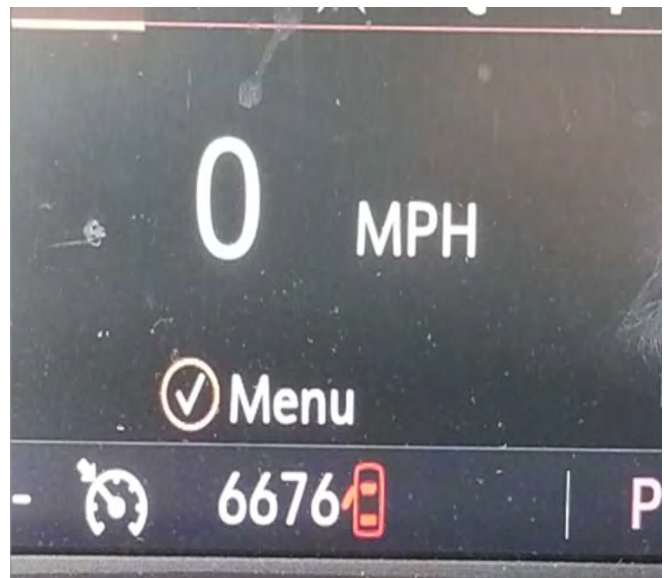
5335736

5. Continue shutting the door, and gradually increase the force until you reach the **minimum force** when the rear door ajar lamp first turns off. The lamp is now off as in the graphic example above.
6. Pull outboard on the top edge of the door to ensure that the top latch is in primary position, and is secure.
7. Pull outboard on the bottom edge of the door to ensure the bottom latch is in primary position, and is secure.
 - If both latches are secure, with no cross-car movement, **NO further action is required.**
 - If the bottom edge is NOT secure, you will notice movement (cross-car slack) and the ajar lamp will intermittently go **ON** and **OFF** as you move the door **OUT** and **IN**. If this condition still exists, proceed to step #8.
