Service Bulletin

Bulletin No.: 19-NA-249

Subject: Radio Favorites Grayed Out or Unavailable at Times

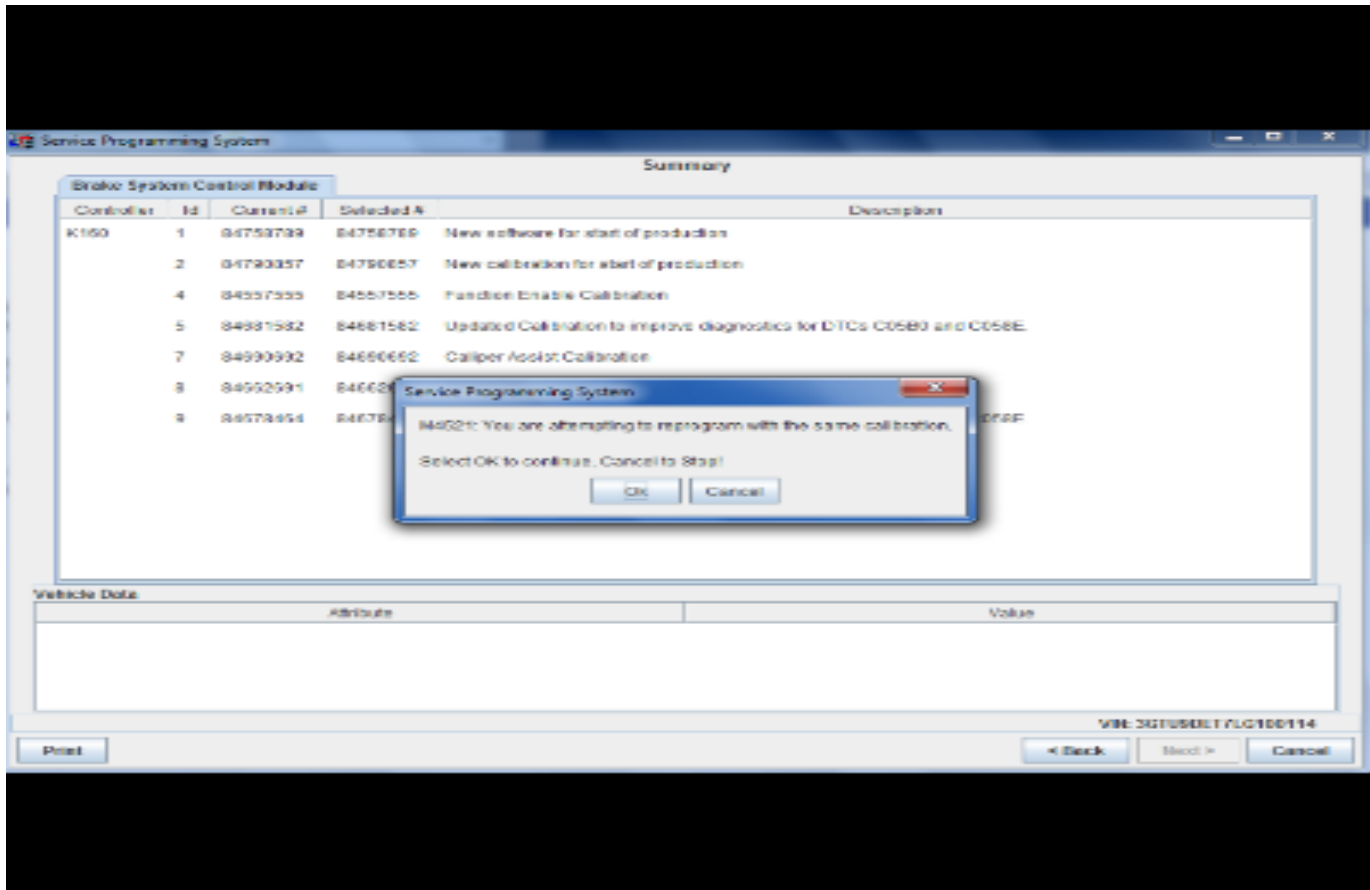
Important: TIS2WEB screen shown. Techline Connect screen is similar and will be included soon.

Important: If the Same Calibration/Software Warning is noted on the SPS screen, select OK and follow screen instructions. After a successful programming event, the WCC is located in the Service Programming System dialogue box of the SPS Summary screen. No further action is required. Refer to the Warranty Information section of this bulletin.

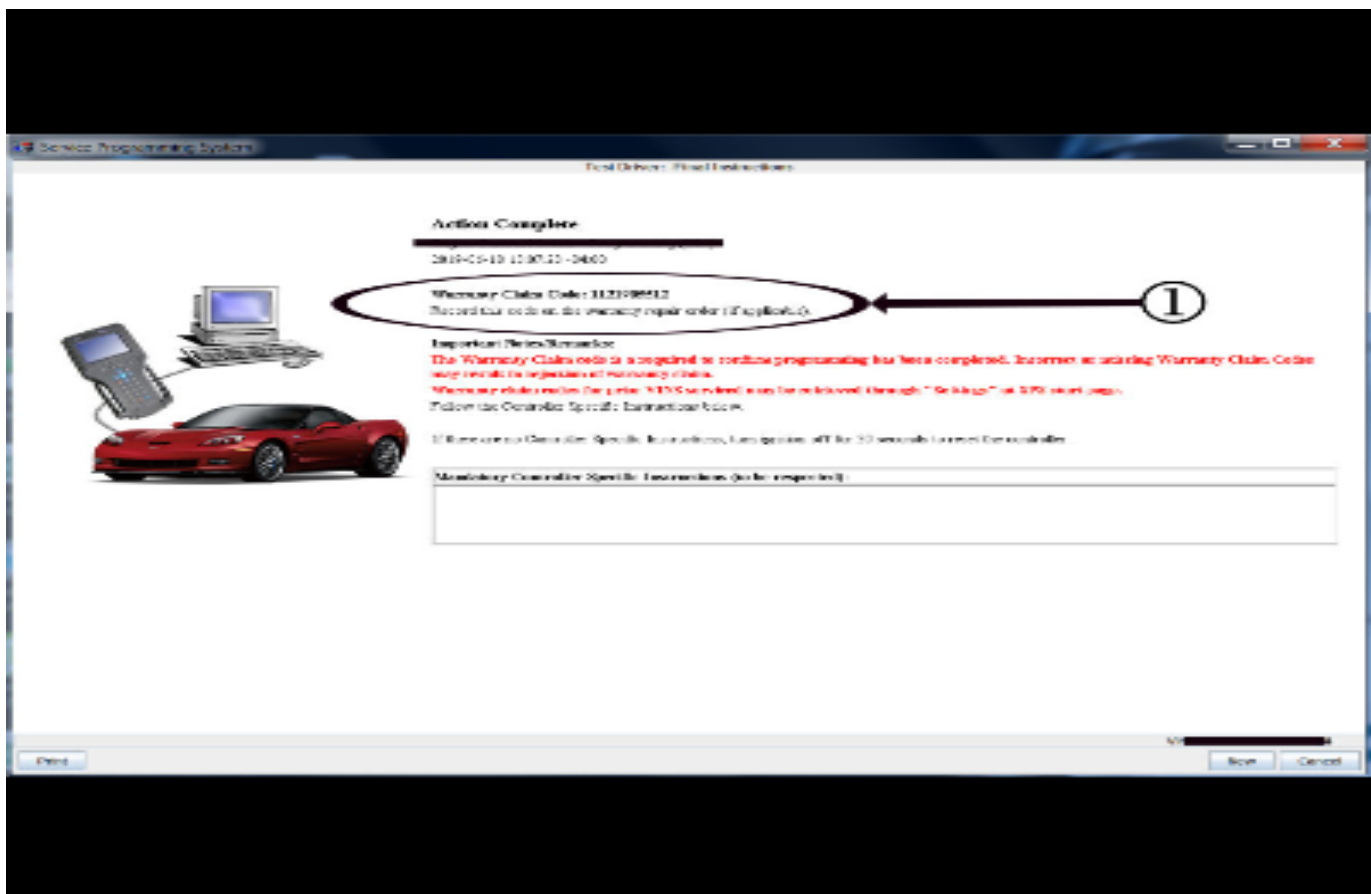
5431209

Important: TIS2WEB screen shown. Techline Connect screen is similar and will be included soon.

Note: To avoid warranty transaction rejections, you **MUST** record the warranty claim code provided on the SPS Warranty Claim Code (WCC) screen on the job card. Refer to callout 1 above for the location of the WCC on the SPS screen.

4. Record SPS Warranty Claim Code on job card for warranty transaction submission.
5. Favorites that were grayed out prior to the installation of 22.10, or greater, may need to be manually tuned and stored again to return their functionality.
