Bulletin No.: 20-NA-059

Subject: Pickup Box Endgate Will Not Fully Close by Itself

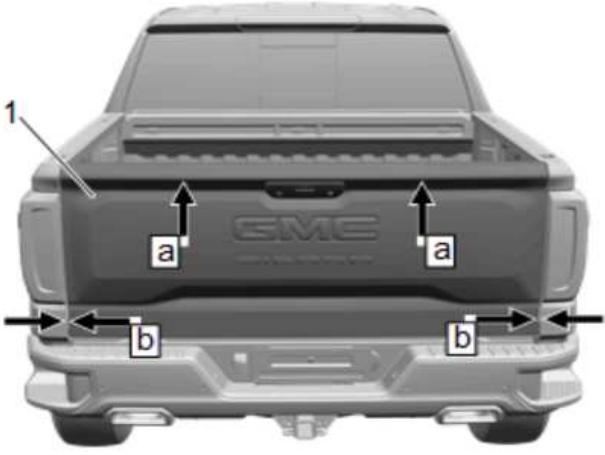
Involved Region or Country	North America, Middle East, Israel
Additional Options (RPOs)	Equipped with GATE FUNCTION-POWER (QT6).
Condition	Some customers may comment that the power up/down pickup box endgate will not fully close when using the power option.
Cause	The cause of the condition may be the endgate may be misaligned, causing a bind.
Preliminary Procedure	<p>Some vehicles, which have a tonneau cover installed, may be affected by a similar Condition, however the Cause and Correction are completely different from this bulletin. On these vehicles, it will be necessary rule out the tonneau cover as the possible Cause of the condition:</p> <ol style="list-style-type: none"> 1. Open the rear end panel of the tonneau cover. 2. Cycle the power tailgate 5 times using push button activation for auto open and close. <ul style="list-style-type: none"> • If the power endgate Does function properly, DO NOT proceed with this bulletin repair, but move on to Bulletin # 20-NA-044 and complete the tonneau adjustment procedure. • If the power endgate still DOES NOT function properly, continue on and complete the Correction outlined in this bulletin.

<p style="text-align: right; font-size: small;">4992376</p>
<p>Upon verifying the condition, adjust the endgate (1). Refer to <i>Endgate Adjustment</i>, in SI.</p>
