Service Bulletin

Bulletin No.: 20-NA-121

Subject: Water Leak at Rear Roof Area

Brand:	Model:	Model Year:		VIN:		Engino	Transmission:
		from	to	from	to	Engine:	Transmission.
Buick	Encore GX	2020	2020	SOP	March 15, 2020	All	All
Chevrolet	Trailblazer	2021	2021			All	All

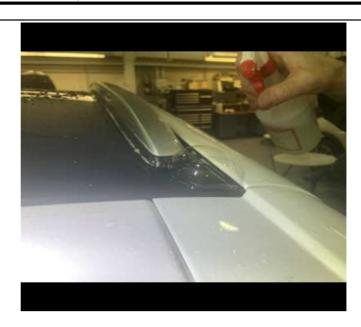
5615611

The cause of the condition may be a pin hole in the roof to body seam.

Inspect for a leak and repair as necessary.

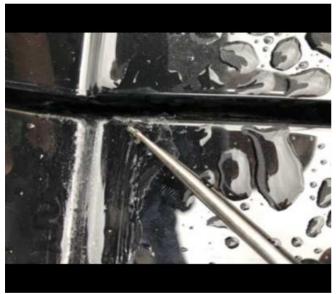
5613597

If you encounter a vehicle with the above condition, inspect the rear cargo interior trim, headliner, and spare tire area for signs of a water leak.

Once the water leak is found, repair any damage that may have been done due to the water leak.

Once the damage is repaired, apply seam sealer along the roof to body seam to correct the condition.
