Service Bulletin

Bulletin No.: 20-NA-124

Subject: Small Front Fascia Paint Chip Below Headlamp

Brand:	Model:	Model Year:		VIN:		Engine:	Transmission:
		from	to	from	to		
Chevrolet	Corvette	2020	2020	—	—	All	All

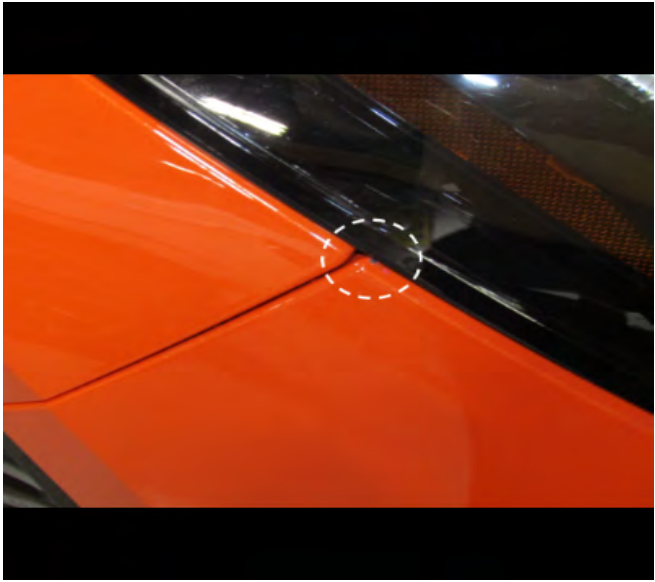
<p style="text-align: right;">5614850</p> <p>Some customers may comment on seeing a small paint chip in the front fascia below the headlamp. This condition could be visible on one or both sides of the vehicle.</p>

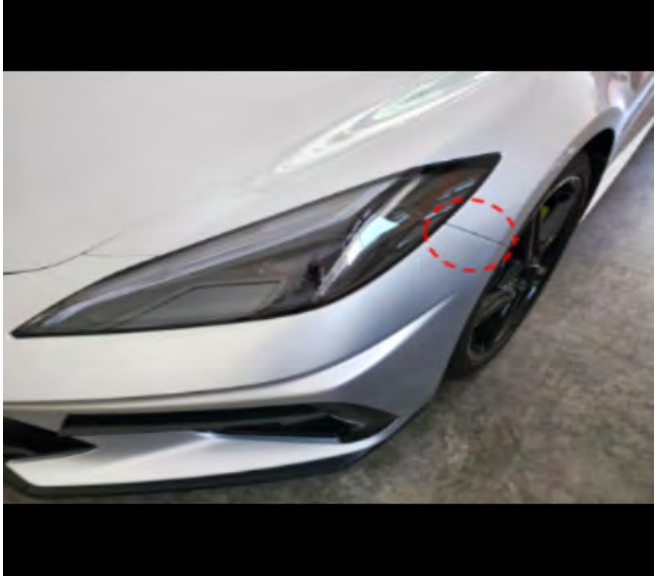
<p style="text-align: right;">5614852</p> <p>The cause of the condition may be that the fender to fascia gap joint may be mis-positioned.</p>
<p>Correction</p>

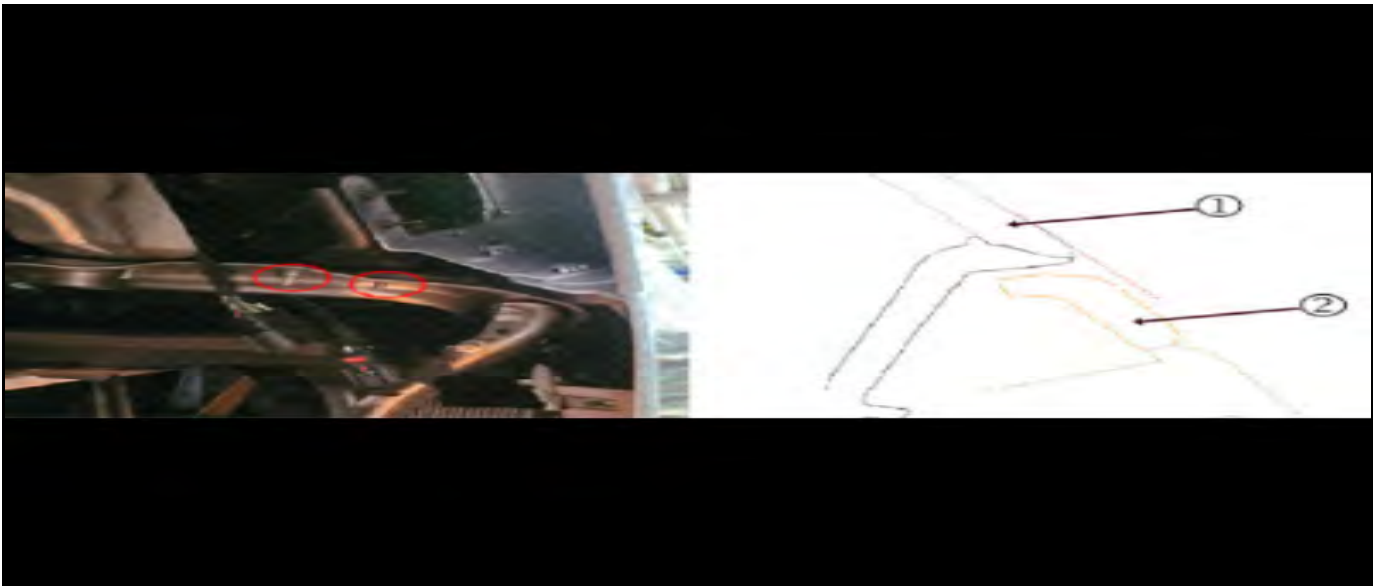
5614867

Note: The section view above shows a dashed red line where the headlamp (1) is proud of the fender (2).

- Loosen the two bolts (shown circled above). Adjust the fender tip inboard until the headlamp lens projects over the fender, and retighten.

Tighten the bolts to 9 N•m (80 lb in).
