# **Service Bulletin**

#### Subject: Check Engine Lamp Illuminated, DTC P159F 00 Set, No Audio

Brand:	Model:	Model Year:		Date Breakpoint:		Engine:	Transmission:
		from	to	from	to	Engine.	Transmission.
Buick	Encore GX	2020	2020	SOP	March 6, 2020	All	All
Chevrolet	Trailblazer (VIN M)	2021	2021

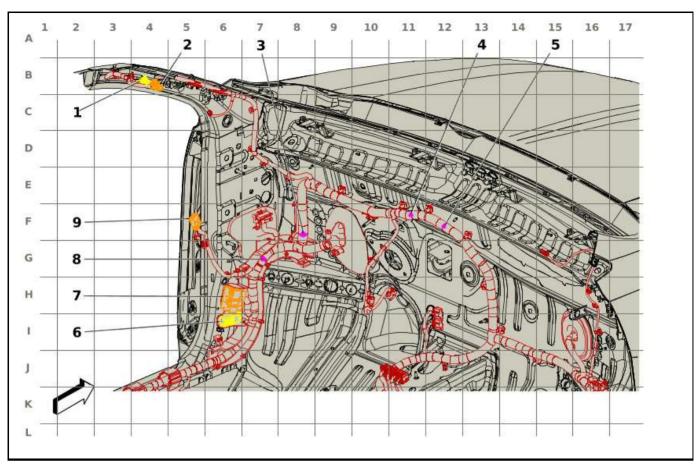
5437484

- 2. Inspect the X200 IP harness to Body harness connector (7), located at the lower Left A-Pillar, for possibly not being seated correctly.
- 3. Ensure that the wires are not twisted, not too taut, and the routing is correct.
- 4. Also ensure that the connection is correctly seated on all 4 sides.
- 5. Verify that the condition has been eliminated.

**Note:** First inspect the X200 connection BEFORE disconnecting.
