# Service Bulletin

Bulletin No.: 20-NA-139

**Subject:** No Crank No Start

Brand:	Model:	Model Year:		VIN:		Engine:	Transmission:
		from	to	from	to		
Chevrolet	Silverado	2018	2018	SOP	November 1, 2018	L83	-
	Suburban						
	Tahoe						
GMC	Sierra	2018	2018	SOP	November 1, 2018	L83	-
	Yukon

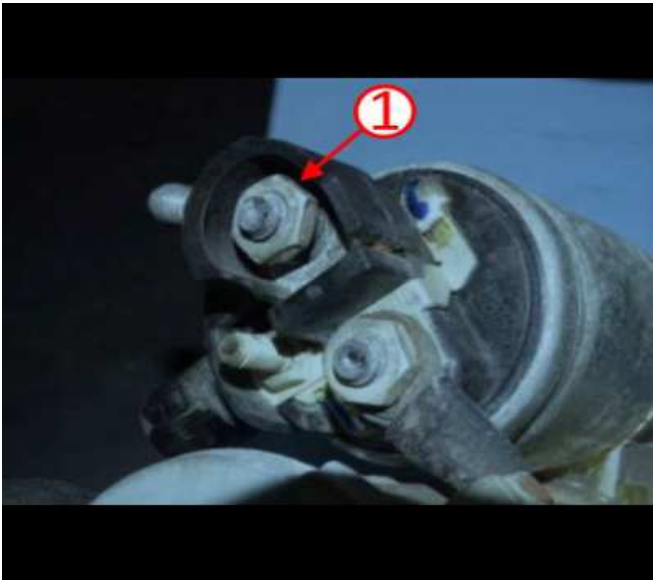
<b>Involved Region or Country</b>	North America
<b>Condition</b>	Some customers may comment that the engine will not crank over or the starter will not engage. Some technicians may not find any DTC or any other immediate indications of a concern.
<b>Cause</b>	This condition may be caused by a loose battery positive connection at the starter.
<b>Correction</b>	<div data-bbox="683 1045 1333 1621">

</div> <p>5619731</p> <p>Inspect the battery positive connection at the starter (1):</p> <ul style="list-style-type: none"><li>• If the battery positive connection is loose, torque the B+ terminal nut to 12.0 ± 0.3 Nm (8.8 lb ft).</li><li>• If the battery positive connection is not loose, refer to SI for further diagnosis and repair.</li></ul>
