Service Bulletin

Bulletin No.: 20-NA-140

Subject: Service Front Leveling System Message - DTC U3000 SYM49 Stored

Brand:	Model:	Model Year:		VIN:		Engine:	Transmission:
		from	to	from	to		
Chevrolet	Corvette	2020	2020	—	—	All	All

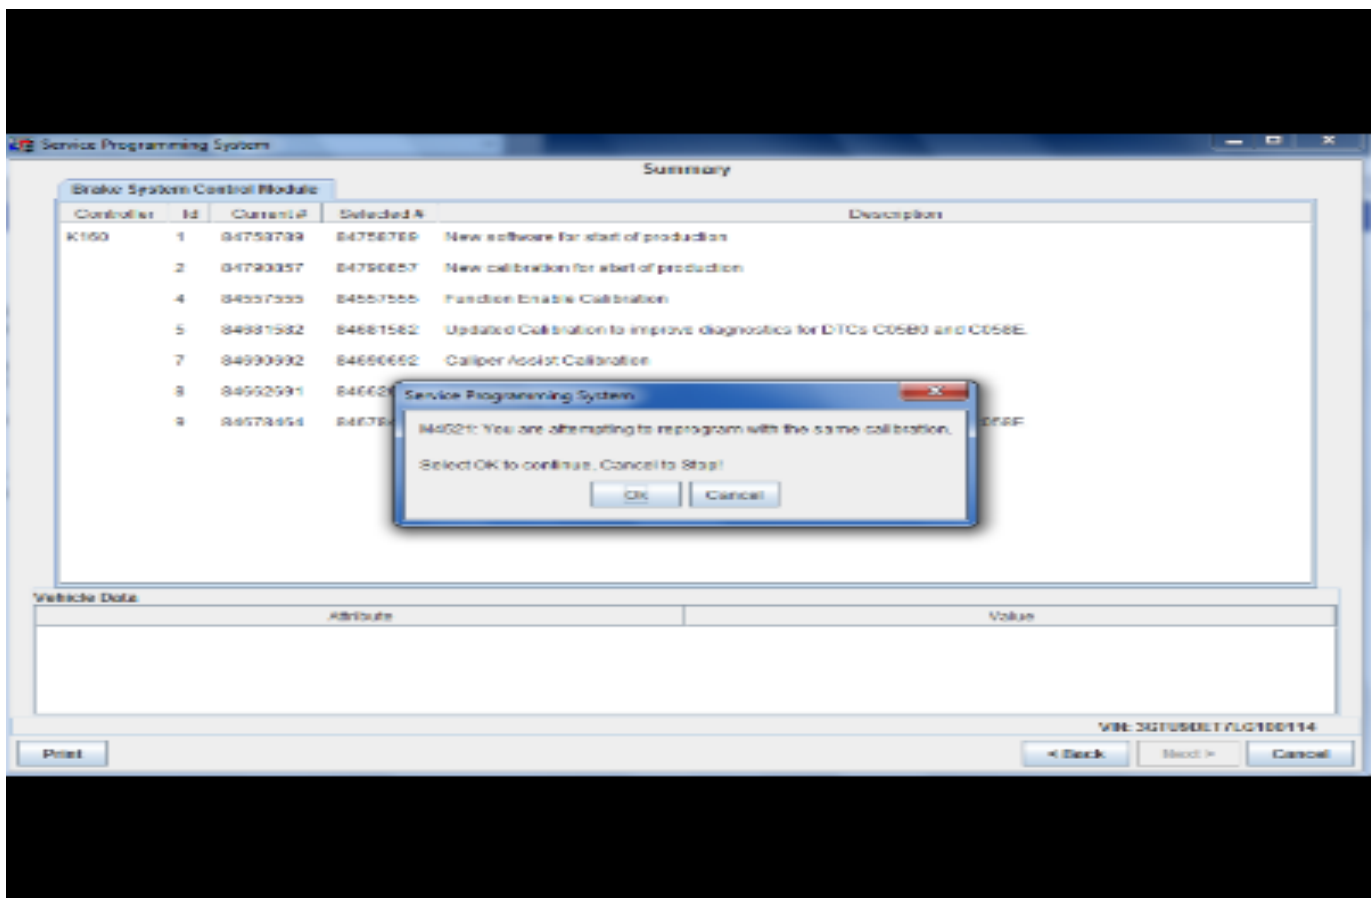
5431207

Important: TIS2WEB screen shown. Techline Connect screen is similar and will be included soon.

Important: If the Same Calibration/Software Warning is noted on the SPS screen, select OK and follow screen instructions. After a successful programming event, the WCC is located in the Service Programming

System dialogue box of the SPS Summary screen. No further action is required. Refer to the Warranty Information section of this bulletin.

1. Reprogram the Front Suspension Lifting/Lowering Hydraulic Power Pack Module. Refer to *K218 Front Suspension Lifting/Lowering Hydraulic Power Pack Module: Programming and Setup* in SI.

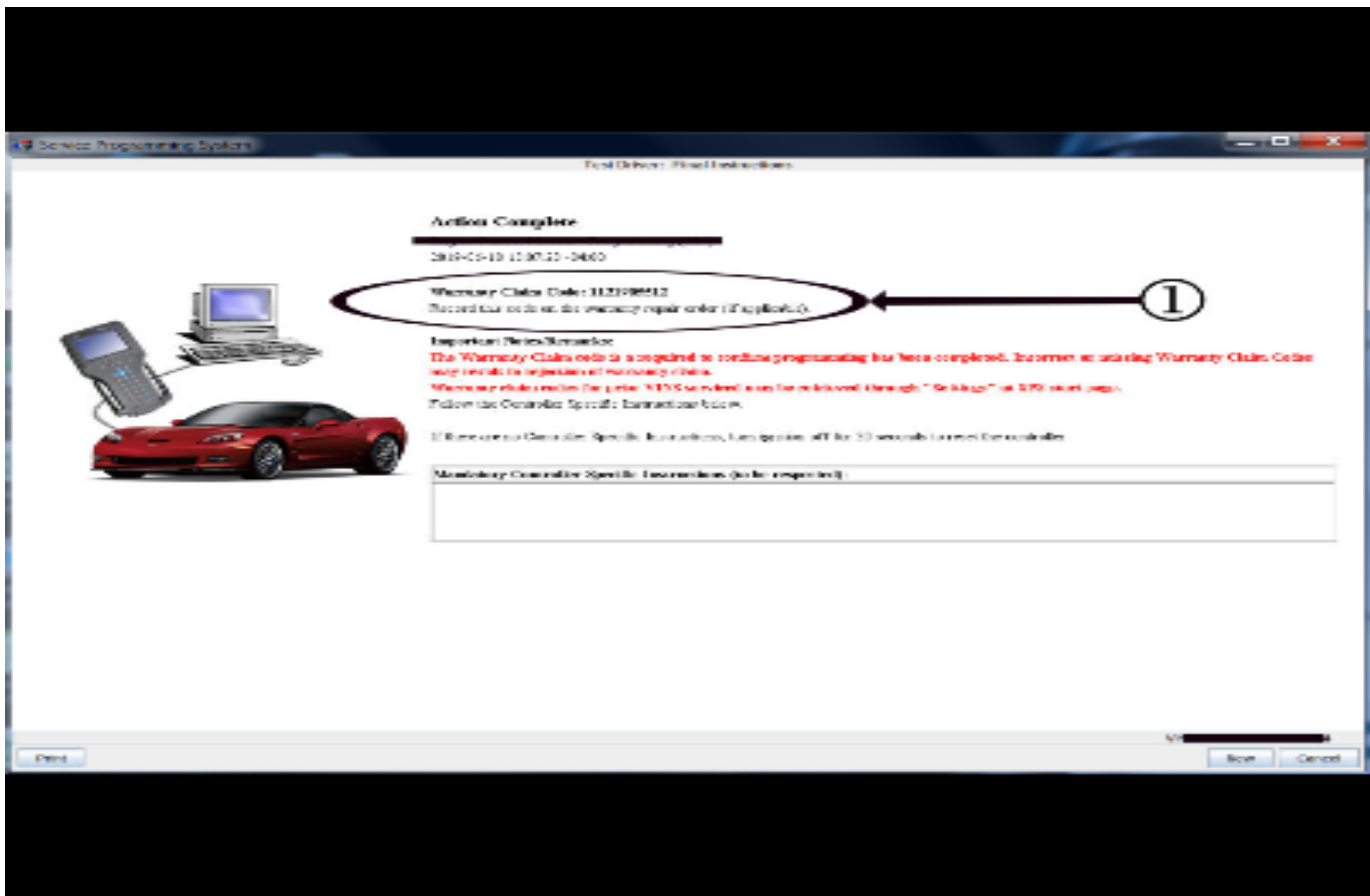
5431209

Important: TIS2WEB screen shown. Techline Connect screen is similar and will be included soon.

Important: To avoid warranty transaction rejections, you **MUST** record the warranty claim code provided on the SPS Warranty Claim Code (WCC) screen on the job card. Refer to callout 1 above for the location of the WCC on the SPS screen.

2. Record the SPS Warranty Claim Code on the job card for warranty transaction submission.
