Bulletin No.: PIT5749
Published date: 06/4/2020

PIT5749 Door May Not Unlock On First Attempt Or Lock Rod Moves Slow/Binds

Brand:	Model:	Model Years:	VIN:		Engine:	Transmissions:
			from	to		
Chevrolet	Silverado 1500 (New Model)	2019	All	All	All	All
Chevrolet	Silverado 1500	2020	All	All	All	All
GMC	Sierra 1500 (New Model)	2019	All	All	All	All
GMC	Sierra 1500	2020	All	All	All	All

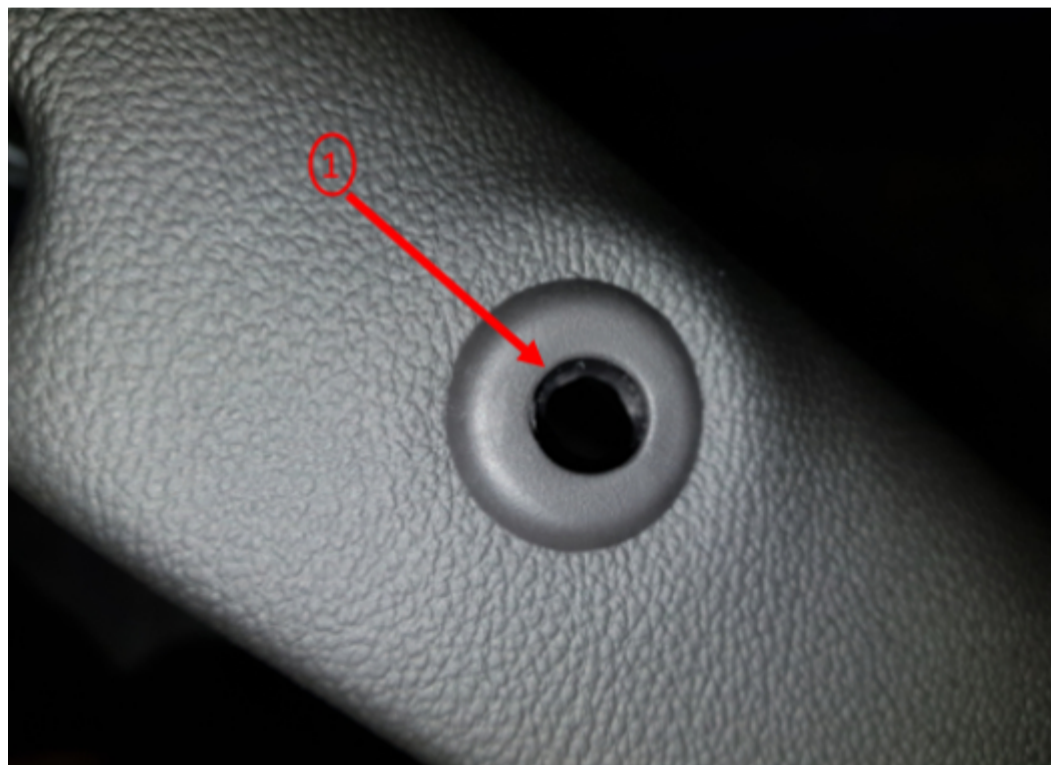
Involved Region or Country	North America
Condition	Some customers may comment that a door may not unlock on the first attempt and may unlock on subsequent unlock attempts. This concern could be with any of the vehicles doors.
Cause	This concern could be caused by friction between the lock rod and the door panel lock rod bezel ring (1), shown below.

Remove the door panel lock rod bezel ring and actuate the door locks. If the locks function properly, inspect the door panel lock rod bezel ring opening for excessive door skin flashing (2), as well as, the key way opening for

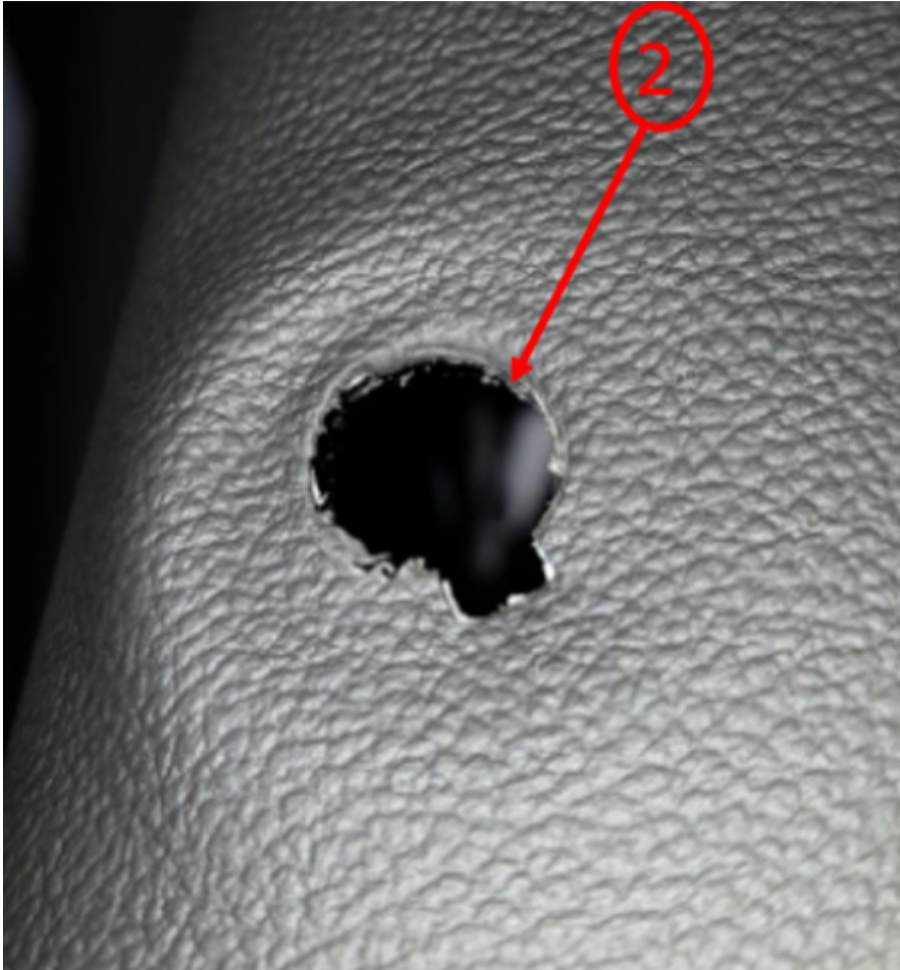
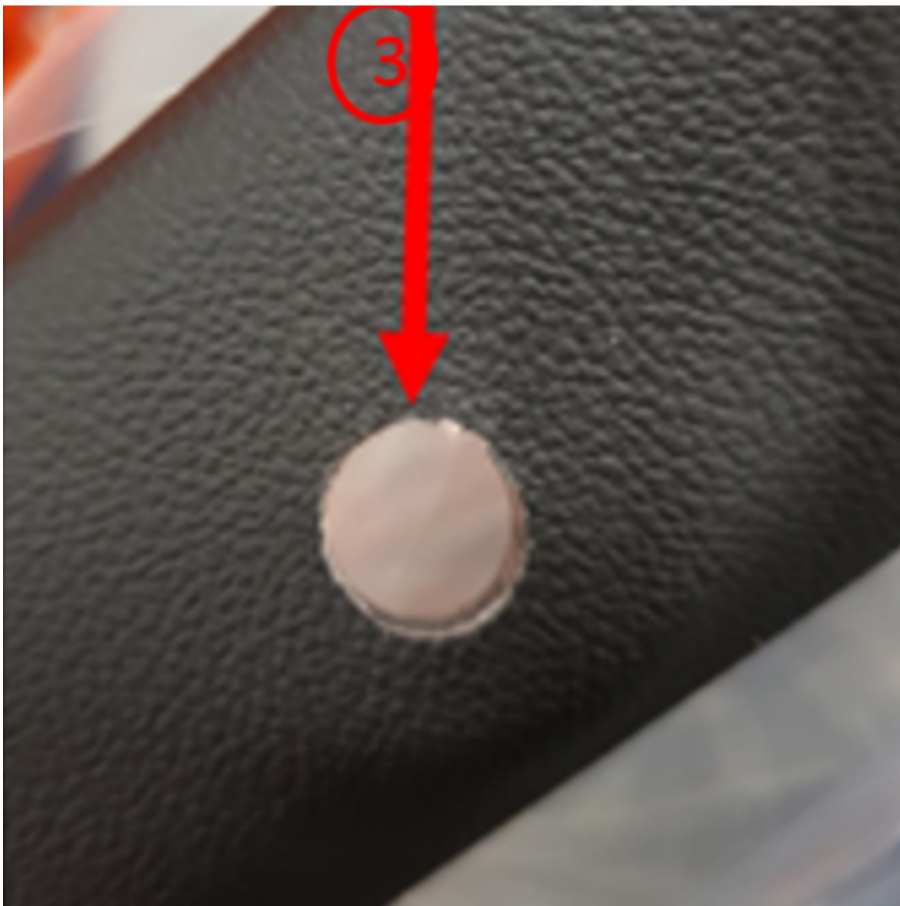
being covered over (3), both shown below. Use a sharp drill/cutter to remove any excessive door skin flashing without making the ID of the door opening larger.

Install a new door panel lock rod bezel ring on the affected door. Bezels are available from CCA, see the "Parts Information" section below. Do not repair any unaffected doors.
