Preliminary Information

PIP5175D Slip Or Shudder During A Launch In First Second Third Or Fourth Gears Delayed Engagement Into Drive Clunk Or Bump During The 1-2 Shift

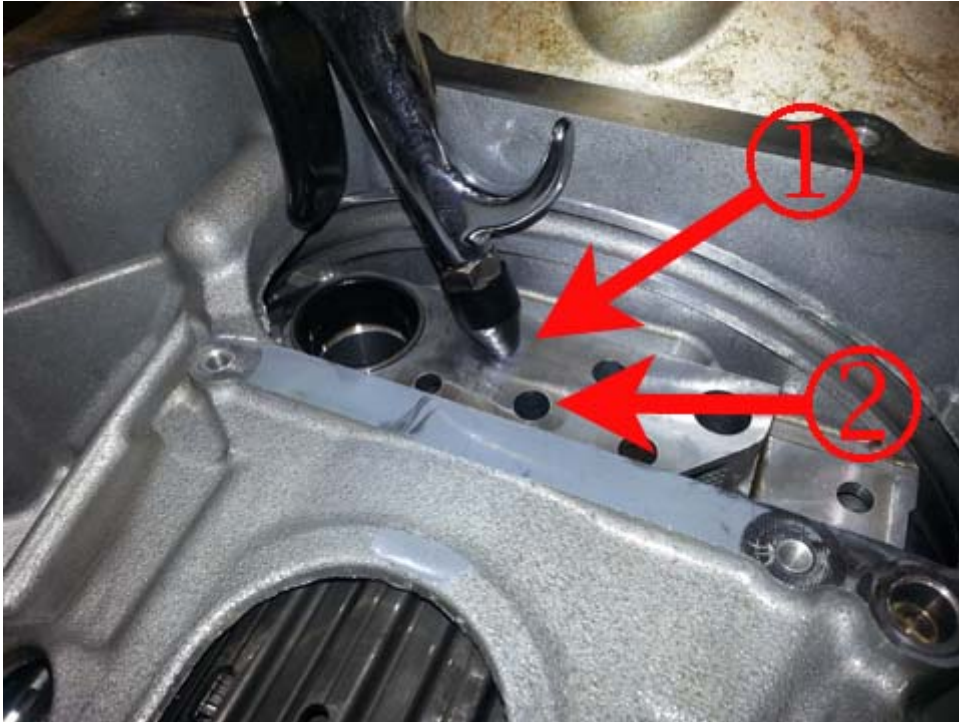
Referring to the picture below and wearing proper eye protection apply compressed air to the 1-2-3-4 clutch apply passage and inspect for air leaking out of the compensator feed passage in the pump cover.

If no leakage is found out of the compensator feed passage listen for excessive air leakage inside the transmission.

Component Name: Applying compressed air to the 1234 clutch passage.

Component Name: Compensator feed passage.

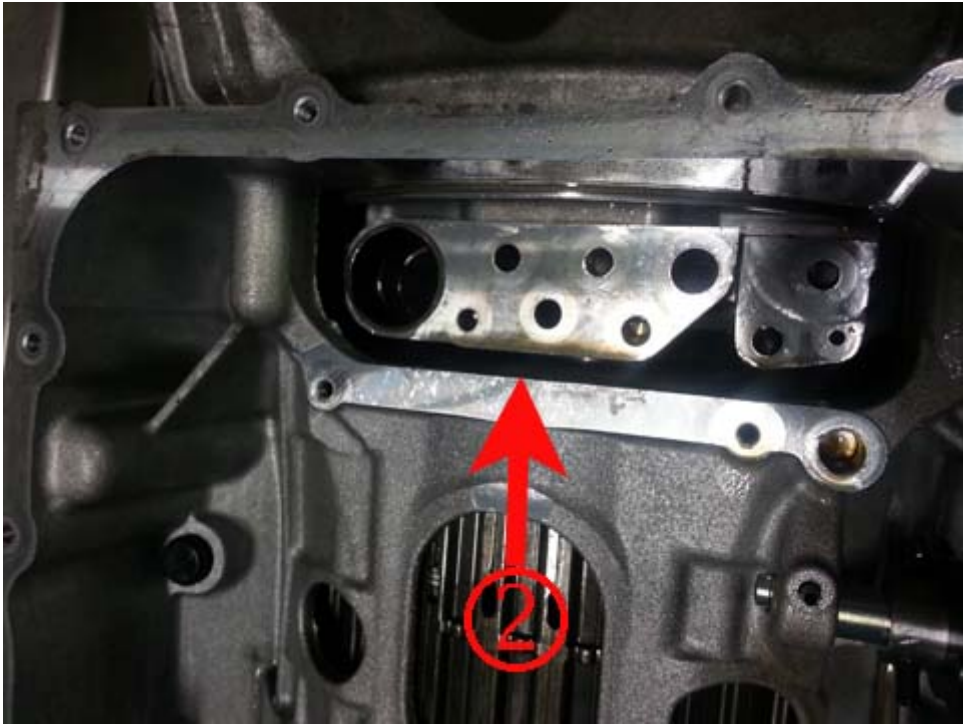
You may also notice fluid leaking or see a misaligned gasket by looking up through the case opening between the pump stator support and the 1234/35R clutch housing during this test as shown below.

Component Name: Gap between the pump cover and the 1234/35R clutch housing.

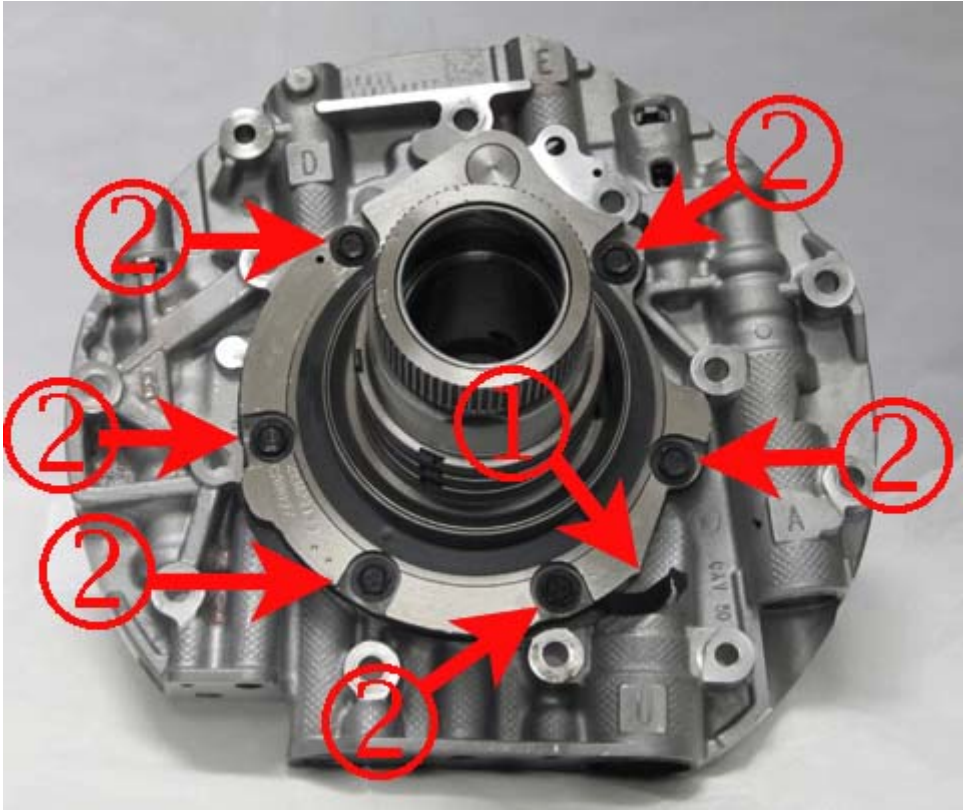
These concerns may be due to loose stator support to pump cover bolts causing a leak at the stator support to pump cover gasket.

If excessive air leakage is found inspect the transmission fluid pump for loose stator support to pump cover bolts or a misaligned stator support to pump cover gasket.

Component Name: Misaligned Gasket

Component Name: Stator Support Bolts

If any of the bolts are loose or the gasket is misaligned or leaking, the transmission pump cover must be replaced and the 1234 clutch plates should be inspected for being distressed and repaired as needed.

Note: The transmission adapts must be reset if the pump cover is replaced to address this concern.
