Preliminary Information

PIT5750 Diagnostic Tip - Intermittent Parasitic Battery Draw / Dead Battery / Slow Crank / Radio Stays On or Fades Slowly After RAP Cancel / (LIN Bus)

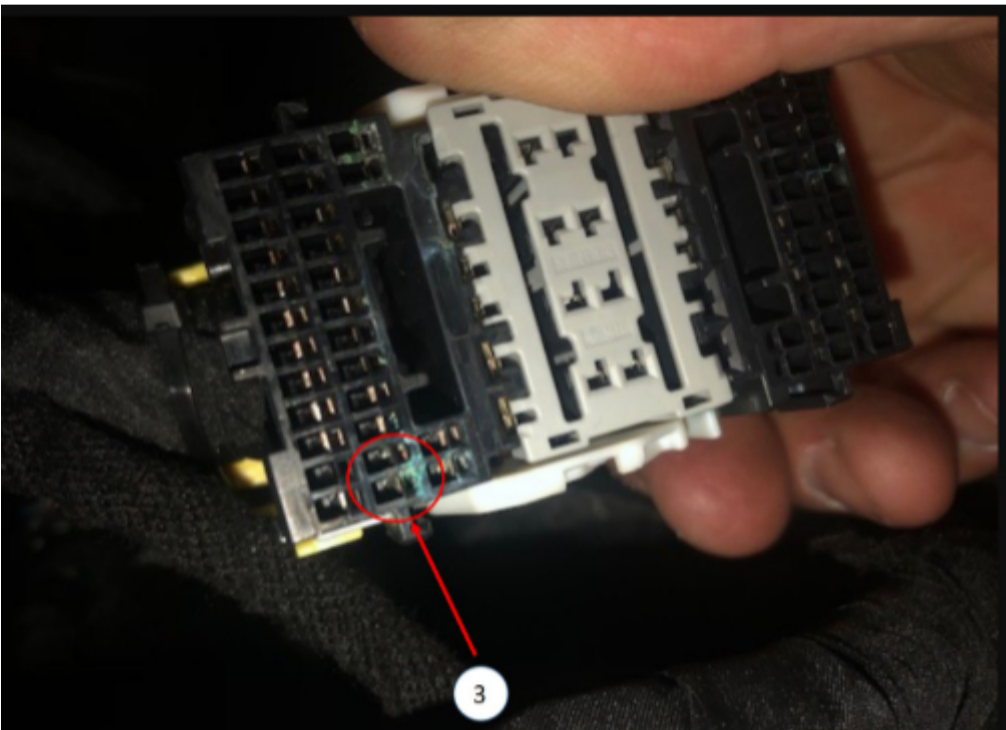
2. Inspect connector X225 for terminal issues/corrosion (3), as shown below. In this scenario, the LIN Bus circuit 4115 was corroded and shorting to other terminals in the connector.

If any issues are found then follow SI Wiring and Connector repair instructions to correct the concern.
