Preliminary Information

PIP5495M Check Engine Light On With P0299 Or P0234

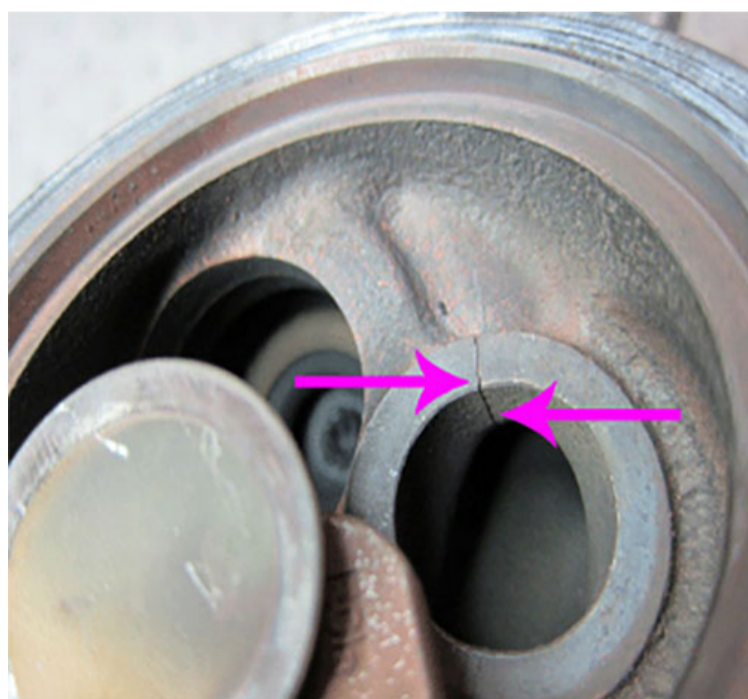
Crack(s) at the wastegate valve port (this is normal and does not affect performance)

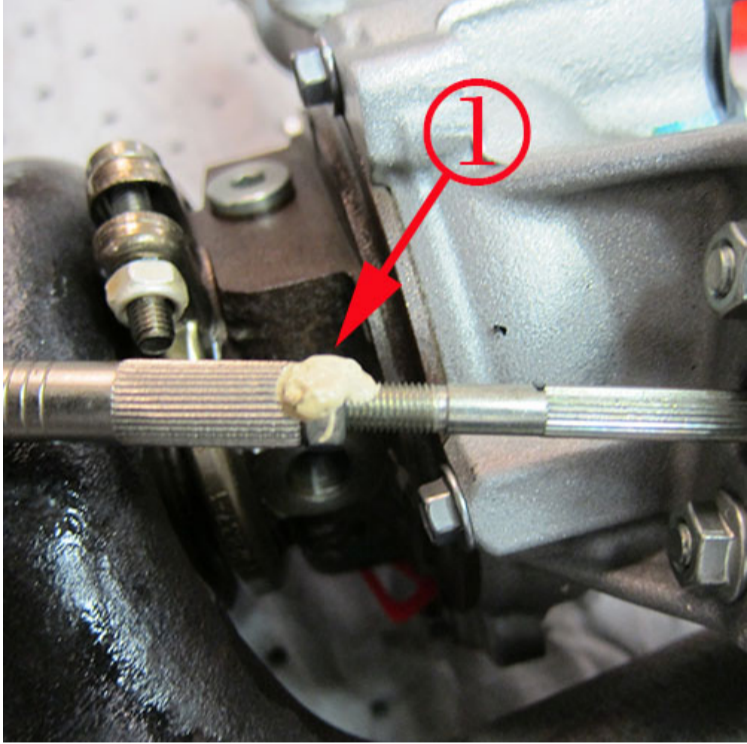
Wastegate actuator clip missing (replace wastegate actuator clip - released for service)

If the tamper paint seal is broken or missing, check the vehicle for any additional sign of modification to the induction, exhaust, or engine calibrations as this may indicate an attempt to adjust the wastegate arm to modify the powertrain operation.

If found, review the powertrain warranty status with your service manager prior to performing repairs

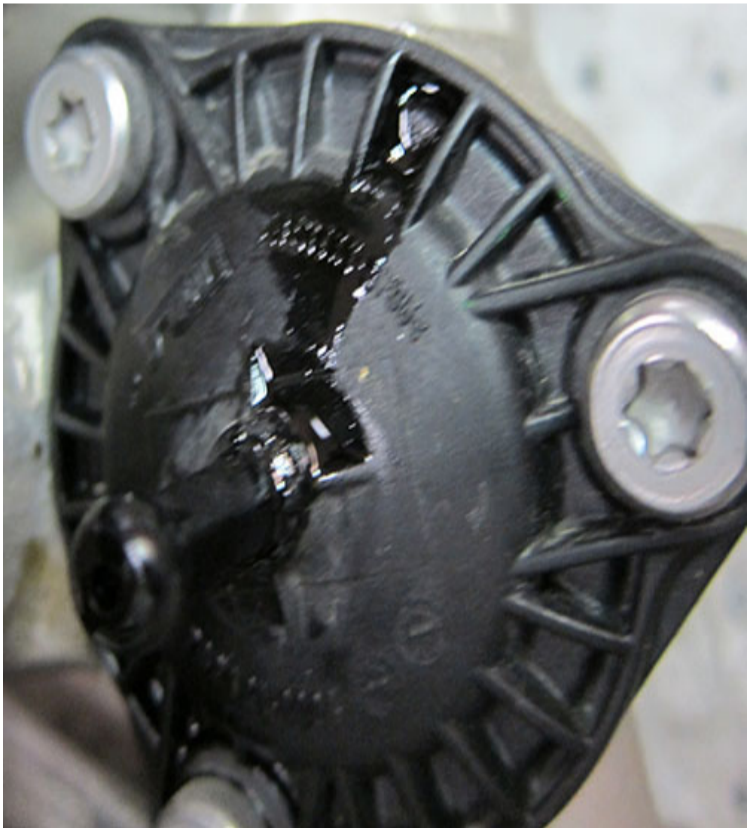
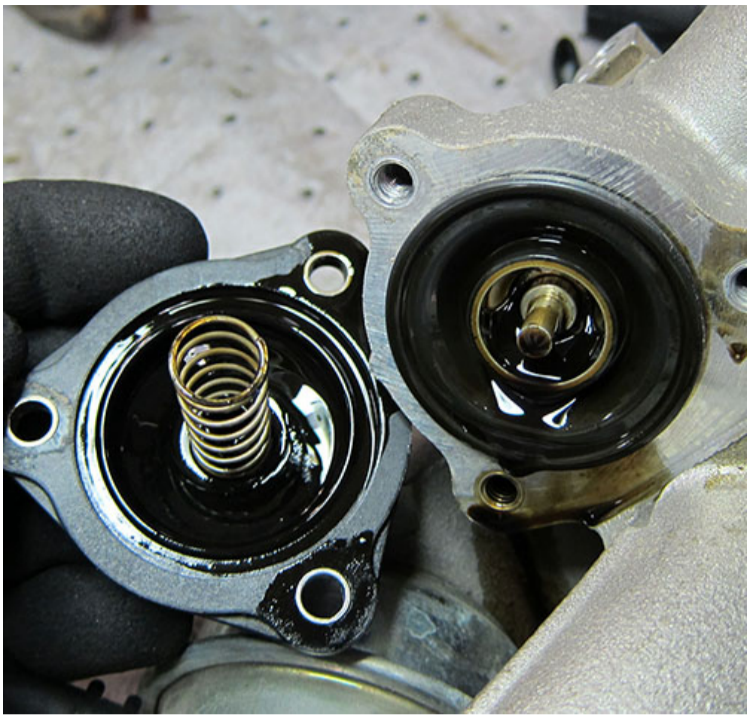
Bypass (recirculation) valve cover port broken or water/oil found inside the valve (clean the components, if necessary replace bypass (recirculation) valve assembly - released for service)

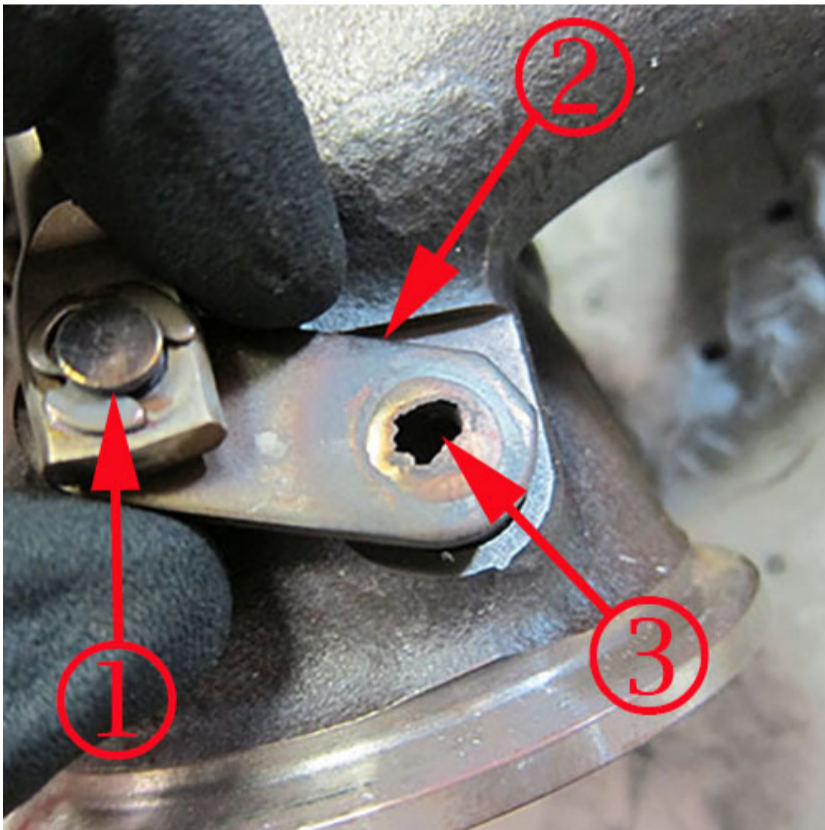
Disconnected wastegate lever arm (crank) (2) from the shaft (3).

Disconnected wastegate lever arm pin (1) from the lever arm (crank) (2).

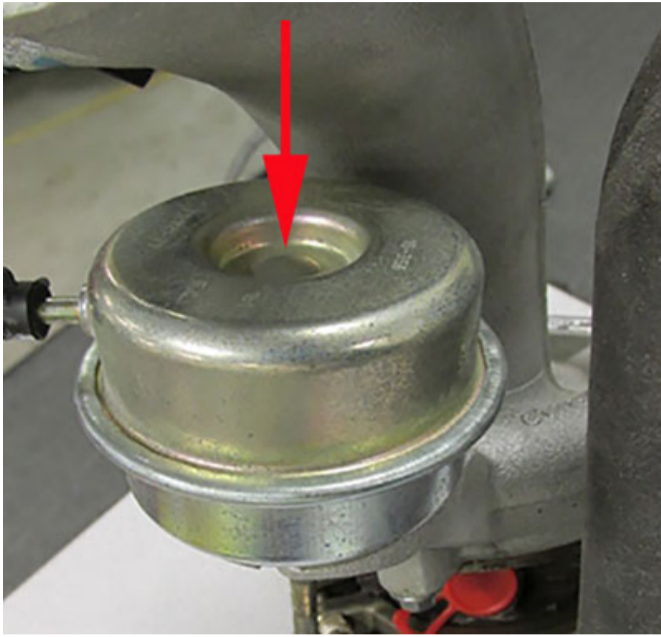
Original equipment actuator is found on 2011 and 2012 model years.

The original equipment wastegate actuator found on 2011 and 2012 model years shown below, has a recessed stop at the head of the actuator.

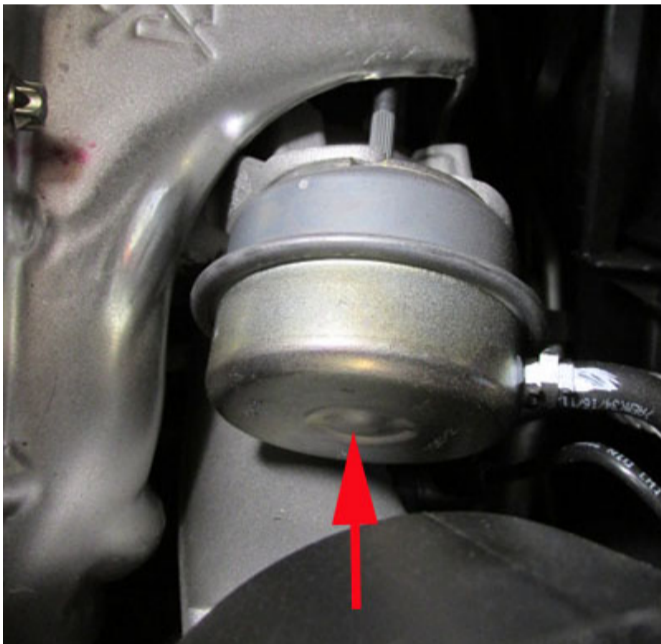
Updated design.

The updated design actuator shown below has a stop that is not recessed and allows 5mm more travel in the closed direction.

With this updated design, it is very unlikely that an insufficient preload issue exists.

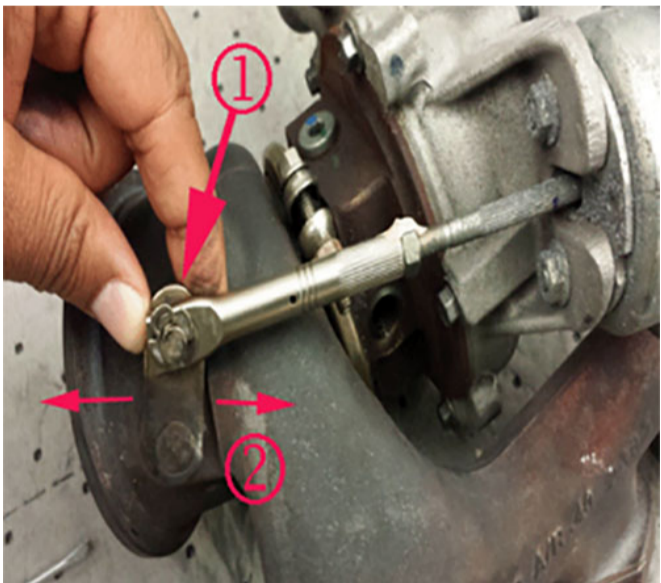
Wastegate Preload Inspection.

Wastegate lever arm (1) moves with little effort in the direction as shown (2) while the actuator rod remains static, see picture below "Wastegate Preload Inspection".

If the lever wiggles with little effort while the actuator rod remains static, the pre-load is insufficient and the turbocharger must be replaced.

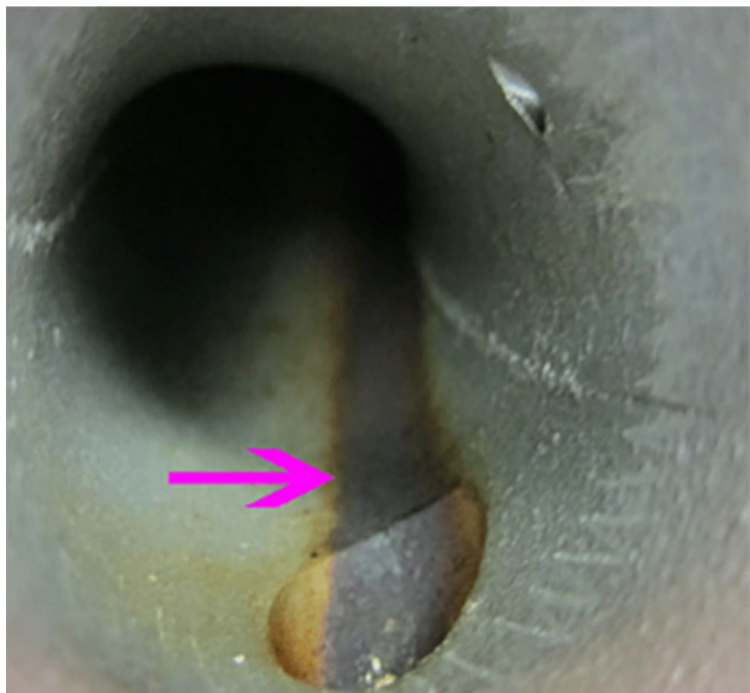
Note: The view shown below indicates NORMAL oil staining in the turbocharger outside air inlet. This dry stain does not represent an oil leak.

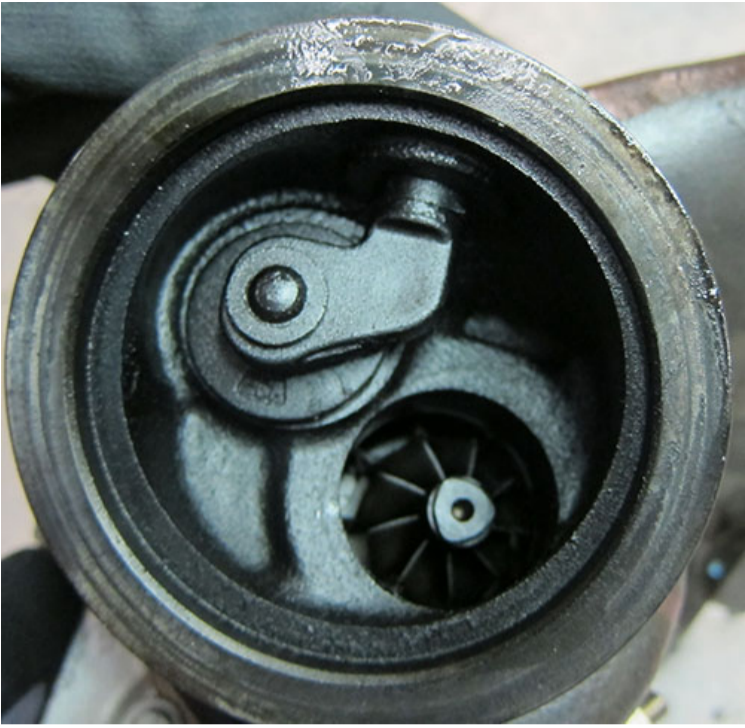
Inspect for the presence of oil in the exhaust system.

If oil is present in the exhaust system, then inspect the turbocharger turbine and compressor wheels to be sure that they are not broken off.

It is very unlikely that the turbocharger will leak oil internally if the turbine and compressor wheel shaft is not broken.

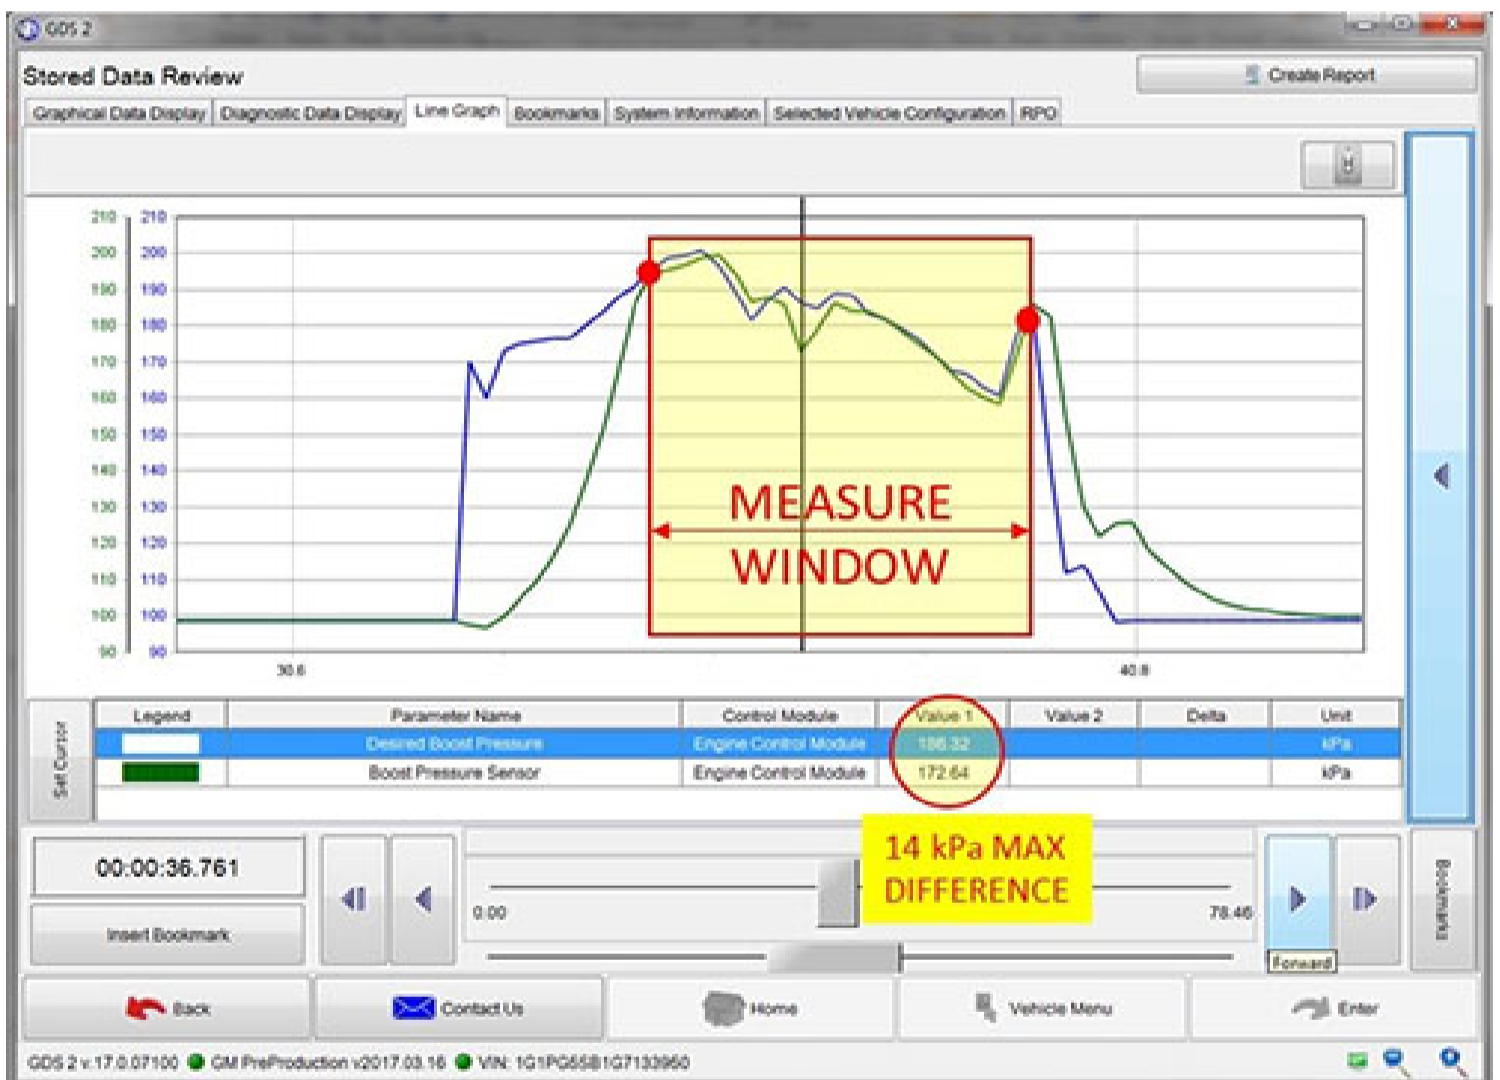
Example of normal turbocharger wastegate operation:

In this example, notice that the measure window begins once the Boost Pressure Sensor reading (Green) meets the Desired Boost Pressure reading (Blue) and ends when the APP is released per the testing instructions.

The Boost Pressure Sensor reading (Green) closely tracks the Desired Boost Pressure reading (Blue) indicating normal Turbocharger operation.

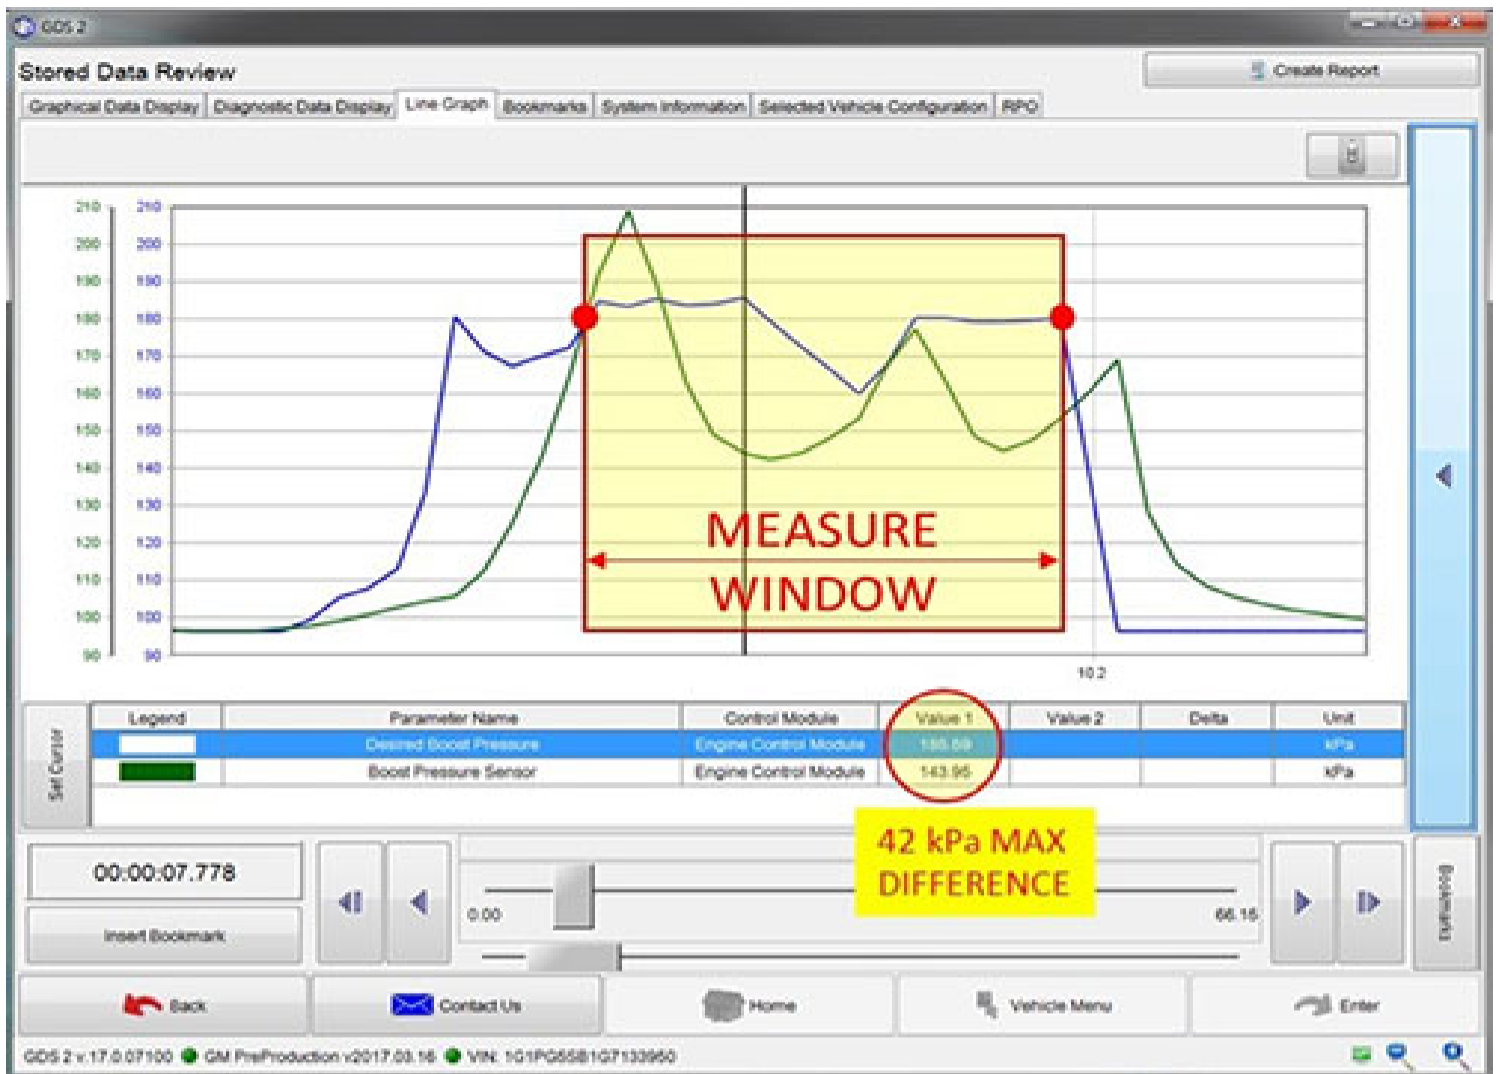
Example of a malfunctioning turbocharger wastegate:

In this example, notice that the Boost Pressure Sensor reading (Green) moves thru and well above the Desired Boost Pressure reading (Blue).

As the abnormally high pressure is corrected by the management system, the Boost Pressure Sensor reading (Green) over reacts and dips well below Desired Boost Pressure reading (Blue).

A difference of 14 KPA (2 PSI) between the Boost Pressure reading (Green) and the Desired Boost Pressure Sensor reading (Blue) Indicates a Malfunctioning Turbocharger.
