Preliminary Information

PIC5852C No Fob Detected Message All Other Functions Normal Models

with Passive / Keyless Entry System (RPO ATH)

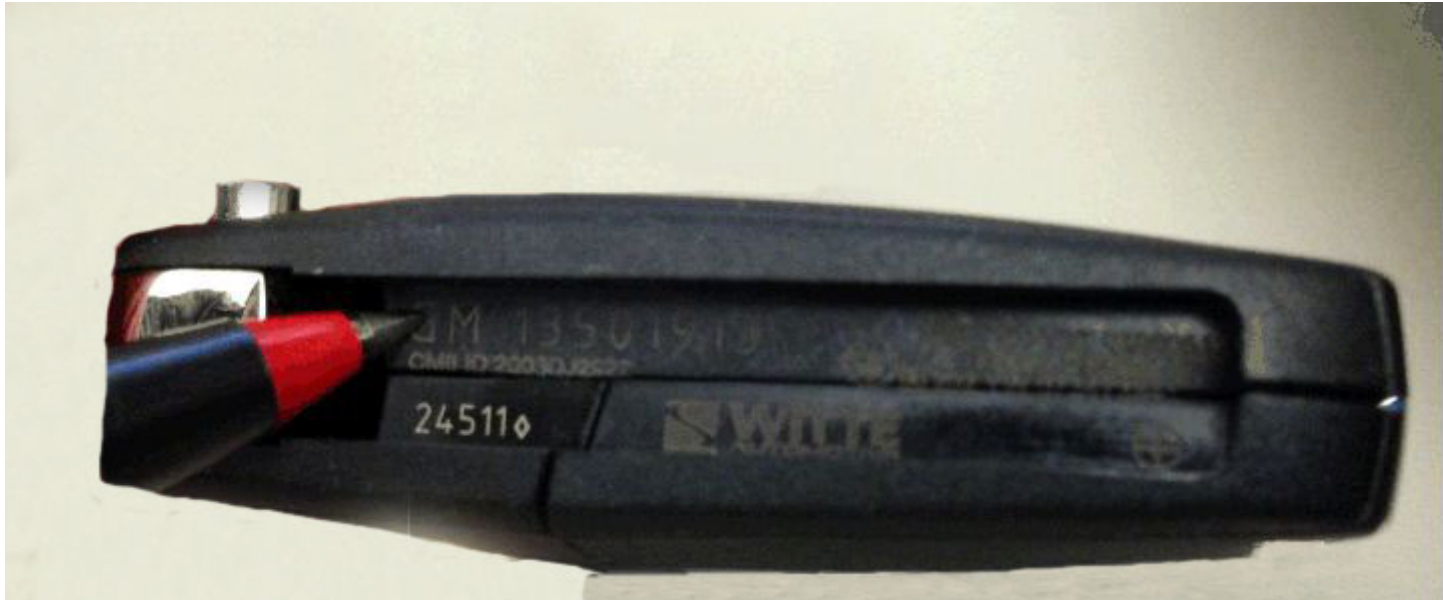
It is possible the vehicle may have been shipped with or a dealer mistakenly added a "non-PEPS" fob to a "PEPS" (Passive Entry Passive Start) vehicle. This can be confirmed by obtaining the part number from the body of the fob behind the key blade and comparing to the Electronic Parts Catalog (EPC).

Replace the effectedfob as required.

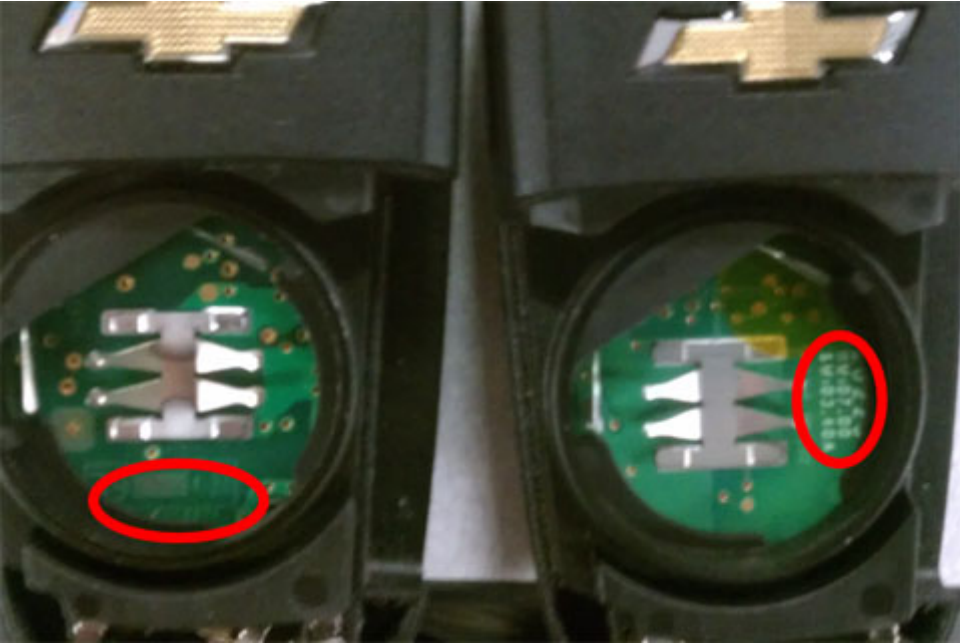
An alternate method would be to remove the battery cover and battery from the fob. With the black of the key at 12 o'clock, look at the printed circuit board. A non-PEPS fob (right) will have words stamped on the circuit board at the 3 o'clock position. A PEPS fob (left) will have a stamping at the

6 o'clock position.
