Preliminary Information

PIP5734 Check Engine Light On With P0521 and/or P06DE, P06DD

Brand:	Model:	Model Years:	VIN:		Engine	Transmissions:
			from	to	Engine:	Transmissions.
Buick	Encore GX	2020	All	All	LIH (1.2L)	All
Chevrolet	Trailblazer	2021	All	All	LIH (1.2L)	All

Involved Region or Country	North America
Condition	MIL on P0521 and/or P06DE, P06DD
Cause	Potential Engine Oil Pump Pressure Control Issue

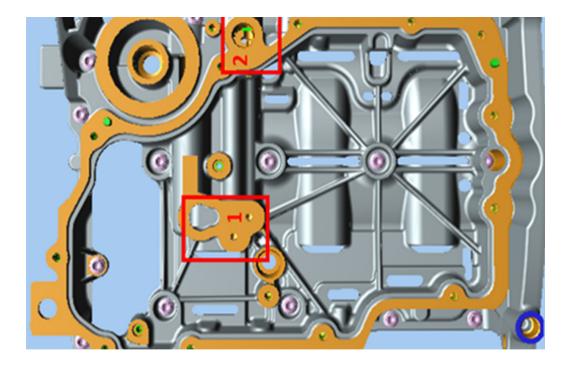
Once the Engine Oil Pan, Engine Oil Pressure Control Solenoid Valve, and Oil Pump have been removed, inspect the three oil pump ports (1) and the Engine Oil Pressure Control Solenoid Valve port (2) for debris.

If found, remove any debris from the ports using caution not to scratch or damage related surfaces.

Do not use brush type tools or cloth materials that may leave debris in the oiling circuit ports.

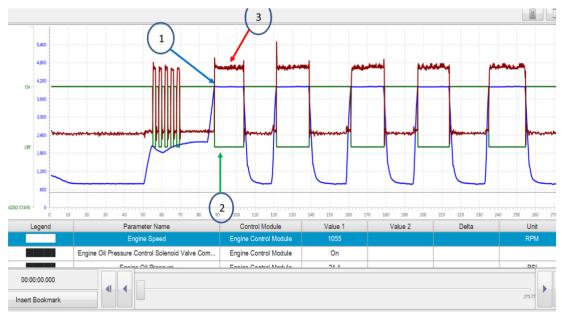
In this example, each time that the engine RPM (1) is raised to 4000, the Engine Oil Pressure Control Solenoid Valve Command (2) moves from ON (low pressure) to OFF (high Pressure).

The actual engine oil pressure (3) moves up to a normal 45-55 PSI range.

This is a normal pattern.

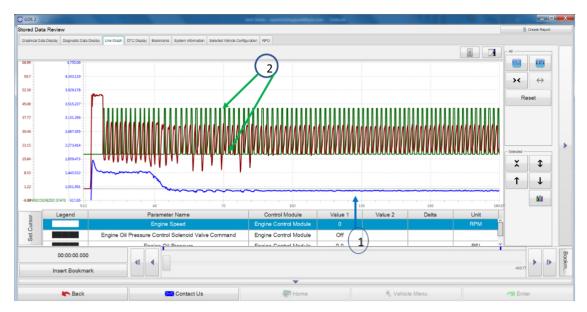
Anytime during engine idling (1) the Engine Oil Pressure Control Solenoid Valve Command may cycle rapidly between on and off (2).

This is a normal characteristic of the system and is not an indication of engine oil pump failure.

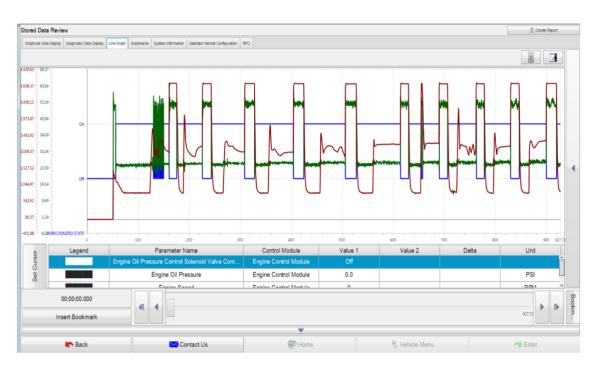
In this example you see a normal oil pump switching pattern thru ten 4000 RPM cycles.

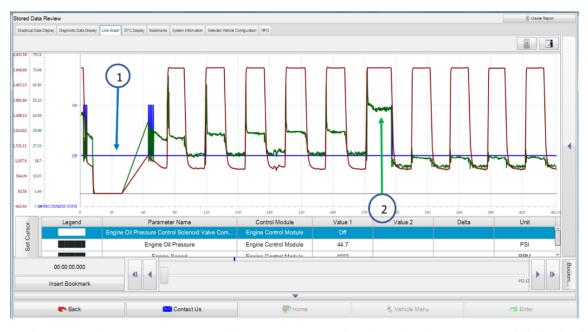
In this example you see Engine Oil Pressure Control Solenoid Valve Command defaulted to off (1) commanding high oil pressure at all times.

The oil pump only achieved a normal high pressure in one of the ten increases to 4000 RPM @ (2) indicating a failed engine oil pump.

Engine Oil Pump replacement and Lower Crankcase Extension port inspections are required. Refer to step #4.

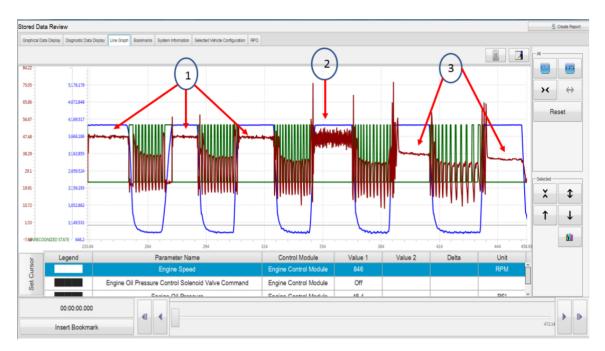
In this example the Oil Pump made normal pressure on the first three switches from low to high (1).

The 4th switch shows an abnormal pattern (2) followed by failures to achieve normal pressure in the 5th and 6th switch (3) indicating a failed engine oil pump.

Engine Oil Pump replacement and Lower Crankcase Extension port inspections are required. Refer to step #4.
