Preliminary Information

PIT5564C SIR MIL With DTCs B0012 B0013 B0014 B0015 B0019 B0020 B0021 and/or B0022 (Aftermarket USB/Phone Charger)

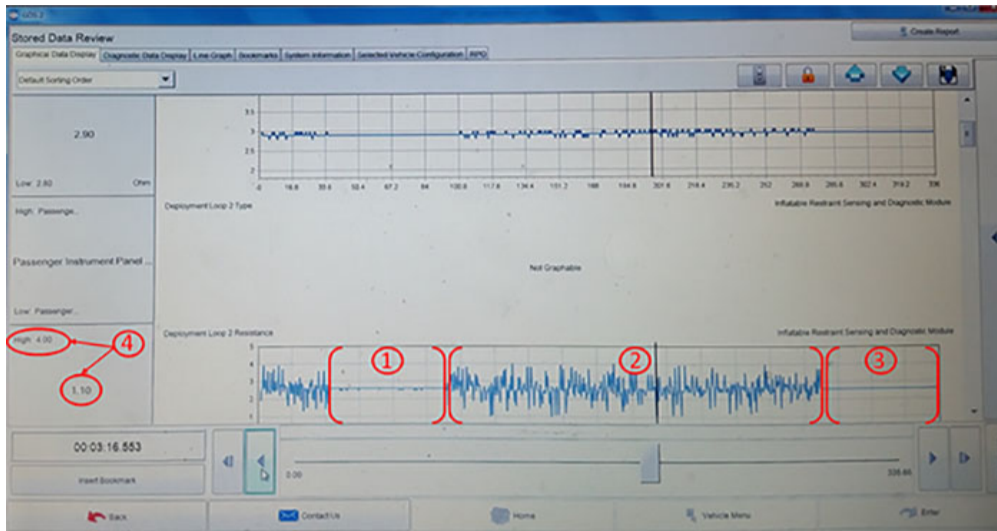
Involved Region or Country	North America
Condition	Some owners may comment of an intermittent SIR MIL. When checking for DTC's, any of the following may be set: B0012, B0013, B0014, B0015, B0019, B0020, B0021, and/or B0022. In most cases, it will have symptom codes for both high and low loop resistance (0D - Loop Resistance Above Threshold and 0E - Loop Resistance Below Threshold).
Cause	<p>This concern could be caused by interference from an aftermarket USB and/or phone charger plugged into the 12 volt power outlet. Below is a screen print of the scan tool displaying the resistance of an air bag deployment loop.</p> <ul style="list-style-type: none"> - 1 is with only a USB charger plugged into the center console 12 volt power outlet and slight resistance changes can be seen. - 2 is when a phone was plugged into the USB charger and the deployment loop resistance is fluctuating up and down greatly. This fluctuation up and down is why many cases will have both symptoms codes for the loop resistance being above and below threshold (0D and 0E). - 3 is with everything unplugged from the 12 volt power outlet and the resistance is very steady, as it should be.

If, after following normal diagnostics and the root cause is not found, inspect the vehicle and/or question the customer if they are using any type of USB/phone charger/etc.

As in the example above, the scan tool was used to monitor the suspect air bag loop resistance while using/operating the aftermarket item plugged into the 12 volt power outlet.

If the concern is intermittent and/or can not be duplicated, ask the owner to refrain from using anything that is being plugged into the 12 volt power outlets and see if the issue goes away.

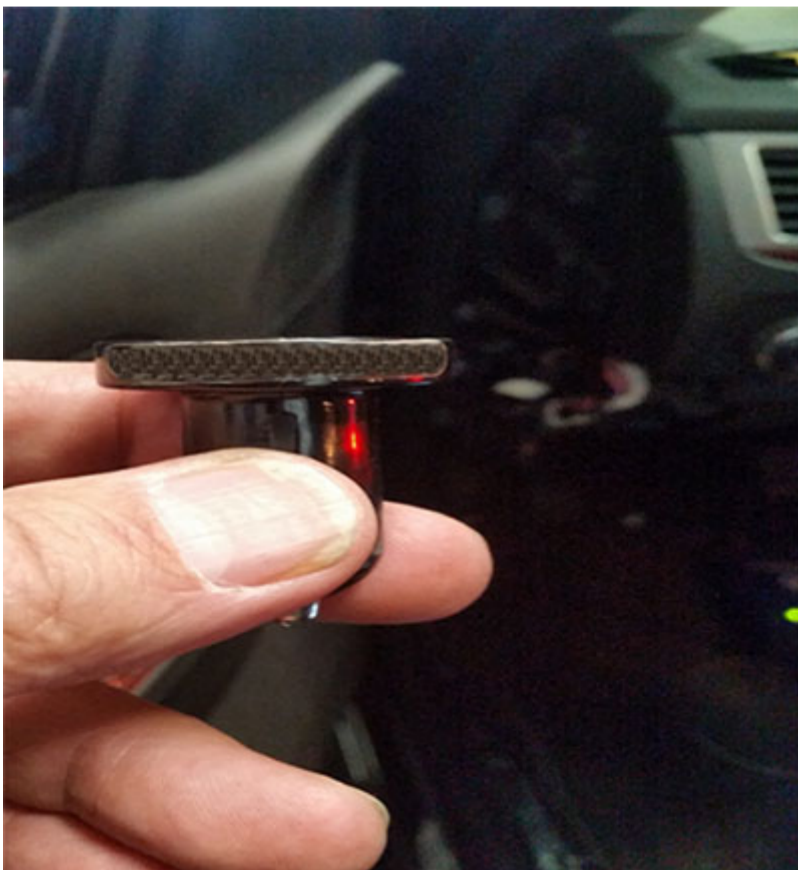
Shown below is one example of a USB charger that has caused this type of concern.
