PIP5739 Diagnostic Tip: 1.2L (RPO LIH) OIL PAN INSTALLATION

Brand:	Model:	Model Years:	VIN:		Engine:	Transmissions:
			from	to		
Buick	Encore GX	2020	All	All	1.2L (LIH)	All
Chevrolet	Trailblazer	2021	All	All	1.2L (LIH)	All

Involved Region or Country	North America
Condition	Diagnostic Tip: 1.2L (RPO LIH) OIL PAN INSTALLATION
Cause	Oil Pan Installation RTV application information

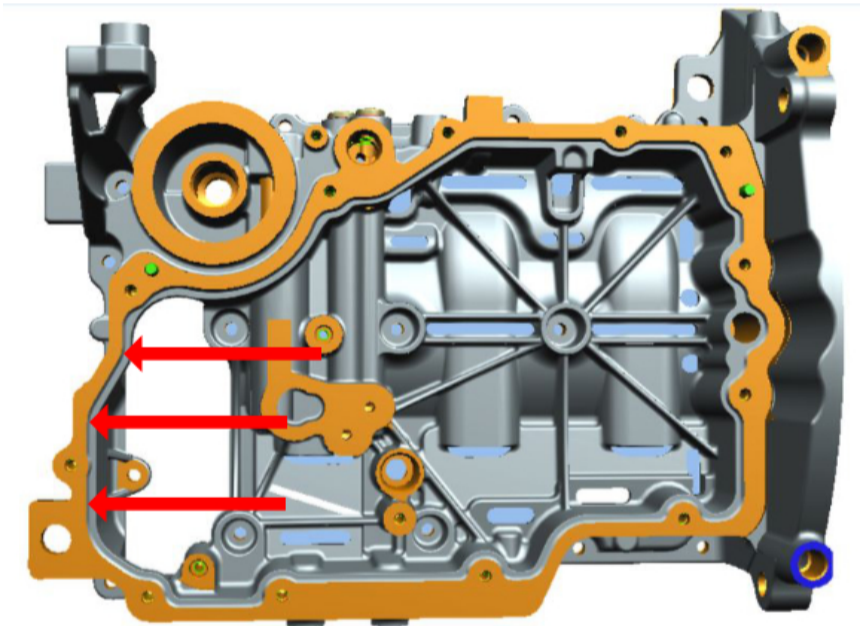
When installing the engine oil pan on the 1.2L (RPO LIH) engine, proper placement of the room temperature vulcanizing (RTV) sealant is critical. All sealing surfaces must be free of contamination prior to applying a 4 mm (0.16 in) bead of sealant to the lower crankcase extension. Ensure that the inside edge of the Lower Crankcase Extension is wiped clean of excessive engine oil to prevent contamination of the sealing surface post RTV sealant application and prior to oil pan installation. The Lower Crankcase Extension oil pan sealing surface has a small edge / grove as indicated by the arrows shown below.
