Preliminary Information

PIT5753 Glove Box Will Not Open When Button Is Pressed

Brand:	Model:	Model Years:	VIN:		Engine:	Transmissions:
			from	to		
Chevrolet	Blazer	2020	All	All	All	All

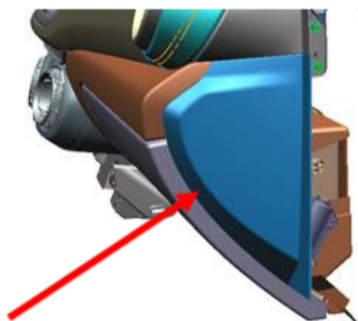
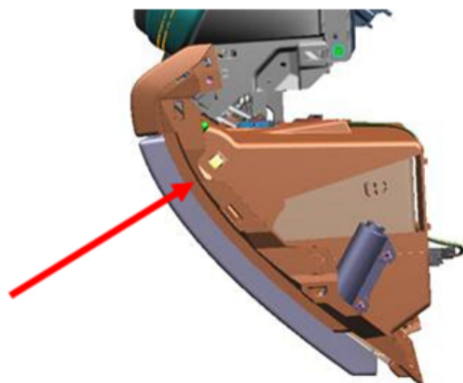
1) Remove right hand End Cap

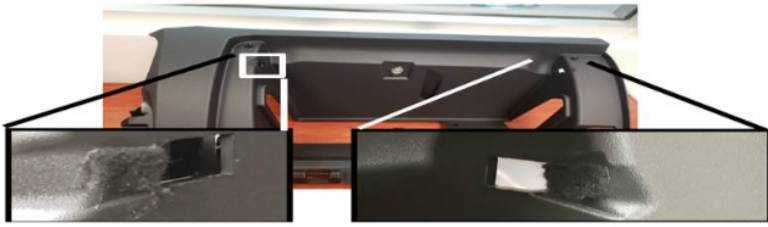
2) Push right hand Rod in-board.

This will un-latch the Glove Box Door and open it.

3) Remove felt tape and any adhesive from felt tape from the rod opening in the Glove Box Frame.
