Preliminary Information

PIP5528F Information Assistance for HFV6 Re-Manufactured Engine Drivability Diagnosis Immediately Following Installation

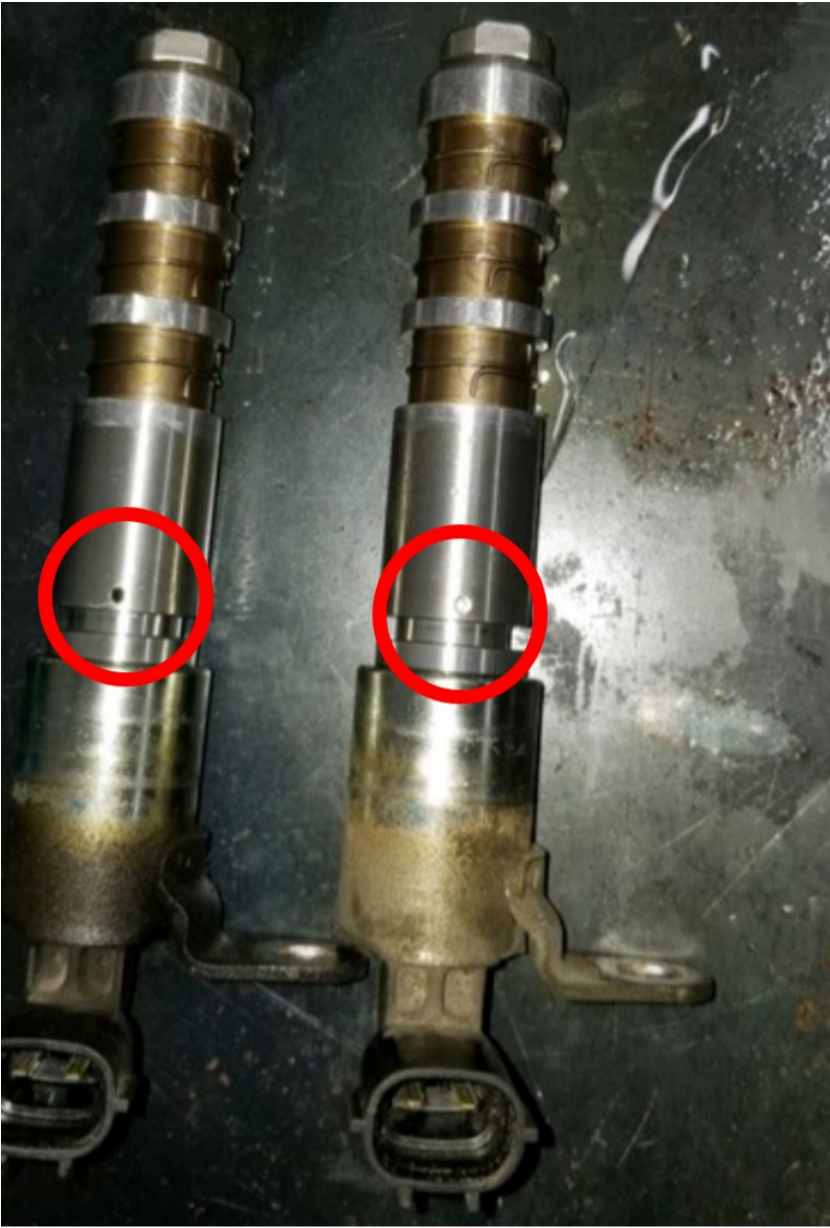
Involved Region or Country	North America
Condition	Some dealers may experience misfires, CEL / MIL, or other drivability concerns immediately after installing a GM re-manufactured HFV6 engine.
Cause	This condition may be caused by a component transferred over from the original engine that was not supplied with the replacement engine. Some of the things we have seen have been camshaft actuator solenoids (OCV's), fuel injectors and fuel, intake manifolds, and catalytic converters. Additionally this could be caused by a mistimed engine or an incorrect camshaft or actuator being installed in the incorrect location.

Comparison of good vs bad Camshaft Actuator Solenoids.

The stuck solenoid pintle is shown in each photo with the open hole visible in the body of the solenoid.

If a misfire or DTC concern is found immediately after engine installation, perform normal diagnostics.

NOTE: Make sure the misfire or DTC is not cause by ignition, fuel, or electrical components that were not part of the replacement engine assembly. See below

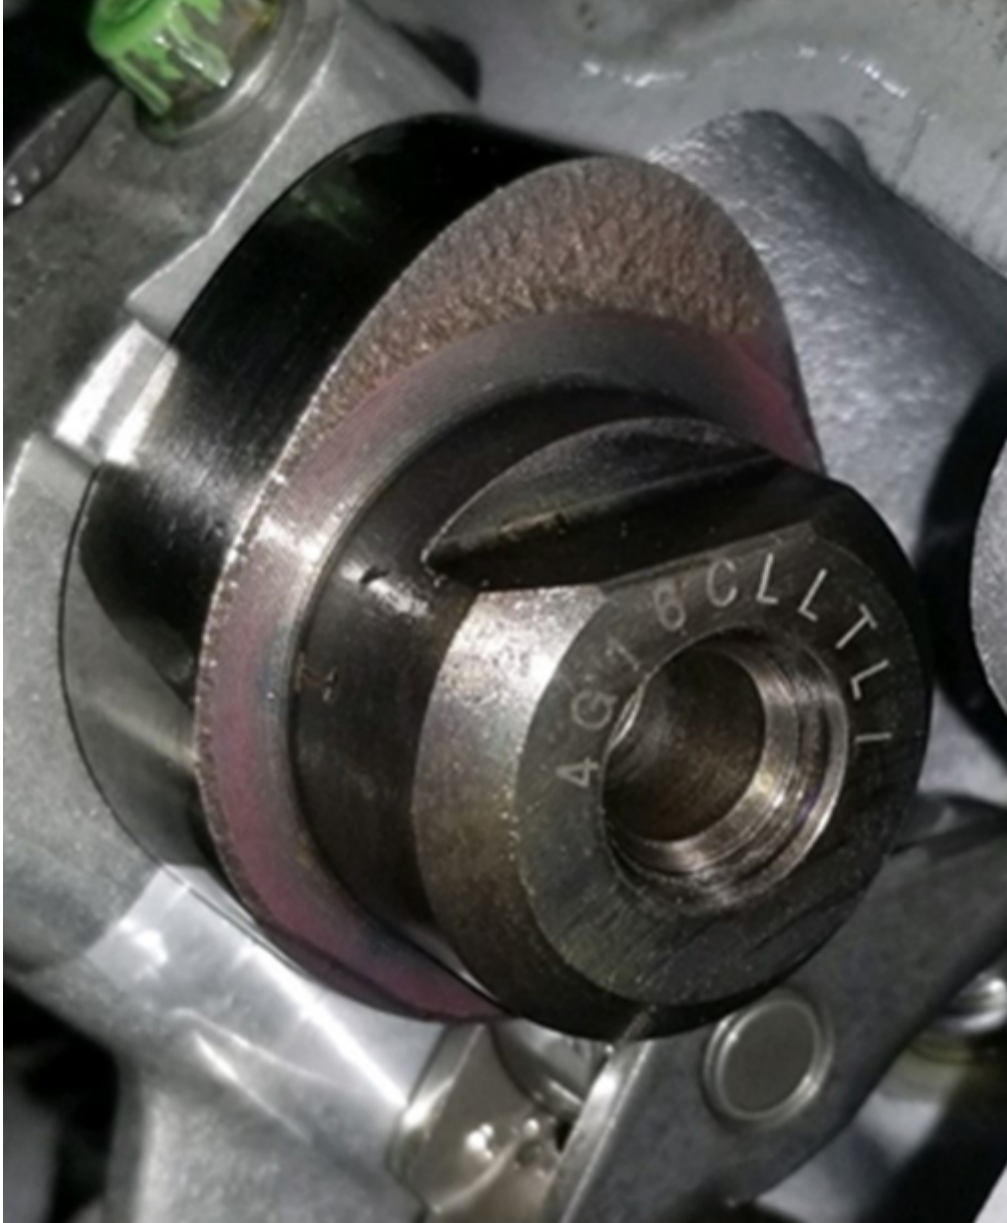
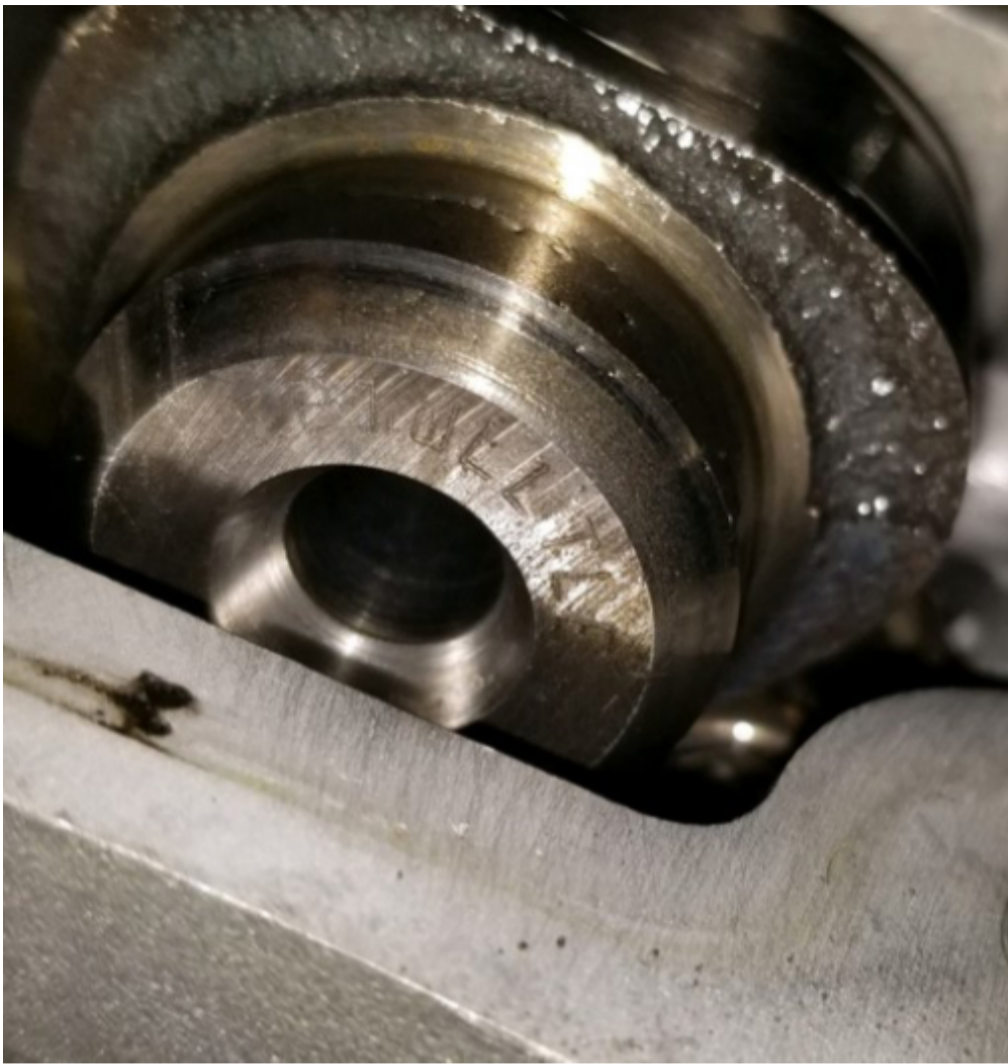
Camshaft Identification on HFV6.

Also check to make sure the camshafts and actuators are correct and in the correct place.

Note last 2 characters.

(L or R) designates the bank, and

(I or E) designates intake or exhaust.

If normal diagnostics along with these enhanced diagnostics do not lead to the cause, prior to removing the timing cover or cylinder heads, call TAC and start a case for next step recommendation.
