### PIP5744 Bolt EV Transmission Fluid Leak at Drain Plugs

Brand:	Model:	Model Years:	VIN:		Engine:	Transmissions:
			from	to		
Chevrolet	Bolt	2020	All	All	All	All

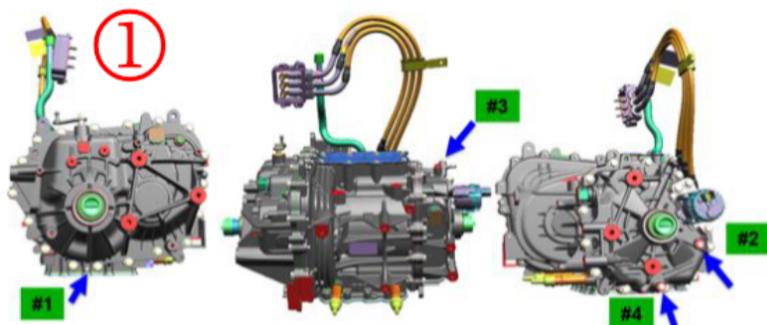
1) Purpose : Increase engagement of one thread pitch (4.5 - 5.5) and sealant (1-1.5 2-2.5pitch) by additional tightening (Rotation Angle : 380 - 400 degrees)

Retrofit plugs (4 locations)

- 1 plug on gear box (#1)
- 3 plugs on end cover (#2,#3,#4)

Tighten the plugs as shown below.

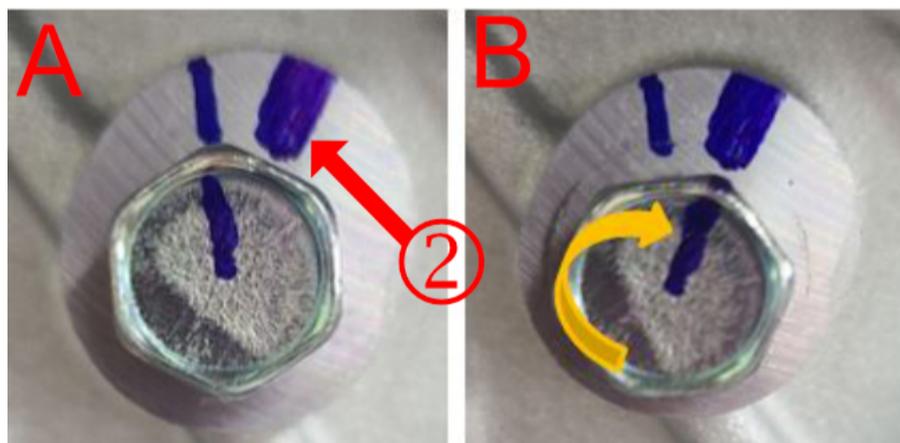
A) Inline Plug and cover for start point

B) Position of plug line to be in marked range

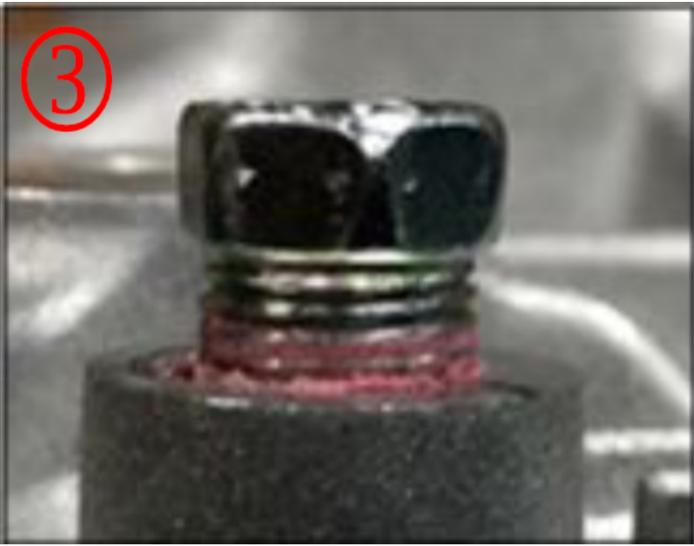
2) Limit band for final angle.

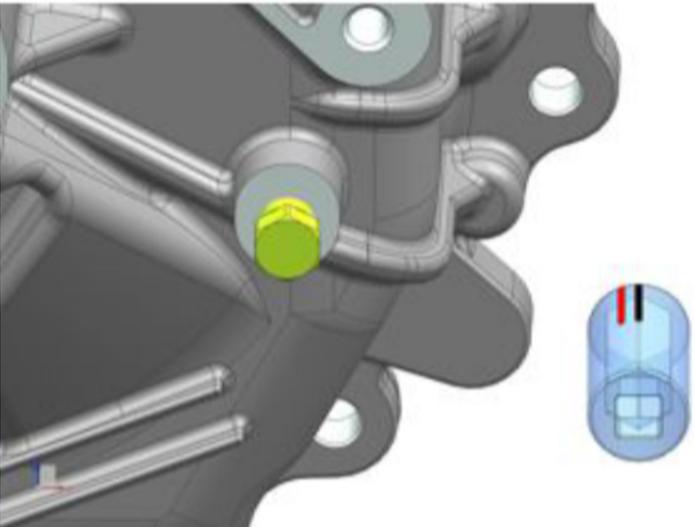
4) Wrench socket has two lines.

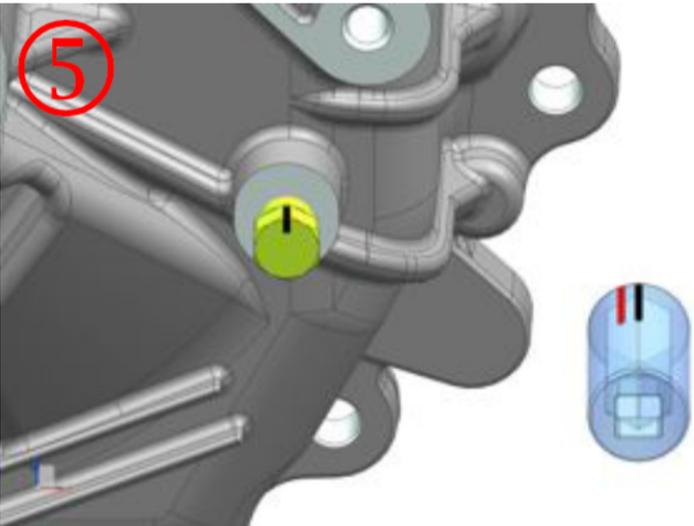
5) Mark on plug edge.

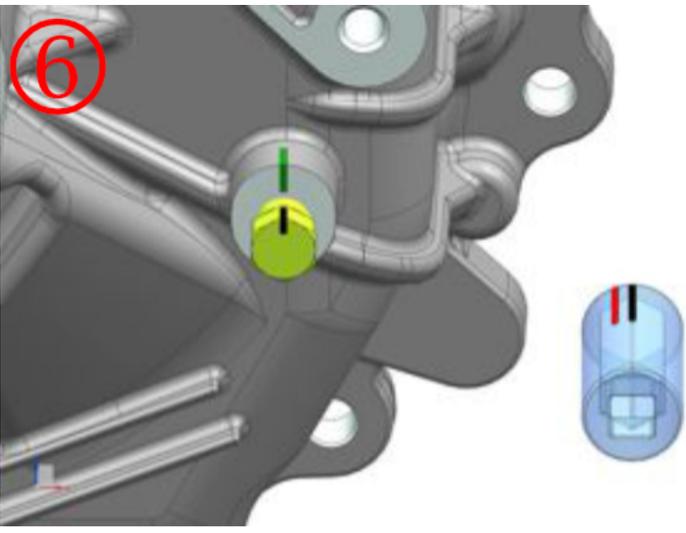
6) Mark on cover / gearbox.

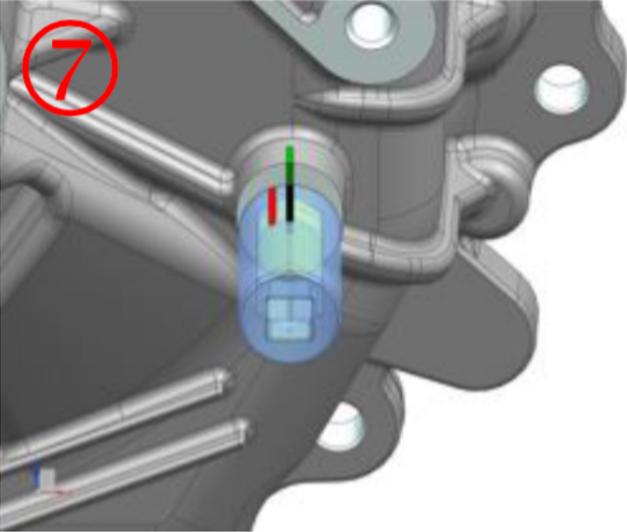
7) Align black line on the socket to park marking.

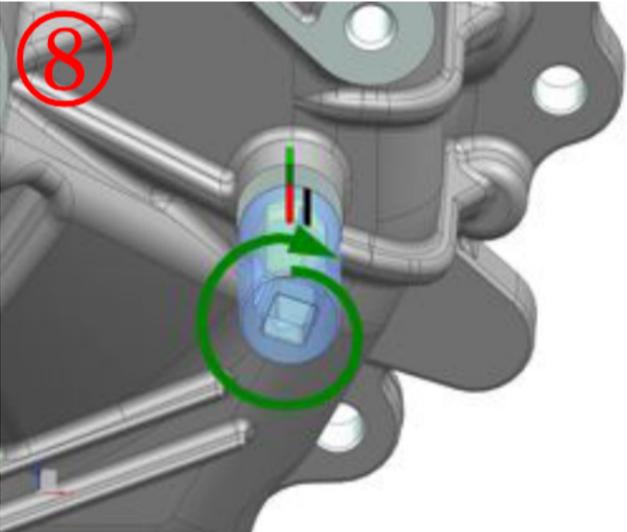
8) Tighten the plug 380-400 degrees (until red line meets cover marking).

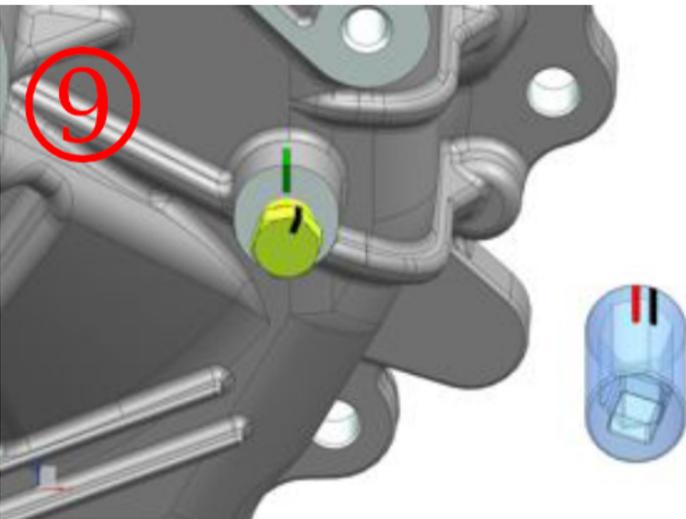
9) Remove the wrench socket and check the angles of parts marking.

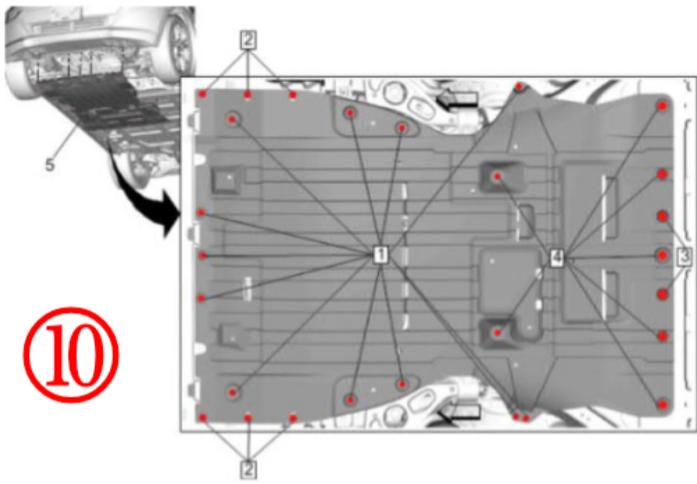
10) To gain access for inspection of plug 1 remove front compartment air deflector. (See also SI Service Document 4533740).

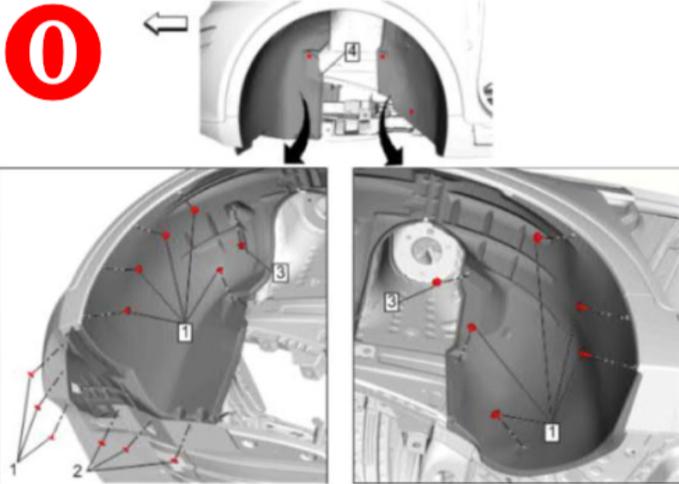
0) To gain access for inspection of plugs 2, 3 and 4 remove left front wheelhouse liner. (See also SI Service Document 4533734)
