Preliminary Information

PIT5737B Loss of Sirius XM Audio Until XM Channel Change

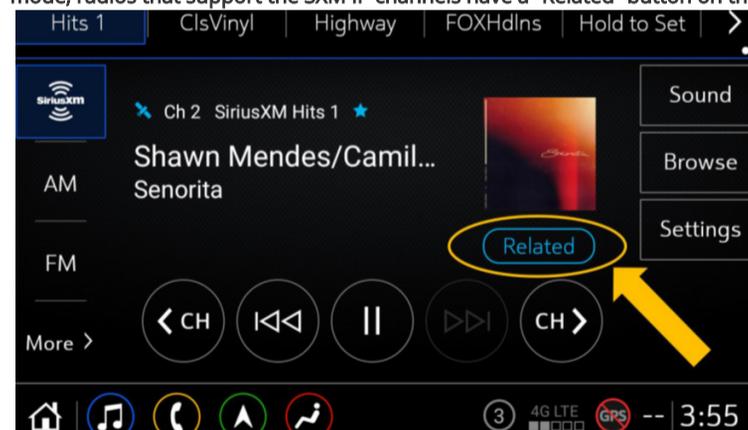
To visually identify if the radio may be involved, switch to the Audio page and select SXM as the Source and look for the "Related" button. When in SXM mode, radios that support the SXM IP channels have a "Related" button on the screen.
