PIT5742A SES MIL / No Start / No Crank / Runs Rough / Reduced Engine Power / Loss Communication / DTCs (V8 and V6 Inspect Engine Harness)

Models

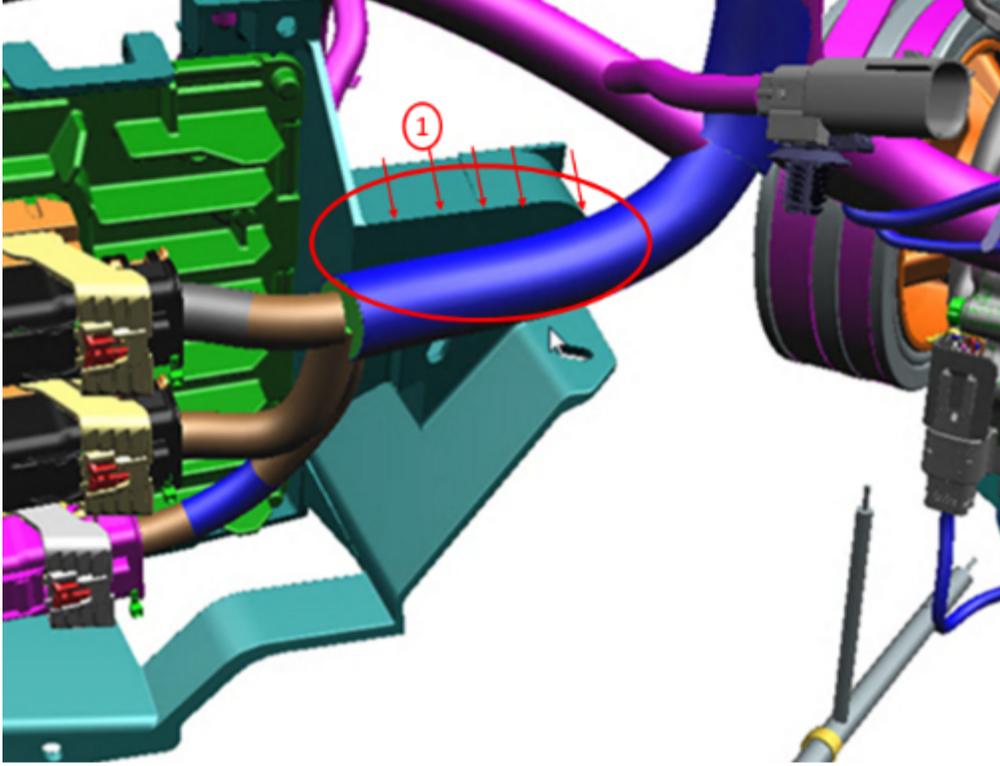
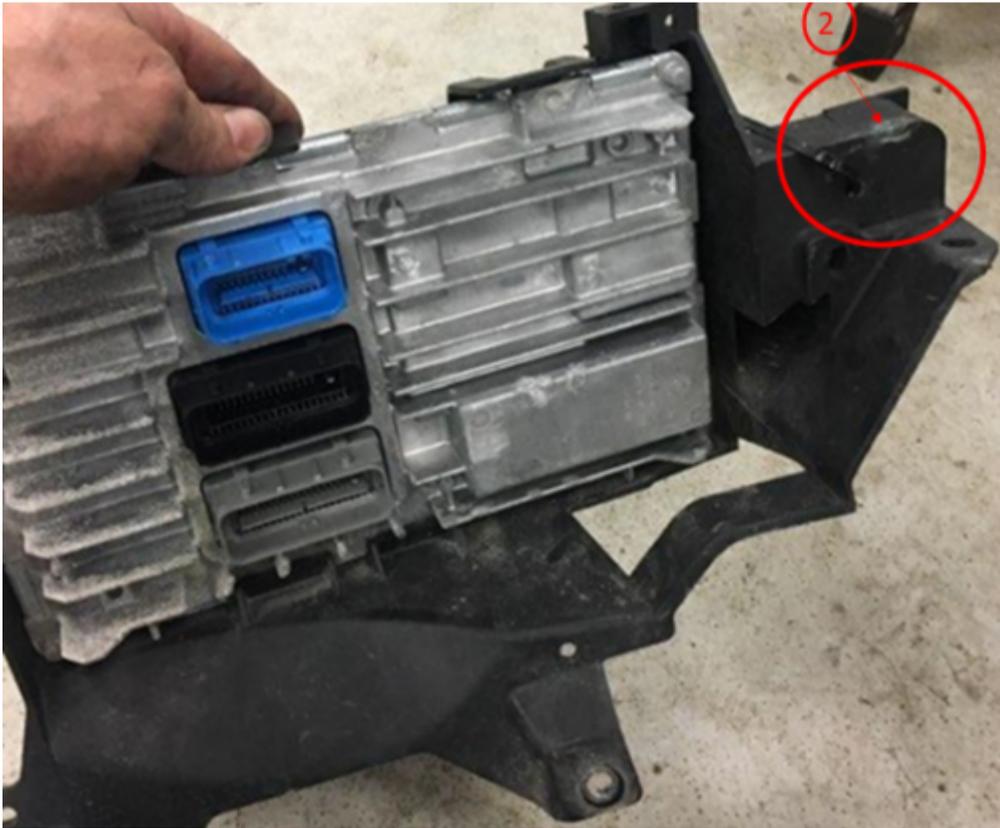
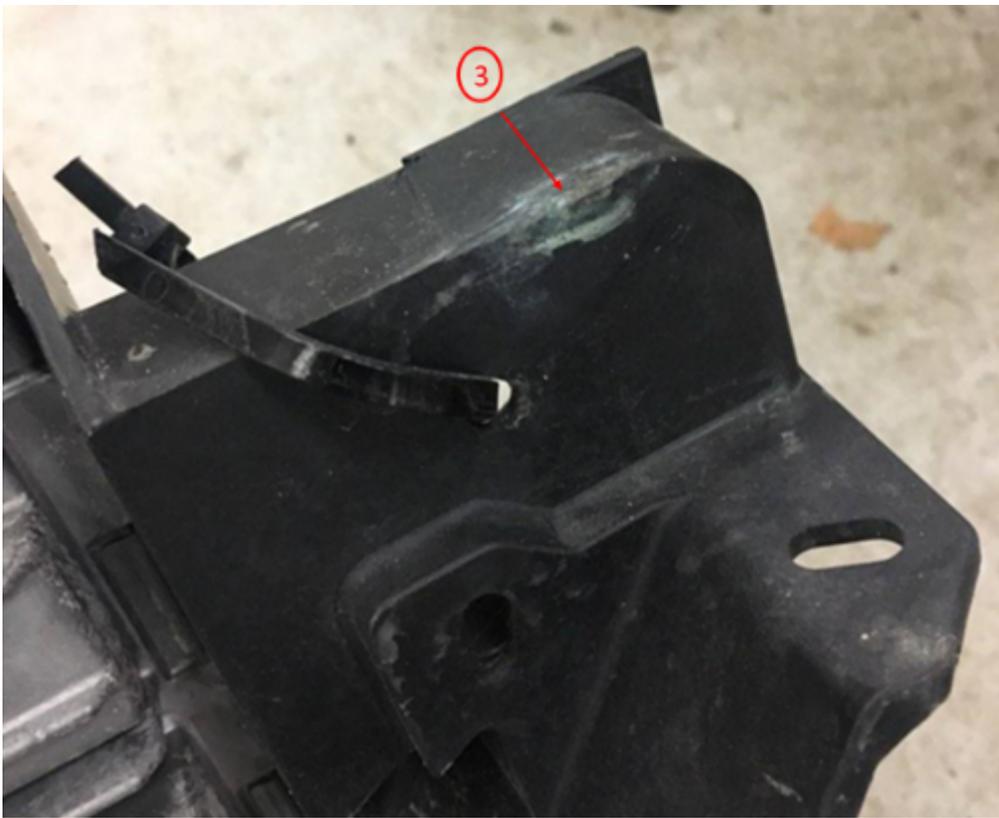
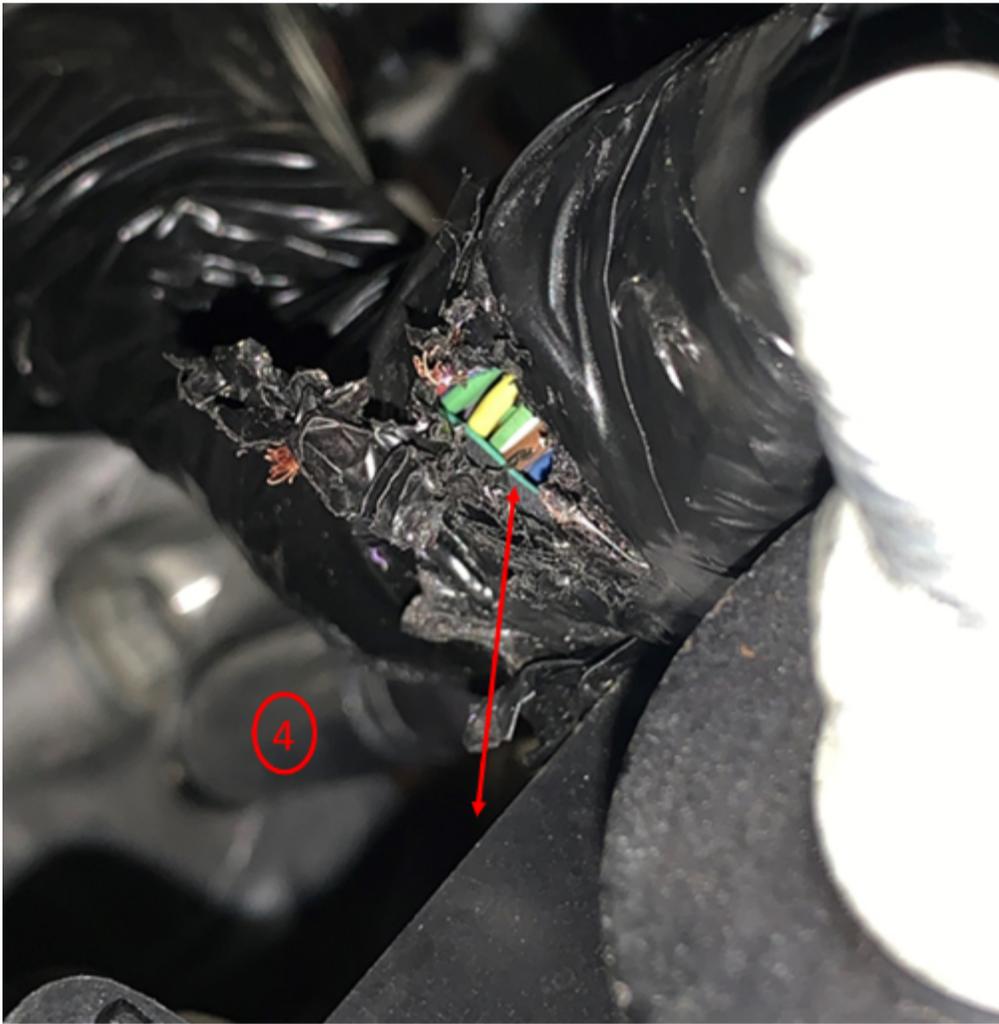
Involved Region or Country	North America
Condition	<p>Some customers may comment on any of the following concerns:</p> <ul style="list-style-type: none"> - SES MIL - No Start - No Crank - Engine runs rough - Reduced engine power - Erratic gauge operation - Transmission shifting erratically or not shifting - Blown Fuse(s): F46UA, F78UA, F86UA, F88UA, F87UA, F90UA, F60UA, F67UA, and/or F91UA <p>When checking for DTC's there may be any of the following:</p> <p>P0101 P0103 P0106 P0108 P0300 P0562 P0615 P0617 P0641 P0689 P0700 P12A6 P15A0 P216E P1682 P16BD P16BC P2147 P06A3 P349P P2B96 U0073 U0078 U0100 u0101 U0102 u0121 u0128 U0129 u0131 U0140 U0146 U0184 U0422 U1345 U1346 U1347 U1348 U1349 U1501 U1502 U1503 U1510 U1511 U01B0 U18B4 U18D5 U2413</p>
Cause	<p>These concerns could be caused by the engine wiring harness chaffing on the ECM mounting bracket, as shown below. The ECM mounting bracket has a sharp edge (1) and it can cut into the wiring harness. Due to the number of circuits in the harness, there is a wide variety of different symptoms that could occur depending on which circuit(s) are damaged.</p>

Inspect the engine harness in the area shown above. If harness damage is found, repair the damaged wiring following the SI wire to wire repair procedures. Once repaired, protect the engine wiring harness using Woven Polyester (PET) Electrical/Anti-Abrasive Tape. This tape may be purchased at kent-automotive.com Item# 1089482.
