# Preliminary Information

## PIP5745 MIL illuminated with DTC P026A

Brand:	Model:	Model Years:	VIN:		Engine:	Transmissions:
			from	to		
Chevrolet	Silverado 1500	2020 - 2021	ALL	ALL	LM2	All
GMC	Sierra 1500	2020 - 2021	ALL	ALL	LM2	All

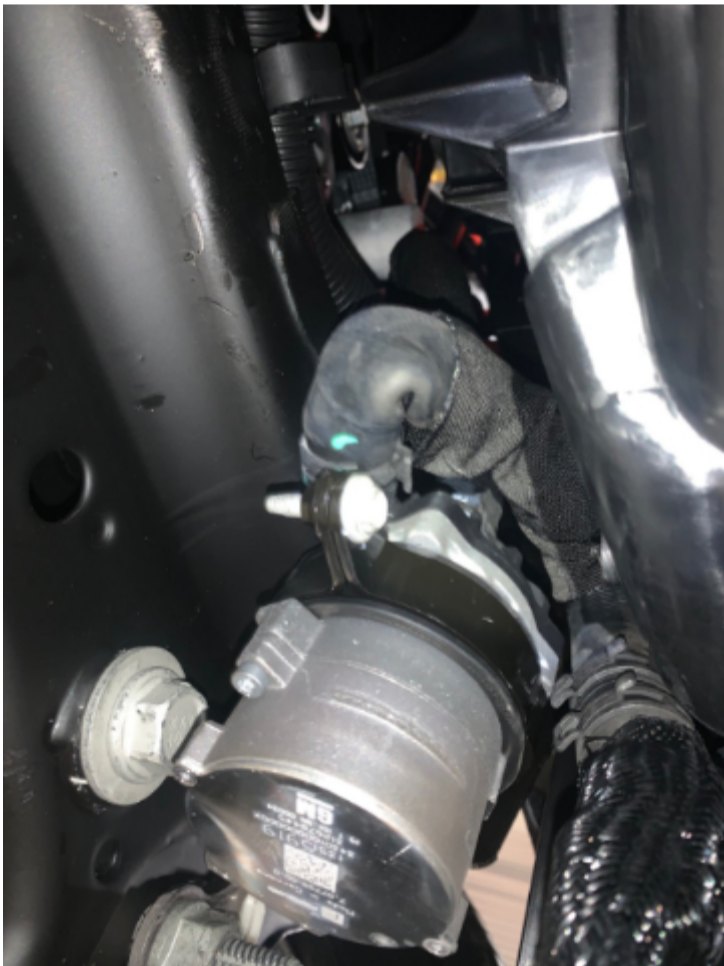
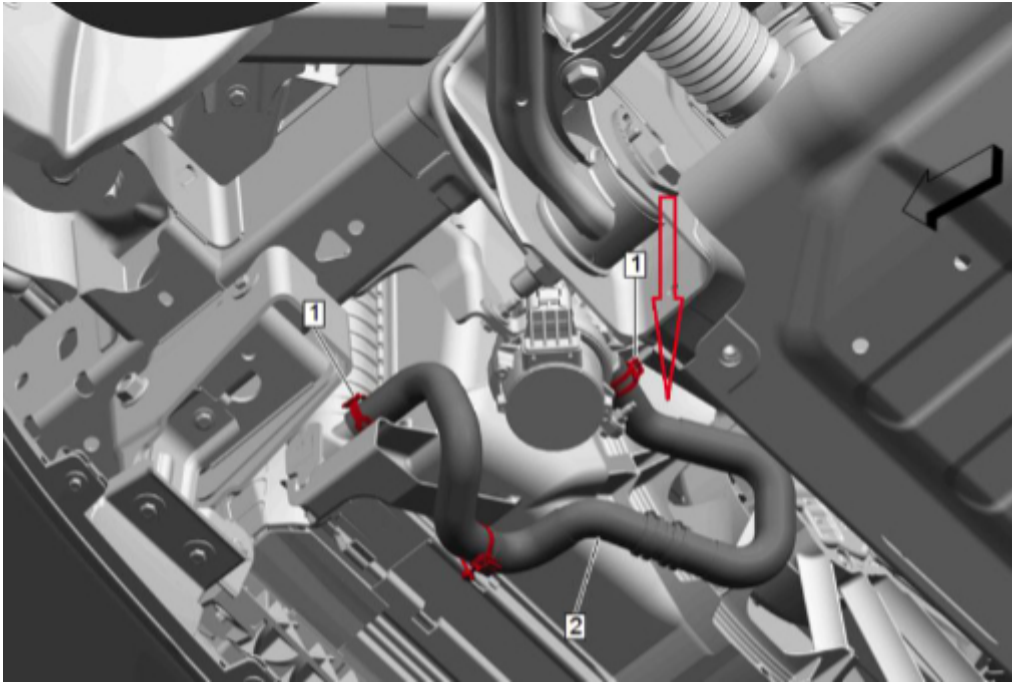
Involved Region or Country:	North America
Condition:	A vehicle may arrive at the dealer with the MIL illuminated and DTC P026A set.
Cause:	This may be due to a kinked hose at or near the low temperature auxiliary coolant pump.

If this condition is encountered, loosen the hose clamp and rotate the hose to allow for proper coolant flow.
