GLOBAL SAFETY FIELD INVESTIGATIONS  
DCS5458  
URGENT - DISTRIBUTE IMMEDIATELY

Subject: N202299080 - Special Coverage  
Camshaft Cover Replacement

Models: 2014 Buick Encore  
2011-2014 Chevrolet Cruze  
2012-2014 Chevrolet Sonic  
2014 Chevrolet TRAX

## N202299080 Camshaft Cover Replacement

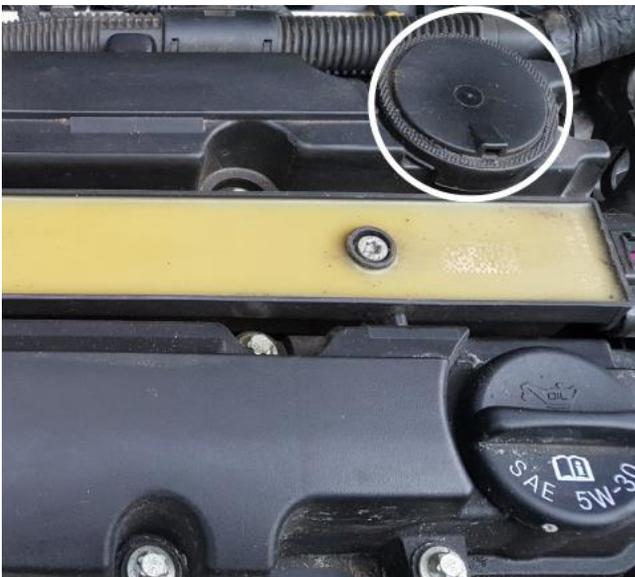
5354610

- c. With the engine running, listen for noise coming from the PCV valve, shown above. If noise is heard, check to see if the noise gets quieter or disappears with the engine oil dipstick removed.
- d. Reinsert the dipstick.

- e. Check to see if there is vacuum at the PCV vent at the front of the PCV valve by placing a piece of tissue near it. The tissue will be sucked against the vent and held if vacuum is present.
  - If the PCV valve is making noise and there is vacuum present at the PCV valve vent, replace the Camshaft Cover. Refer to *Camshaft Cover Replacement* in SI.
  - If the PCV valve does NOT make noise or leak vacuum, no further diagnosis or repair is covered under this special coverage. Claim diagnostic time and inform the customer that any further diagnostics or repair will have to be covered by customer pay, warranty, or good will.
3. Reinstall the engine cover. Refer to *Engine Cover Replacement* in SI.
