Subject: N202300240 - Customer Satisfaction Program  
Transfer Case Leak

Models: 2019 Chevrolet Silverado 4500 HD / 5500 HD / 6500 HD

# Customer Satisfaction Program

## N202300240 Transfer Case Leak

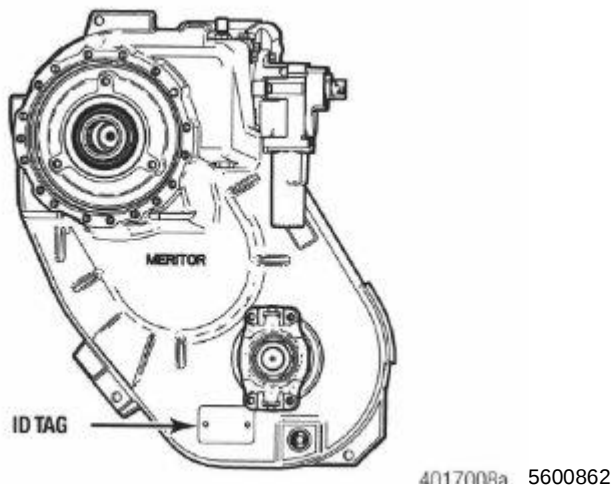
**Note:** Some vehicles may have chassis paint overspray on the transfer case identification label, making it difficult to read. If this condition exists, verify the VIN is in the specified Special Coverage population. In addition, ensure the oil leak is sourced from the idler and/or front output adjustable bearing carrier.

1. Locate the identification tag on the front of the transfer case.
2. Check and record the serial number on the transfer case ID tag.

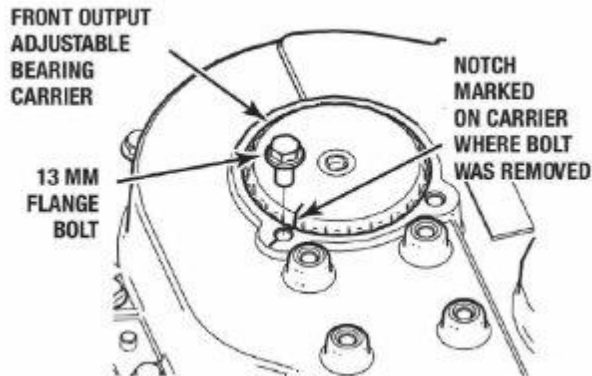
5600878

**Note:** This step is to mark the orientation of the adjustable carrier to the case, so it can be installed in the same position during re-assembly. The bearing preload is set by the manufacturer using the adjustable bearing carriers. It is critical that the removed carrier is threaded back to its exact original location upon reassembly.

7. Beginning with the front output adjustable bearing carrier, mark the exact notch/position of the case and carrier where the 13mm retaining flange bolt is located. With the carrier to case position marked, remove the retaining bolt. DO NOT rotate the carrier until AFTER the reference mark has been made.
