GLOBAL SAFETY FIELD INVESTIGATIONS
DCS5460
URGENT - DISTRIBUTE IMMEDIATELY

Subject: N202310520 - Service Update
Engine Oil Cooler Lines

Models: 2021 Chevrolet Tahoe, Suburban
2021 GMC Yukon, Yukon XL

N202310520 Engine Oil Cooler Lines

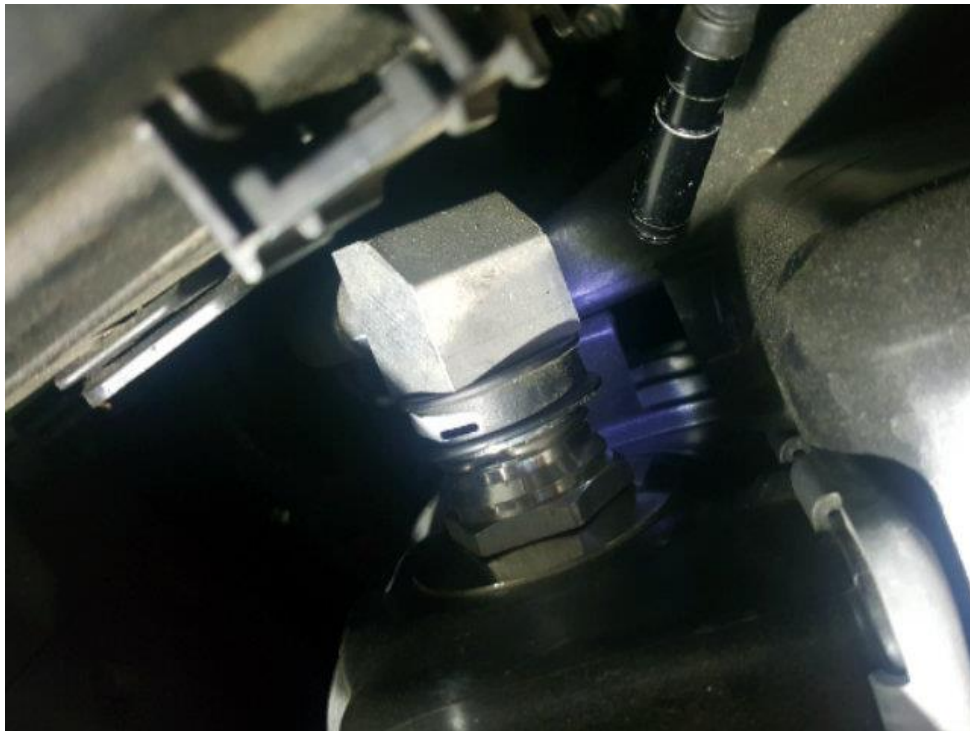
5636481

2. Locate the upper oil cooler line where it goes into the radiator as shown.

3. Firmly push the engine oil cooler line into the radiator to be sure it is seated, then gently tug on the line to check that it cannot come loose.
4. Lift the vehicle. Refer to *Lifting and Jacking the Vehicle* in SI.
5. Remove the passenger's side wheelhouse liner. Refer to *Front Wheelhouse Liner Replacement* in SI.

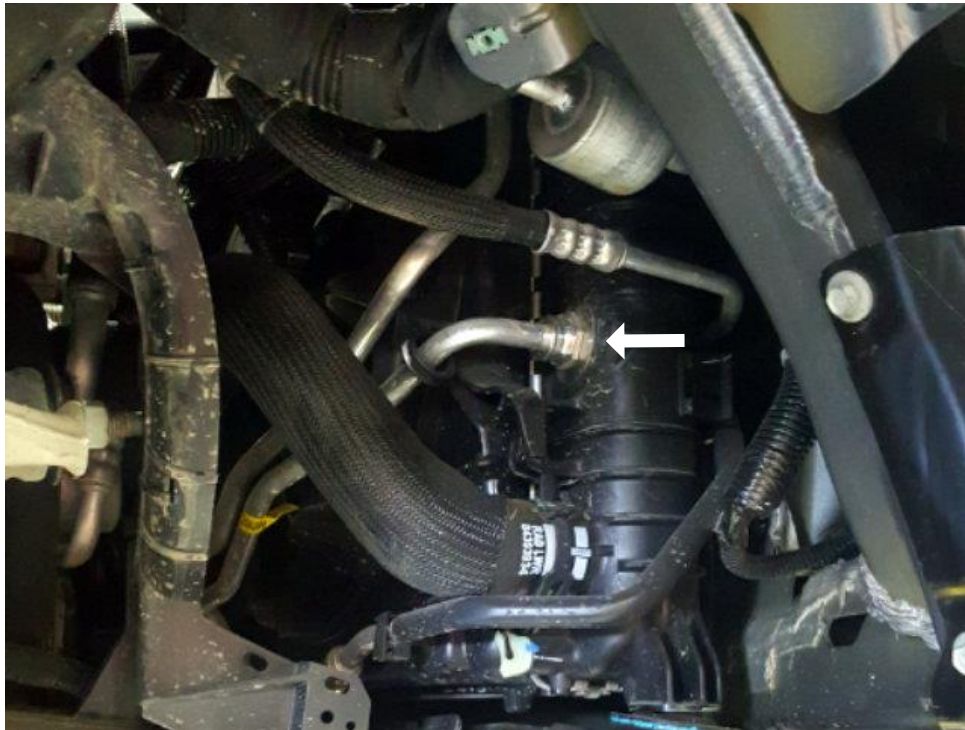
5636485

6. Locate the lower oil cooler line where it goes into the radiator as shown.
7. Firmly push the lower engine oil cooler line into the radiator to be sure it is seated, then gently tug on the line to check that it cannot come loose.

Caution: The purpose of this field action is to ensure the engine oil cooler lines are seated in the quick connect fitting. Catastrophic engine failure can occur if they are not. Be completely sure both engine oil cooler lines are seated fully in the radiator before proceeding.
