Subject: A202309040 - Customer Satisfaction Program  
Right Hand Lower B-Pillar Inner Panel Crack – US Only

Models: 2020 Buick Encore

# Customer Satisfaction Program

## A202309040 Right Hand Lower B-Pillar Inner Panel Crack – US Only

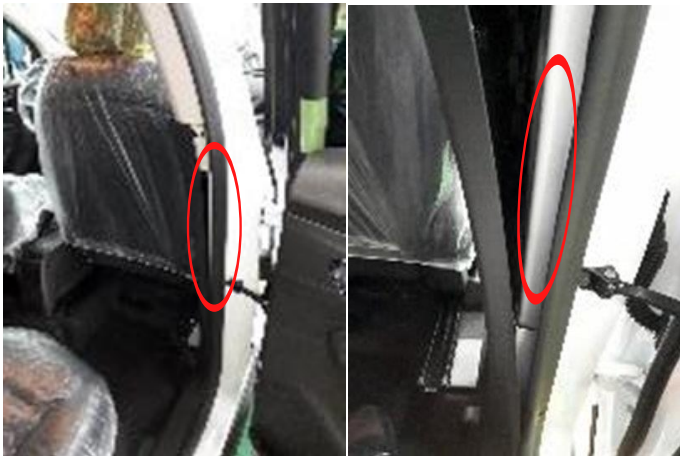
2. Using an appropriate trim tool, partially remove the center pillar lower trim panel to gain access to the body inner panel as shown. Refer to *Center Pillar Lower Trim Panel Replacement* in SI.

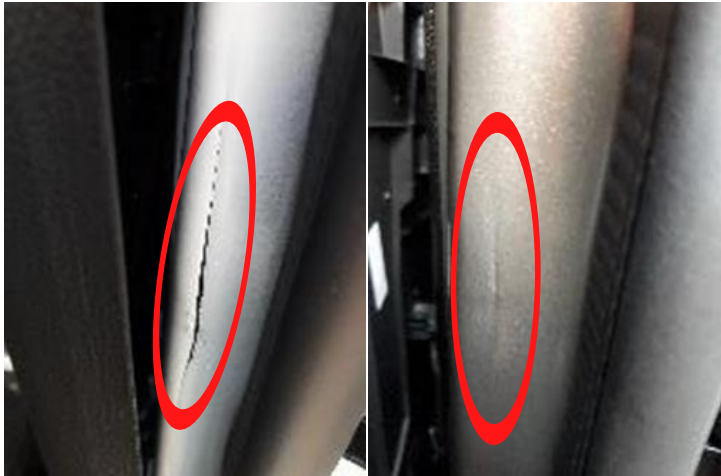
<b>Condition</b>	Certain 2020 model year Buick Encore vehicles may have a condition in which a crack is present in the right-hand lower B-Pillar body inner panel. If this crack propagates and widens, it could destabilize the B-pillar structure and increase the potential risk to door check link rigidity and corrosion.
<b>Correction</b>	Dealers are to inspect the B-Pillar body inner panel (pass/fail); <b>If any evidence of cracks is found during the inspection process, you must quarantine the vehicle and follow instructions provided in step 4 of the service procedure.</b>

3. Inspect the body inner panel for cracks or wrinkles as shown above.
4. Verify that there are no cracks, or indication of cracks in this area.
  - **If no cracks are found, reinstall center pillar lower trim panel and return the vehicle to service.**
  - **If any evidence of cracks is found during the inspection process, you must perform the following steps:**  
**Quarantine the vehicle.**

For US Dealers - Submit a Field Product Report (FPR) and Pictures using the Field Product Reporter App found in the Certified Service Mobile Tools (reference TSB 02-00-89-002). Be sure to include the following information:
