**91-20-09TT - Car Net® 2.0 - Emergency Call Module and Communication Unit  
-J949- Green Light Does Not Illuminate**

Release date: 08/10/2020

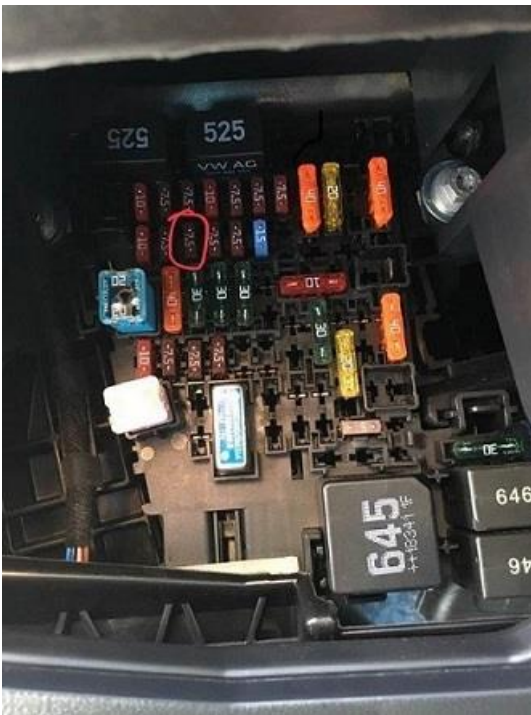
Figure 1. Fuse SC17

Car-net® 2.0 may not fully complete the initial Register and Pairing process (R&P) after removal of transport mode during ePDI. This may result in a lack of functionality and the green Car-net® LED in the overhead console not illuminating.

1.3. Remove the 7.5 amp fuse in position SC17 (for all MQB platform vehicles). The instrument cluster losing power is an indication that the proper fuse was pulled. (Figure 1.)

1.4. Wait 5 minutes with the fuse out to allow the Control Module for Emergency Call Module and Communication Unit **-J949-** internal backup battery to completely discharge.

1.5. Re-insert the fuse into the slot and reinstall the pull out door.
