# TECHNICAL SERVICE BULLETIN

Technical Service Bulletin: 51-1205  
LCI TSB Number: TSB 01-004-20B

Per the TSB received by Lippert Components, Inc.: This document outlines the inspection (and correction) of Thule Regal Awnings to determine if there is too much gap between the roll tube and end plates, which could cause the fabric to extend over the edge or the roll tube could shift along the axle plane.

# THULE® REGAL AWNING INSPECTION

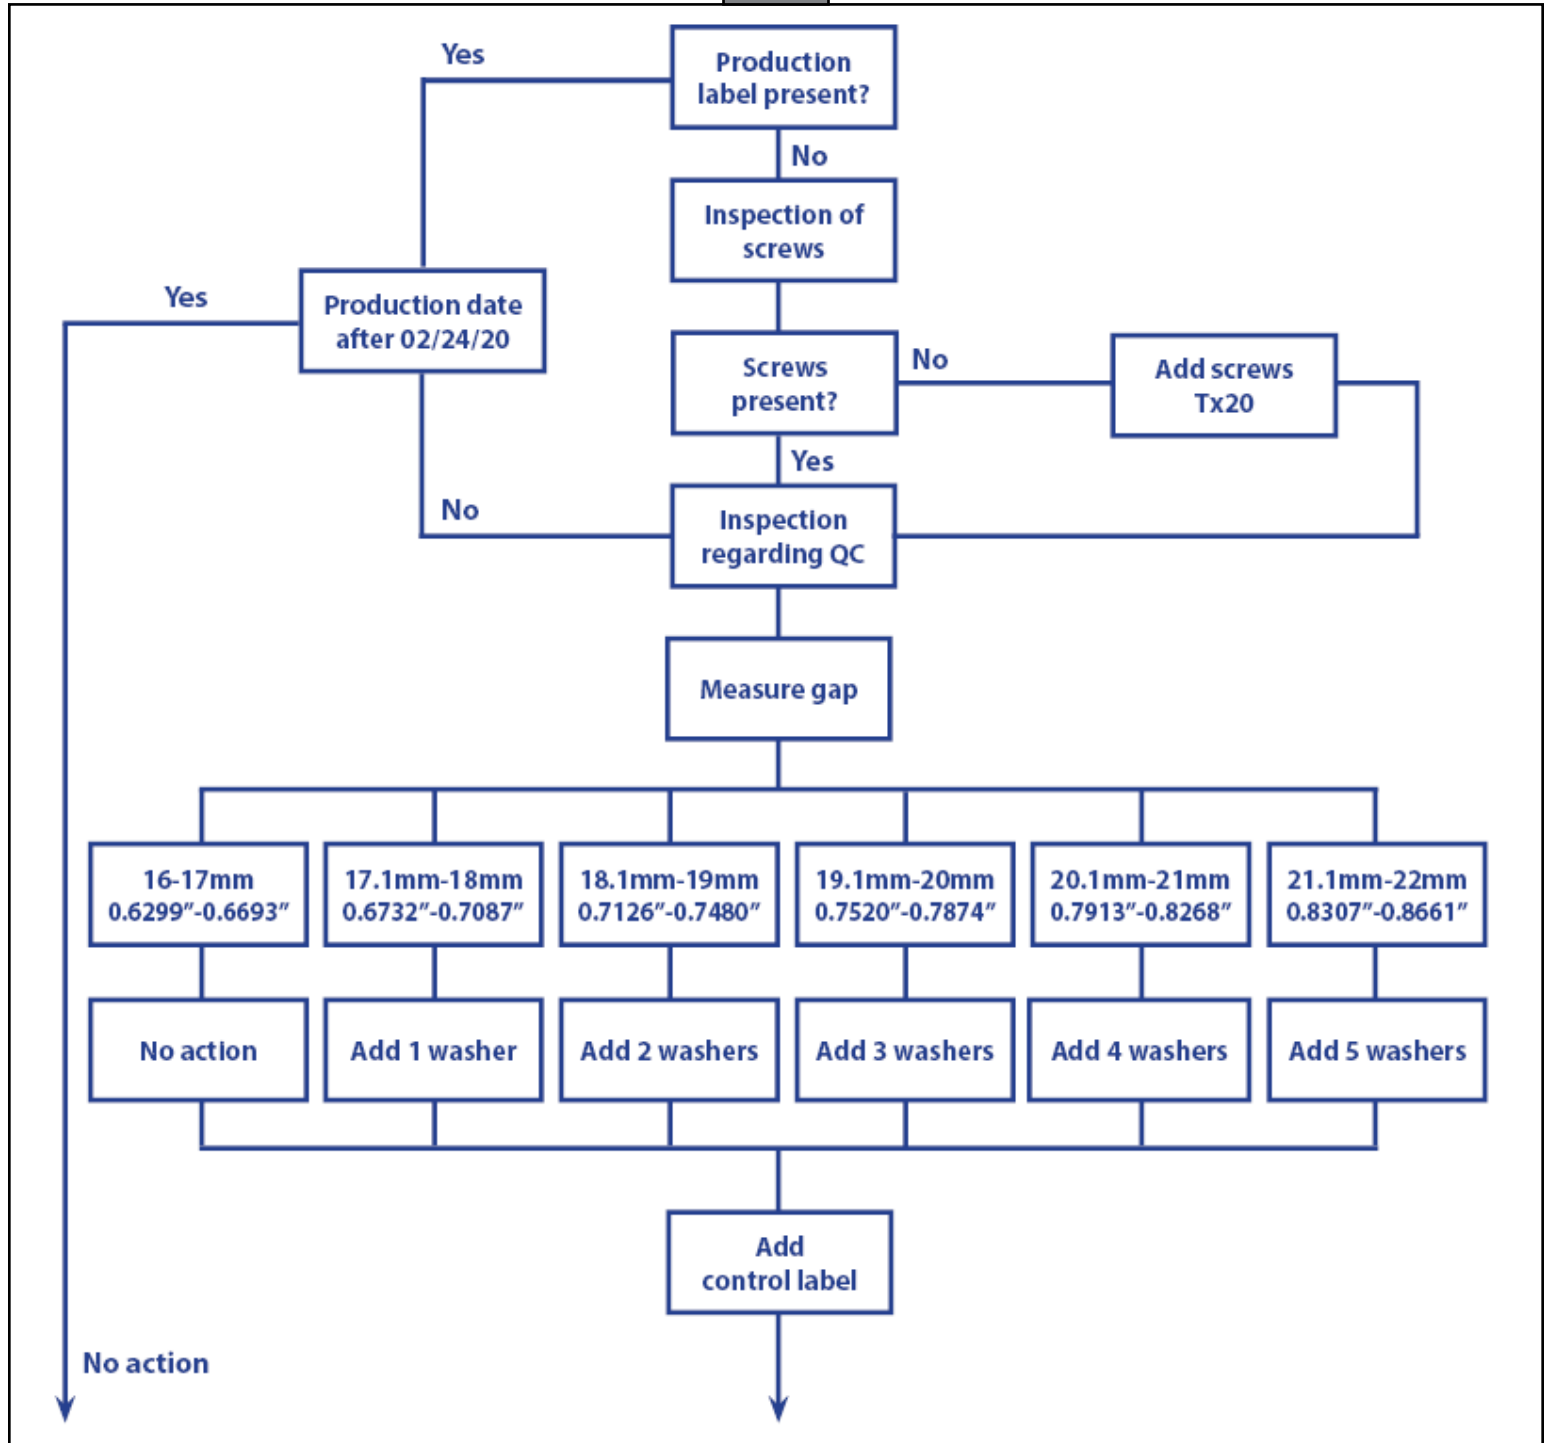
Fig. 1

Check the following steps on the flow chart (Fig. 1 ) to determine if the awning needs to be modified.

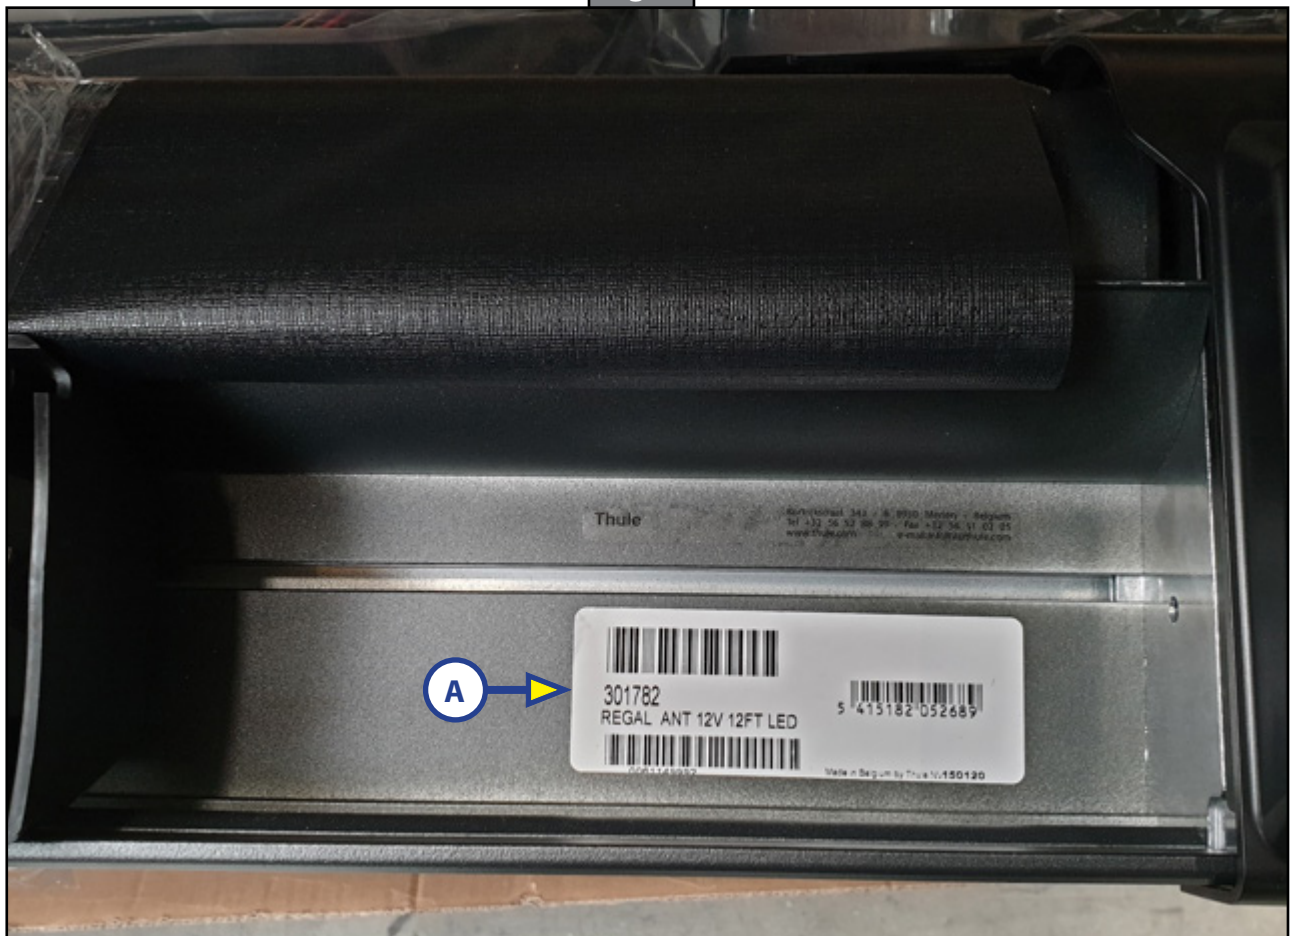
Fig. 2

1. Open the awning at least three feet.
2. Check for the production label (Fig. 2A) near the left hand end cap, inside the lead rail profile.

**NOTE:** If the production label is not present, go to the Screw Inspection section on page 4. If the production label is present and dated (DD/MM/YY) prior to February 2020, skip to the Tolerance Inspection on page 5. If the production label is present and dated (DD/MM/YY) February 2020 or later, no further action is needed.

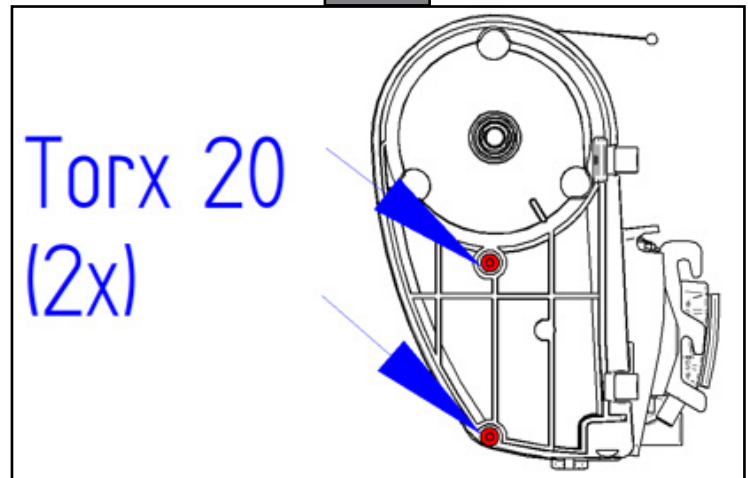
Fig. 6

5. Remove the three 3mm hex fasteners (Fig. 5) securing the rear end cap with appropriate bit.
6. Verify the presence of the two 20mm torx fasteners (Fig. 6) on the awning end plate.

7. Repeat steps 2 through 6 for the other end cap. Retain all hardware for re-installation.  
If the fasteners are present on the awning ends, go to the Tolerance Inspection section on page 5. If the fasteners are not present, install the two 20mm torx fasteners provided.

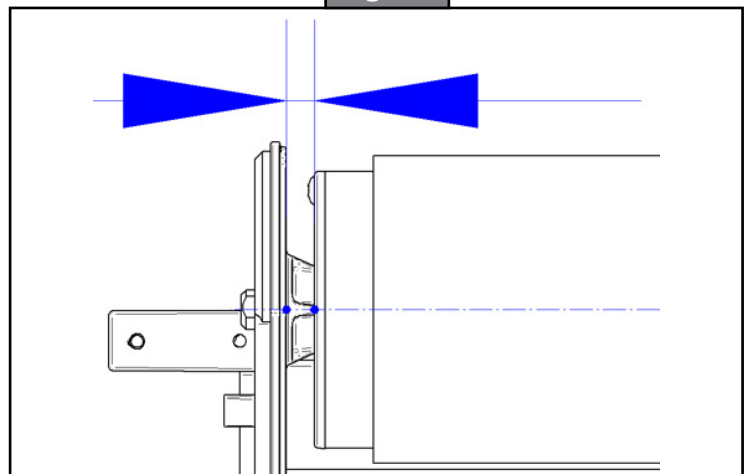
Fig. 10

4. Set front end cap (Fig. 8A) aside for re-installation.
5. Repeat steps 1 through 4 for the other end cap. Retain hardware for re-installation.
6. Using a micrometer measure the gap between the awning roll tube and end plates on both the right and left sides (Fig. 10).
7. Add the two measurements and see Tolerance Inspection Table on page 6 for measurement specifics.

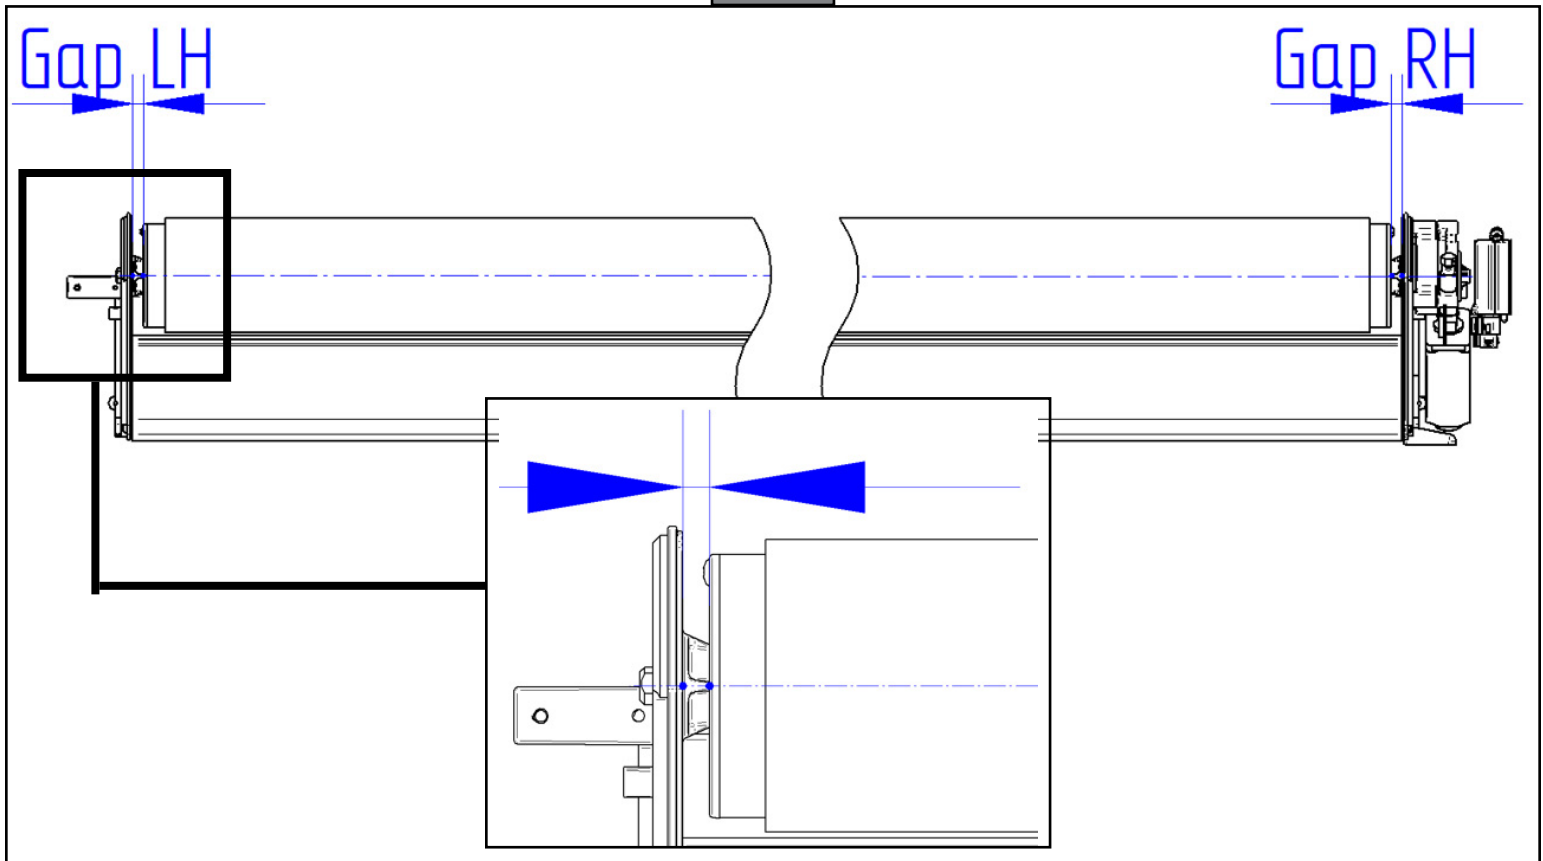
Fig. 11

1. Measure the gap on the left and right sides (Fig. 11).
  - Measure at the axle centerline height.
  - The minimum is always 8mm (0.3150")

2. Add both values and compare with table below.

| Gap sum (mm) | Gap sum (") | Action |
| 16mm - 17mm | 0.6299" - 0.6693" | No action |
| 17.1mm - 18mm | 0.6732" - 0.7087" | Add 1 washer (*) |
| 18.1mm - 19mm | 0.7126" - 0.7480" | Add 2 washers (*) |
| 19.1mm - 20mm | 0.7520" - 0.7874" | Add 3 washers (*) |
| 20.1mm - 21mm | 0.7913" - 0.8268" | Add 4 washers (*) |
| 21.1mm - 22mm | 0.8307" - 0.8661" | Add 5 washers (*) |
| (*) DIN988 A2 (16mm x 22mm x 1mm) | | |
