Technical Service Bulletin

50 Water ingress into the longitudinal member and footwell

50 20 00 2060335/1 August 4, 2020.

Model(s)	Year	VIN Range	Vehicle-Specific Equipment
A6, A6 Avant, A6 allroad, and A7	2019 - 2021	All	Not Applicable

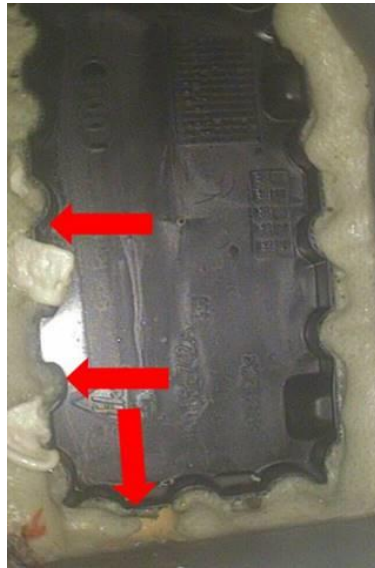
1. The cause for the water ingress is due to incorrect bonding of the sound absorber inside of the longitudinal member (Figure 1).

Figure 1. The exact location of the water intrusion.

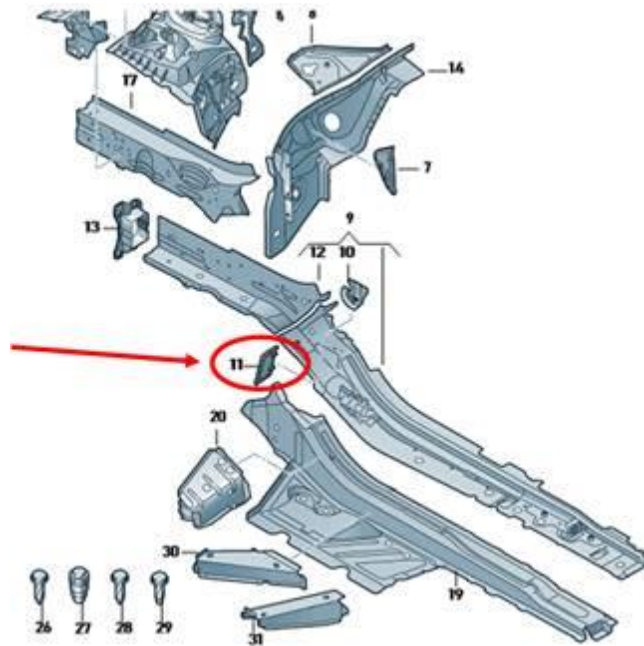
2. ETKA drawing (803-000) shows the location of the sound absorber inside the longitudinal member (Figure 2).

Figure 2. ETKA drawing (803-000) showing the location of the sound absorber.

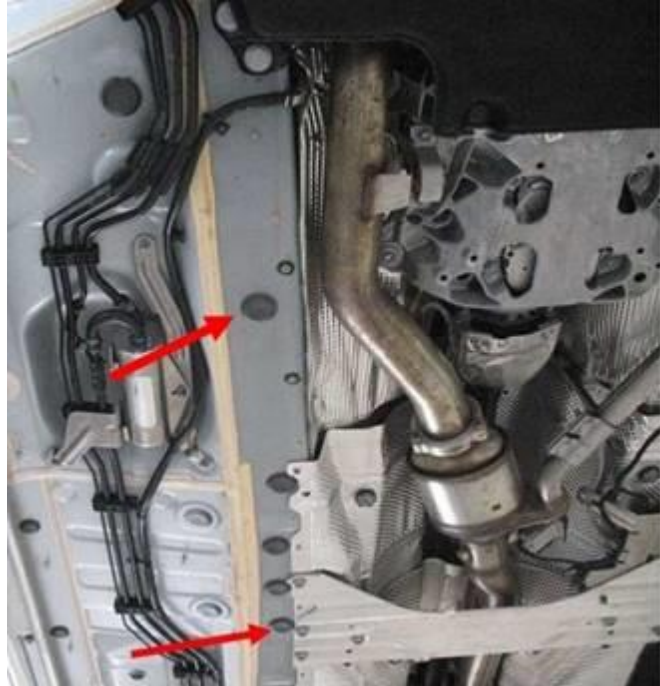
To check the water ingress in the footwell, remove plug 1 and 5 on the longitudinal member, lower right and left.

If there is a water leak from the lower longitudinal member after removing the plugs, this sealing measure is to be performed on the affected side. Check this on both sides. Repair both sides if necessary.

Figure 3. Plugs in the longitudinal member.

3. Remove any necessary underbody covers to gain access to the longitudinal member plugs (Figure 3).

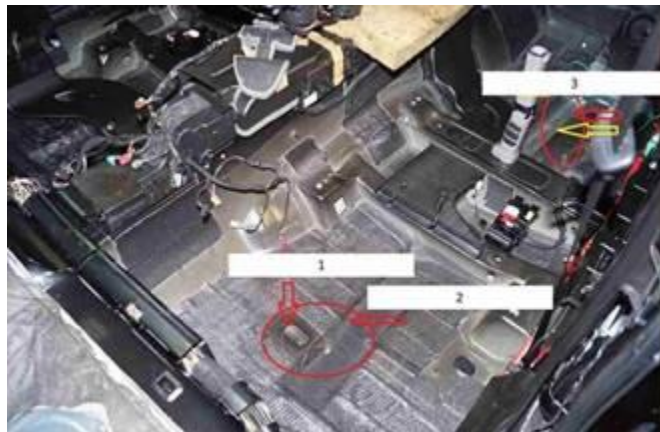
4. Figure 4 shows the areas on the inside of the cabin floor where water intrusion is likely. See arrows 1, 2, and 3.

Figure 4. Areas where water enters the cabin.

Check the electrical connectors under the floor covering for corrosion. If corrosion is found these are to be repaired according to the Elsa repair manual.

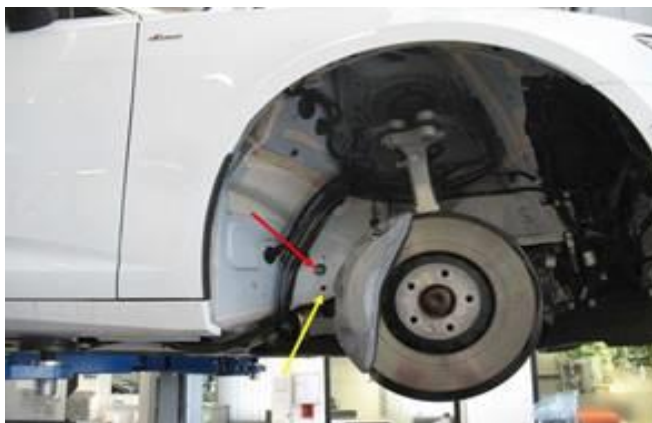
Figure 5. Point of entry for the borescope.

1. Remove front wheel housing liner from the affected side of the vehicle. Remove the plug indicated by the red arrow. This is the opening where the sealer will be applied. The opening indicated by the yellow arrow is the opening that will be used to inspect the area with a borescope (Figure 5).

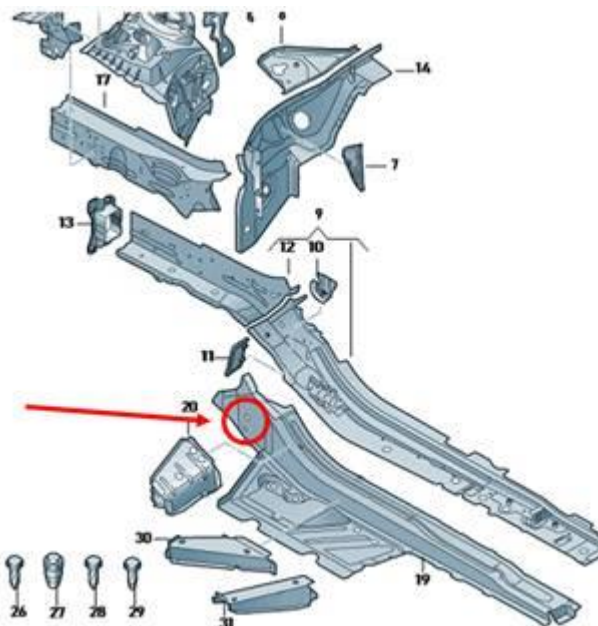
Figure 6. ETKA drawing (803-000) showing the location of the openings in the wheelhouse.

- ETKA drawing (803-000) shows the location of the openings in the wheelhouse where the borescope is to be inserted and where the repair is performed (Figure 6).

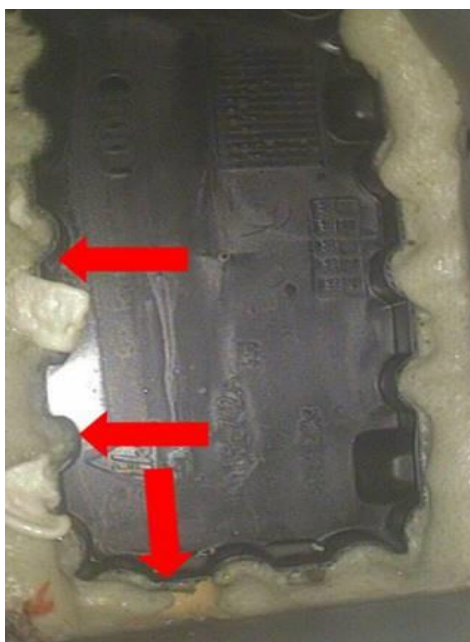
Figure 7. Sound absorber to be completely sealed off.

- The sound absorber is to be completely sealed in the longitudinal member with 1k adhesive sealant D 511 500 A2 (Figure 7).

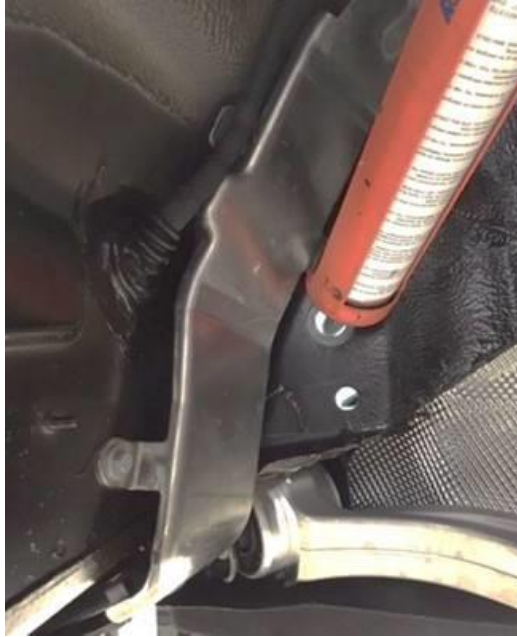
Figure 8. Sealant application.

4. Inject 1k adhesive sealant D 511 500 A2 using the VAG1628 (or equivalent) through the opening shown in Figure 6 onto the sound absorber (Figure 8).

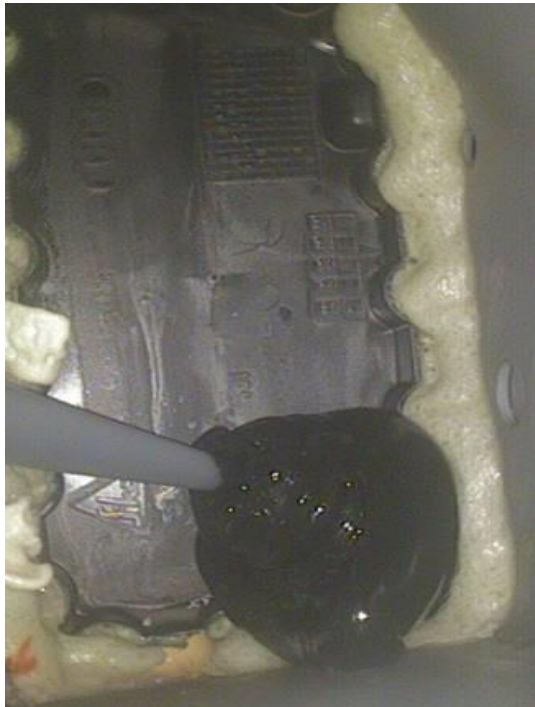
Figure 9. Applying sealer.

5. Apply an amount of sealer sufficient to cover the surface and perimeter of the sound absorber (Figure 9).

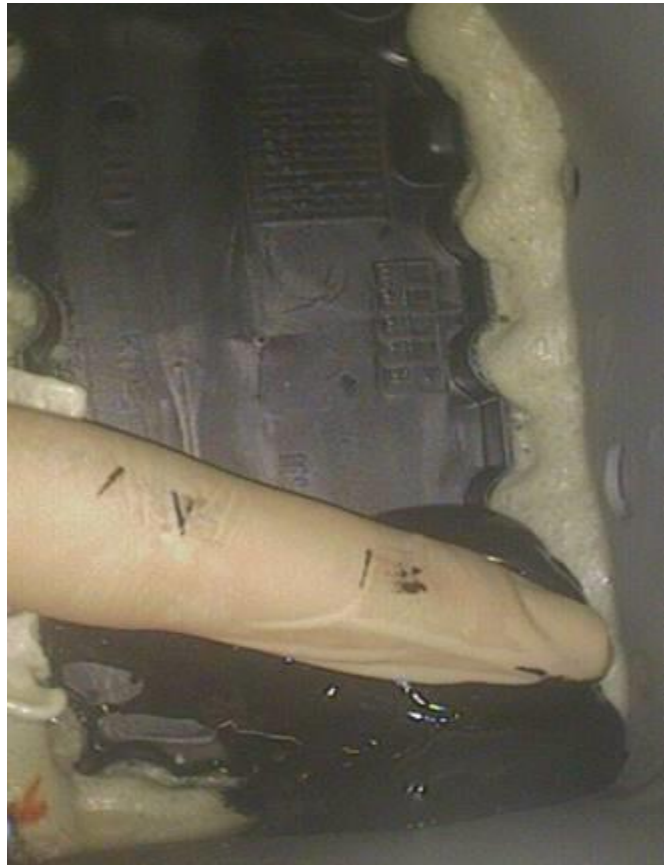
Figure 10. Distributing sealer over the web plate.

6. Spread the sealer using your gloved finger (Figure 10).

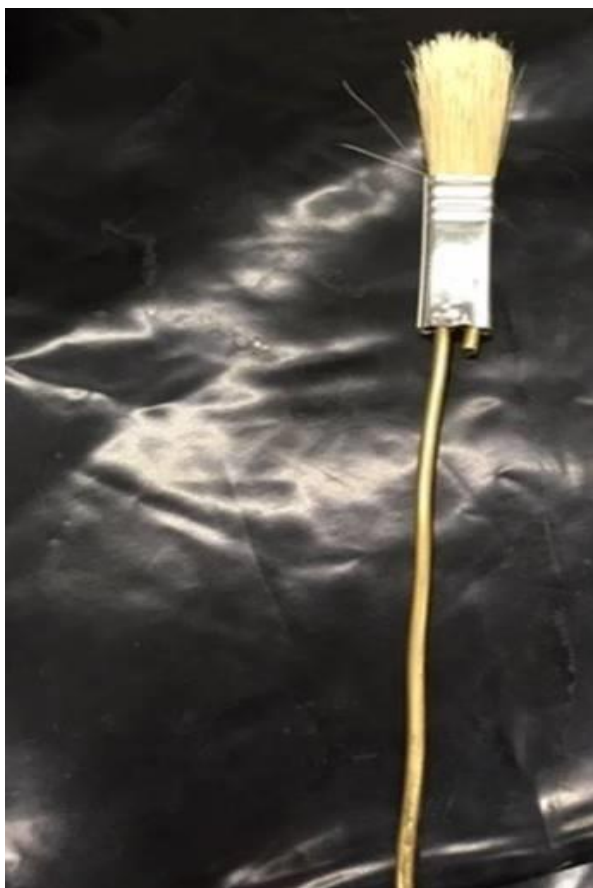
Figure 11. Modified brush.

7. Alternatively, a brush can be fashioned to distribute the sealer as shown in Figure 11. If this is the method chosen, ensure that no brush fragments are left inside the longitudinal member.

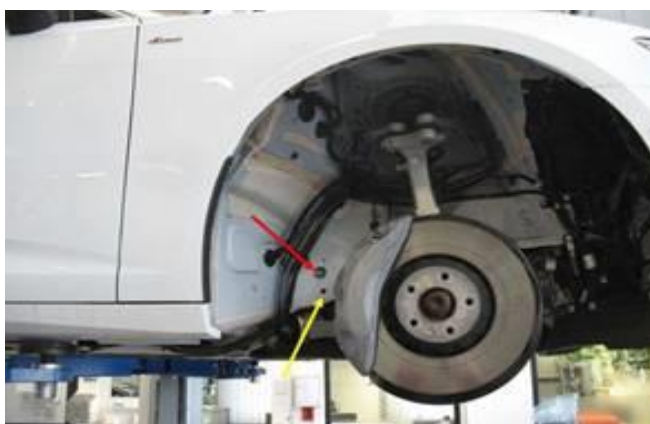
Figure 12. The yellow arrow indicates the opening where the borescope will be inserted to inspect the completeness of the sealant application.

8. Insert a borescope to confirm visually complete sealer coverage. The borescope can be inserted in the hole indicated with a yellow arrow (Figure 12).

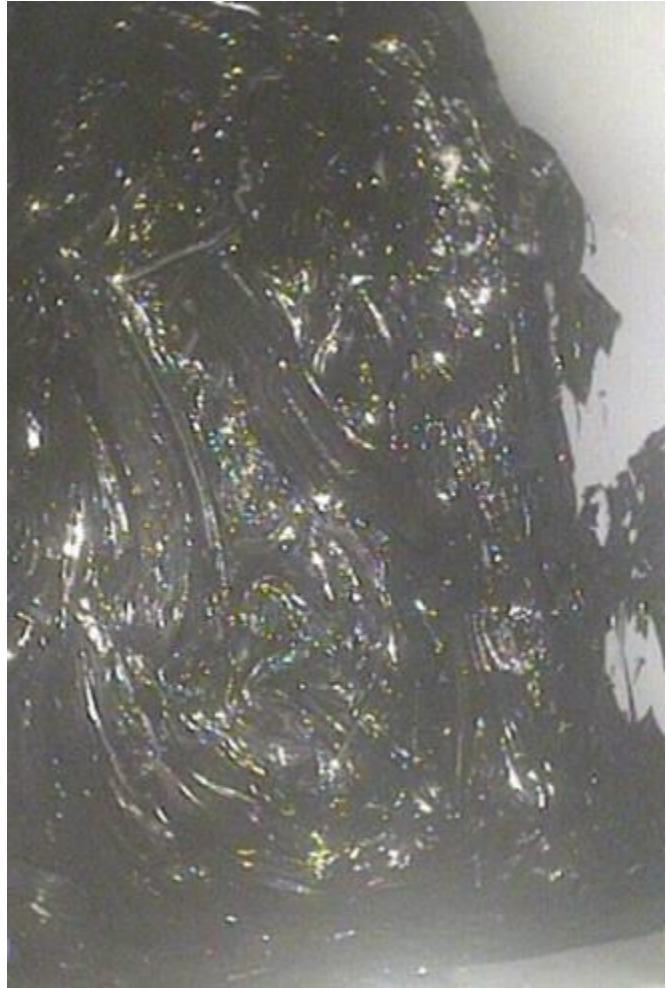
Figure 13. Sealer completely applied and distributed.

9. Figure 13 illustrates a completed seal over the sound absorber as viewed with the borescope.

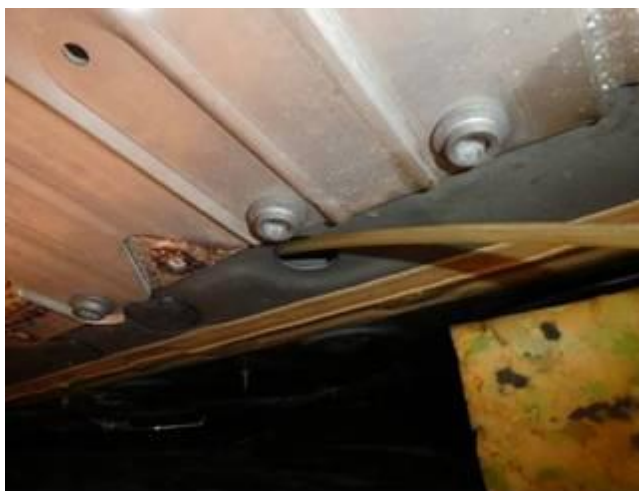
Figure 14. Conservation wax application.

10. After the sealing procedure is completed and the sealer has fully cured, coat the inside of the longitudinal member with cavity preservative D 330 KD2 A1 through the opening shown (Figure 14).

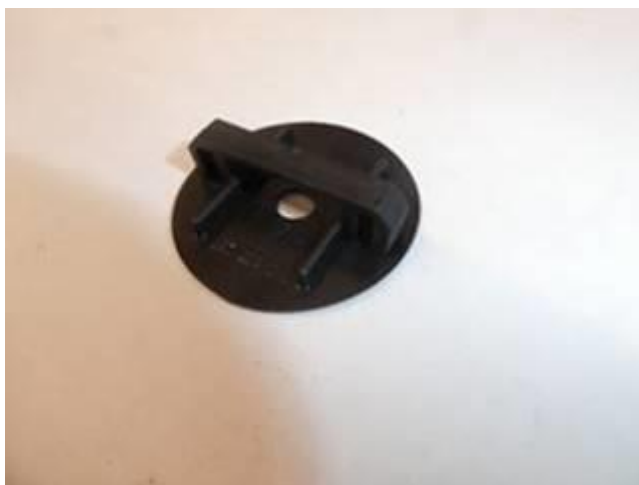
Figure 15. New longitudinal member plugs with integrated drain.

11. After cavity conservation is carried out, the removed plugs 1 and 5 on right and left are to be replaced with plugs 8K0 805 267 with an integrated drain (Figure 15).
