# Technical Service Bulletin

## PSS 90 Instrument cluster map is blank after start-up

90 20 63 2054351/4 August 4, 2020. Supersedes Technical Service Bulletin Group 90 number 19-31 dated October 29, 2019 for reasons listed below.

Model(s)	Year	VIN Range	Vehicle-Specific Equipment
A3 e-tron	2017 - 2018	All	MIB2 High Navigation
A3, A3 Cabriolet, and RS3	2017 - 2019	All	MIB2 High Navigation

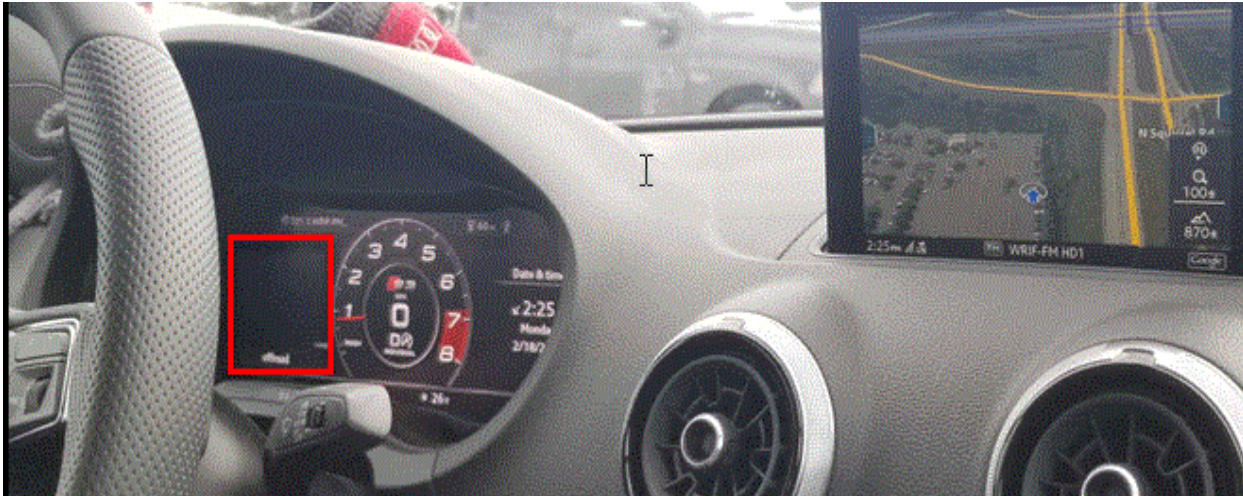
A software bug in the instrument cluster can cause the map not to display if the vehicle is placed in reverse after start-up, then put into park, and the driver's door is opened (Figure 1).

**Figure 1.** Map section is blank in the instrument cluster display.

1. Diagnose the vehicle according to the instructions listed below. If the customer's vehicle condition matches the condition listed in the *Technical Background* of this PSS TSB, explain to the customer that a solution is forthcoming and expected to be available by late Q4/2020, and that no repairs are necessary at this point.

A workaround procedure is available, Pressing the “view” button on the steering wheel will temporarily fix the problem until the next bus sleep cycle.
