96 Adaptive light, pre sense malfunction or unable to calibrate, DTC C12B3F0 is stored in the driver assist module

96 20 54 2054765/2 August 4, 2020. Supersedes Technical Service Bulletin Group 96 number 19-41 dated August 5, 2019 for reasons listed below.

Model(s)	Year	VIN Range	Vehicle-Specific Equipment
Audi e-tron quattro	2019 - 2021	All	With multifunction camera

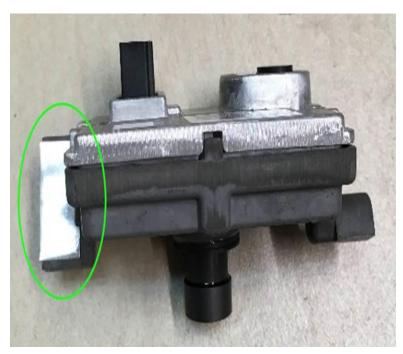
**Figure 1**. How to correctly attach the aluminum adhesive foil on the front camera for assistance systems -R242-.

Check whether an aluminum adhesive foil (part number 4K0 907 231 MTR) with the dimensions 17mm x 7mm x 0.35 mm (length x width x height) is affixed to the front camera for assistance systems -R242- (Figure 1). It is needed to secure the front camera for assistance systems -R242- in the bracket.

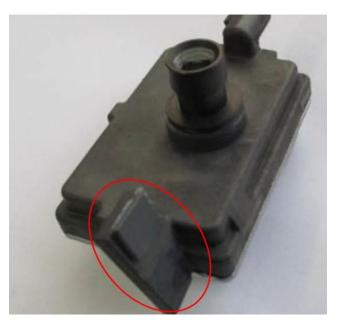
Figure 2. Incorrect attachment of spacer.

Install the aluminum spacer if it was missing or a spacer with other dimensions is fitted.
Remove the old spacer and the adhesive residue from the front camera for assistance systems -R242- (Figure 2).

Be careful to prevent damage to the front camera for assistance systems -R242when removing the adhesive residue.
