Technical Journal

Panoramic sunroof, roller blind hanging loose

REF NO: TJ 35583.1.0	ISSUING DEPARTMENT: Technical Service	CAR MARKET: United States and Canada	
PARTNER: 3 US 7510 Volvo Car USA		ISSUE DATE: 2020-07-06	STATUS DATE: 2020-07-13
FUNC GROUP: 8369	FUNC DESC: Miscellaneous	Page 1 of 4

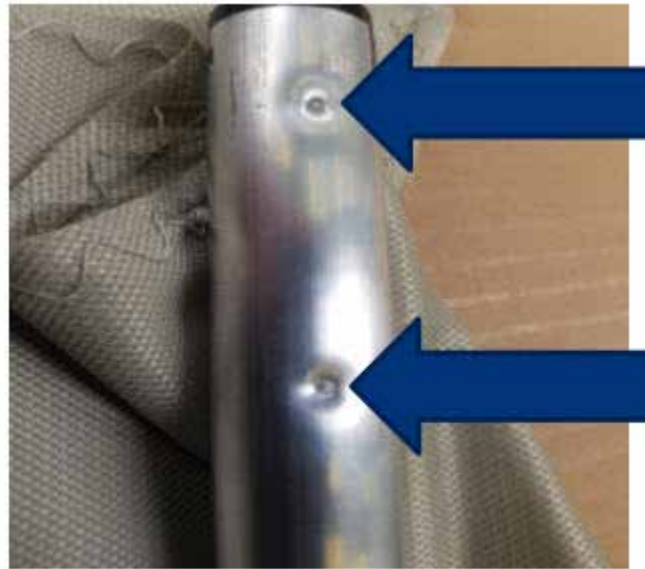
- A. Rollo tube pinching. There should be 6 separated pinchings in the tube, check each pinch that the depth is good. If possible, measure the depth using a caliper.
- B. Socket for rollo fixator. Check if any cracks or imperfections in the plastic.
- C. Roller blind fixator. Check the wings to see if there are any cracks or imperfections in the plastic.

If any problems are found, please replace the roller blind according to VIDA method (search for VCC ID: VCC-371003-6) and send a Vehicle Report with the findings including some photos.

If no abnormalities / damages could be found, repair the car by rolling back the roller blind to the correct position.

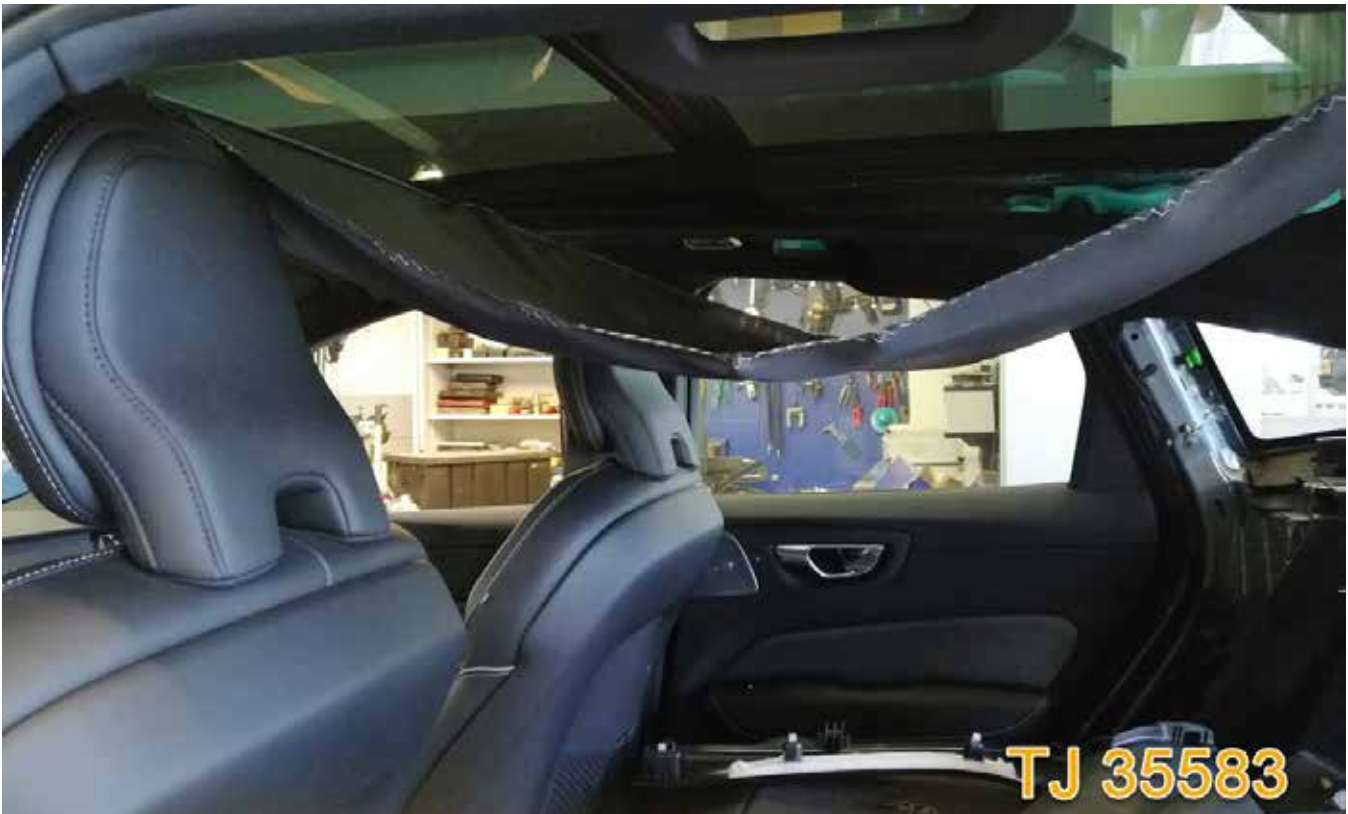
If the roller blind on the panorama sunroof is hanging down and loose in the car, then follow advice under Service.
