TITLE:
D-TPMS, Service required and DTC's

REF NO: TJ 31398.4.0	ISSUING DEPARTMENT: Technical Service	CAR MARKET: United States and Canada	
PARTNER: 3 US 7510 Volvo Car USA		ISSUE DATE: 2020-07-10	STATUS DATE: 2020-07-16
FUNC GROUP: 7761	FUNC DESC: Pressure control	Page 1 of 4

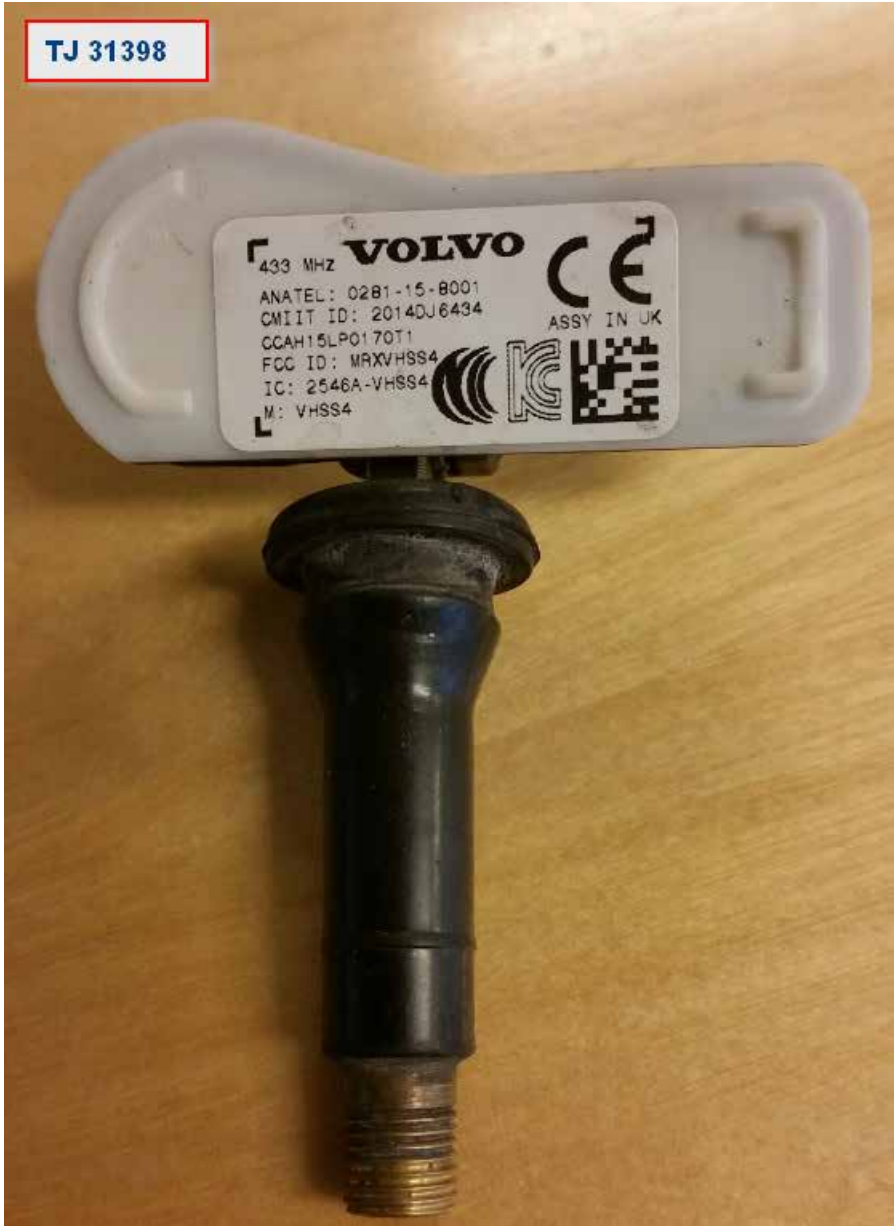
TJ 31398

1. If CEM-U201F00 is present, then start with fault tracing the Multimedia Antenna Module (MAM). Check cables/terminals/ground, eventually try with another MAM unit if nothing wrong can be found.
2. Fault trace DTC's according to VIDA. For TPMS design and function overview, check VIDA VCC-ID VCC-477152-1
3. Check if dark tinted window films has been installed, try TPMS function with windows down to see if anything changes. Remove films if this has negative impact on TPMS functionality.
4. Check and if necessary turn off any non-Volvo accessory using 433 MHz that has been installed in the vehicle.
5. Remove tire from rim and inspect that the correct TPMS sensor is being used, the Volvo logo must be printed on the decal on TPMS sensor (see photo).
6. Try a battery reset.
