Front seat belt, may not retract fully

<b>REF NO:</b> TJ 32985.4.0	<b>ISSUING DEPARTMENT:</b> Technical Service	<b>CAR MARKET:</b> United States and Canada	
<b>PARTNER:</b> 3 US 7510 Volvo Car USA		<b>ISSUE DATE:</b> 2020-07-10	<b>STATUS DATE:</b> 2020-07-16
<b>FUNC GROUP:</b> 8841	<b>FUNC DESC:</b> Seat belt, front	Page 1 of 3

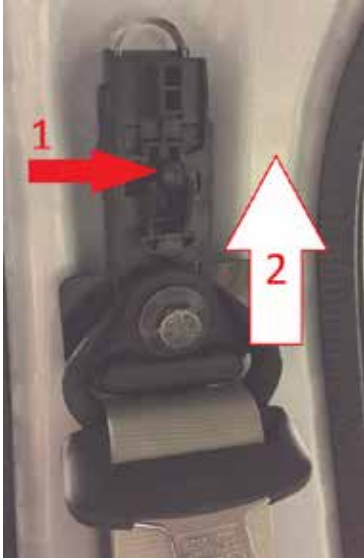
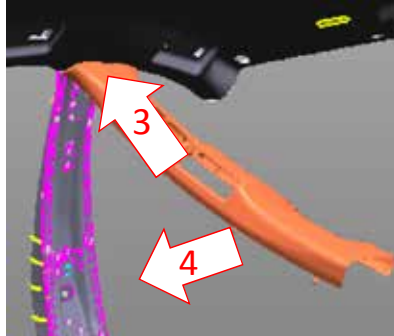
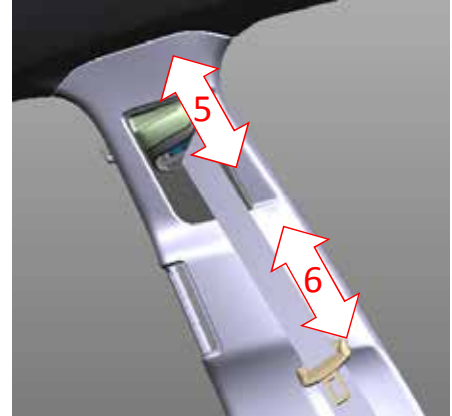
TJ32985

Most replaced front seat belts do not have a fault and the warranty claim will not be approved. Make sure to check that the B-panel is correctly mounted (follow point 1 to 6 under “Service”) before deciding to replace the seat belt.

Remove B-pillar panel. Pull out the belt 0,5 to 1 meter. Release and observe if the belt retracts all the way as normal.

1. Inspect the belt adjustment mechanism. If the button is bent, try to straighten it. If it is broken, replace.
2. Push the adjustment to its highest position.
3. Push the panel up under the inner liner as much as possible.
4. Fold down into normal position.
5. Check that height adjustment operates smoothly.
6. Check that the belt rolls in and out smoothly.

- If the belt does **NOT** retract with the B-pillar panel removed; replace the belt and send a Vehicle Report so that we can order the replaced part back for analysis.
