Technical Journal

Plug-in hybrid electric vehicle high voltage battery repairs

REF NO: TJ 34295.5.0	ISSUING DEPARTMENT: Technical Service	CAR MARKET: United States and Canada		
3 US 7	PARTNER: '510 Volvo Car USA	ISSUE DATE: 2020-06-24	STATUS DATE: 2020-07-13	
FUNC GROUP: 3113	FUNC DESC: Battery, high voltage	Page	1 of 9

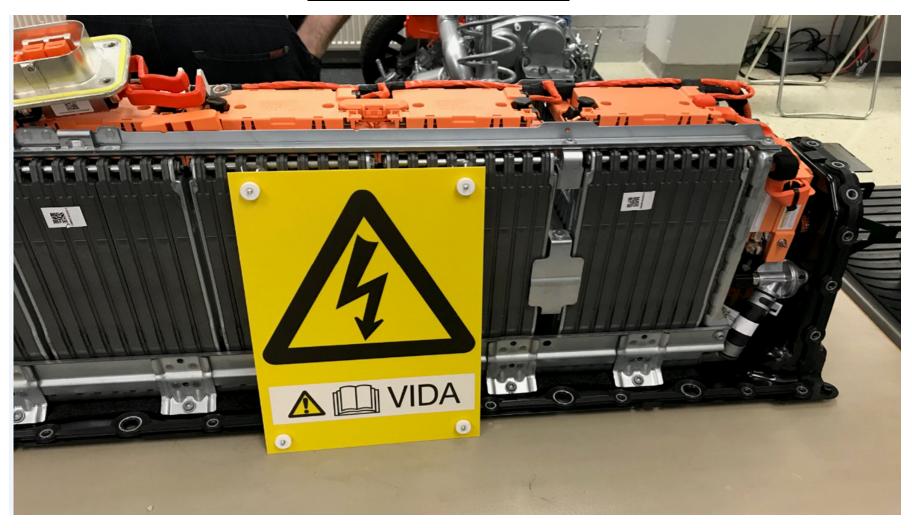
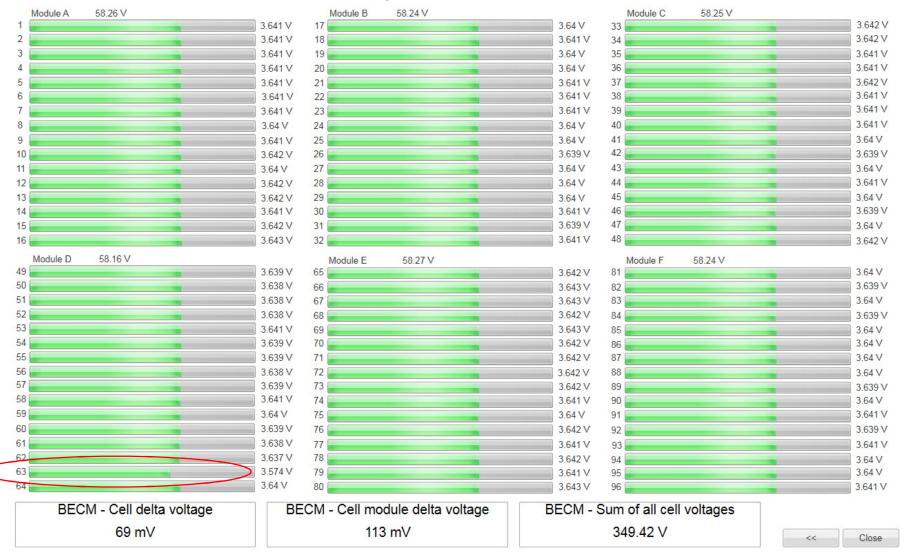
Cell Module: This part is most often used when one cell is defective. The most common cell defects are seen as one cell having a lower Open Circuit Voltage (OCV) and State of Charge (SoC) than all other cells. Normal SOC deviation is less than 5%, more than 10% is a fault. The cell module is delivered complete with temperature sensors and a Cell Voltage and Temperature Node. Examples is attached in "HVB - Cell Voltage Overview"

Example of Cell Fault
