Abnormal Buzz/Groan Noise at 20 - 30 mph From Front Transfer Case

YEAR(S)	MODEL(S)	ADDITIONAL INFORMATION
2019	RAV4

The information contained in this bulletin supersedes Service Bulletin No. T-SB-0065-19.

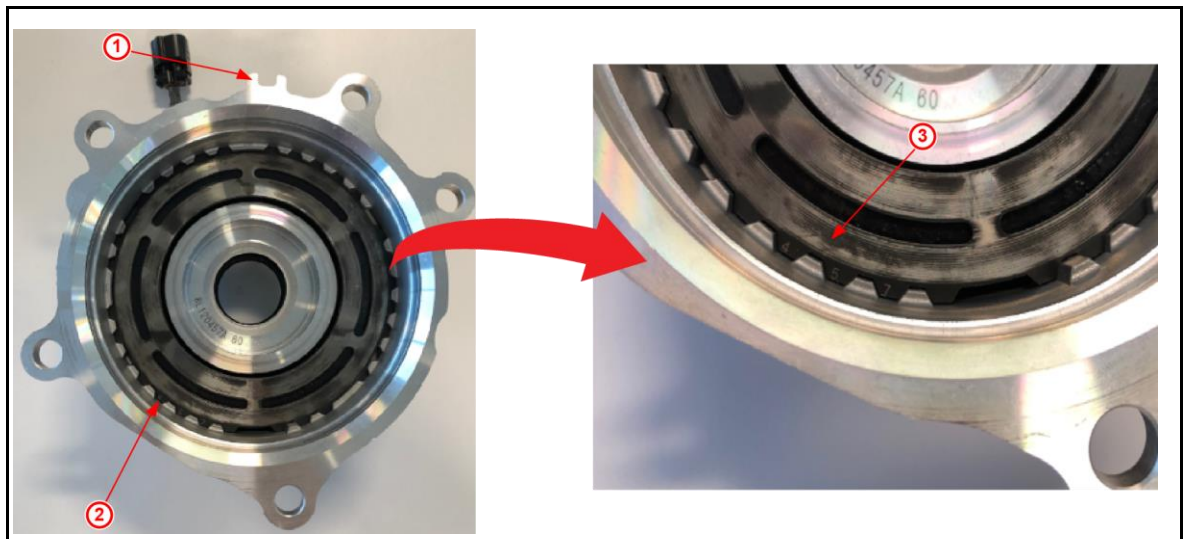
Figure 8.

- Engraved markings **MUST** be visible.
When installed, engraved markings (numbers) will face inward toward the front transfer case/transaxle.
- Outer plate is clocked correctly out of the box as NEW part (it is important to NOT remove the outer plate from the EMC cover).
The reason for NOT removing the outer plate is because it can be easily bent/damaged (there is no reason to handle outside of the cover).

1. Install the NEW front transfer case electro-magnetic clutch.
 - A. Make sure the outer plate is securely installed to the NEW front transfer case electro-magnetic clutch cover.

- Do NOT exchange ANY component of the NEW front transfer case electro-magnetic clutch, in which shim adjustment has been made, with ANY other kit component.
- Do NOT disassemble the outer plate from the cover of the NEW electro-magnetic clutch.

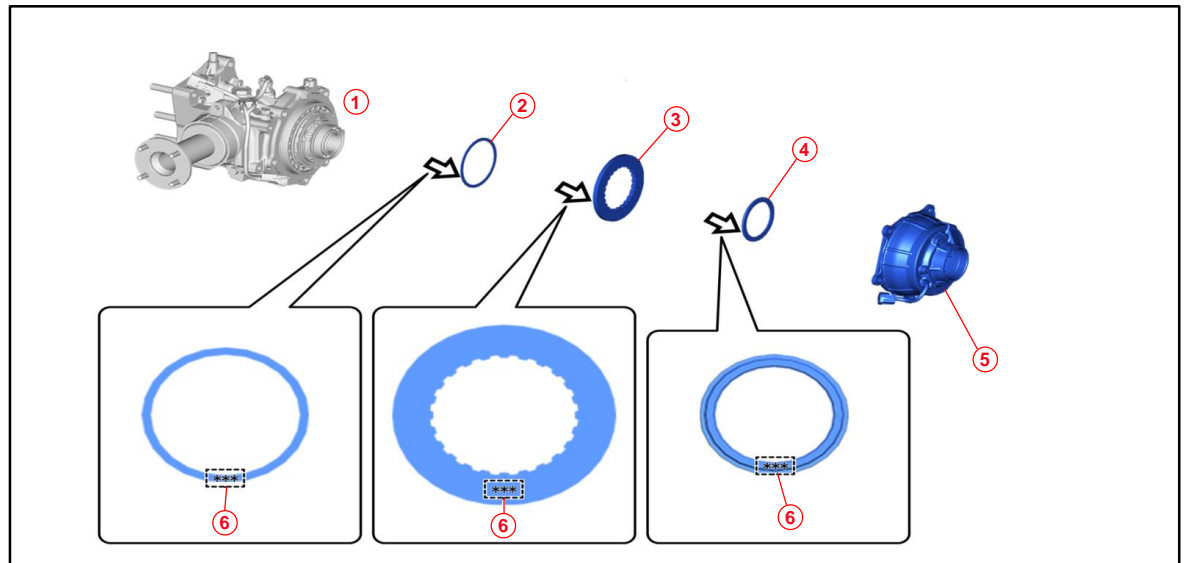
Figure 10.

A NEW shim, armature plate, and thrust roller bearing MUST be installed to the front transfer case with the engraved mark surfaces facing the vehicle inner side (automatic transaxle side). If engraved markings are visible AFTER installation of either shim, armature, and/or needle bearing, the customer may experience the same buzz/groan noise concern AFTER the repair. Ensure the engraved markings are NOT visible when installing these three components.

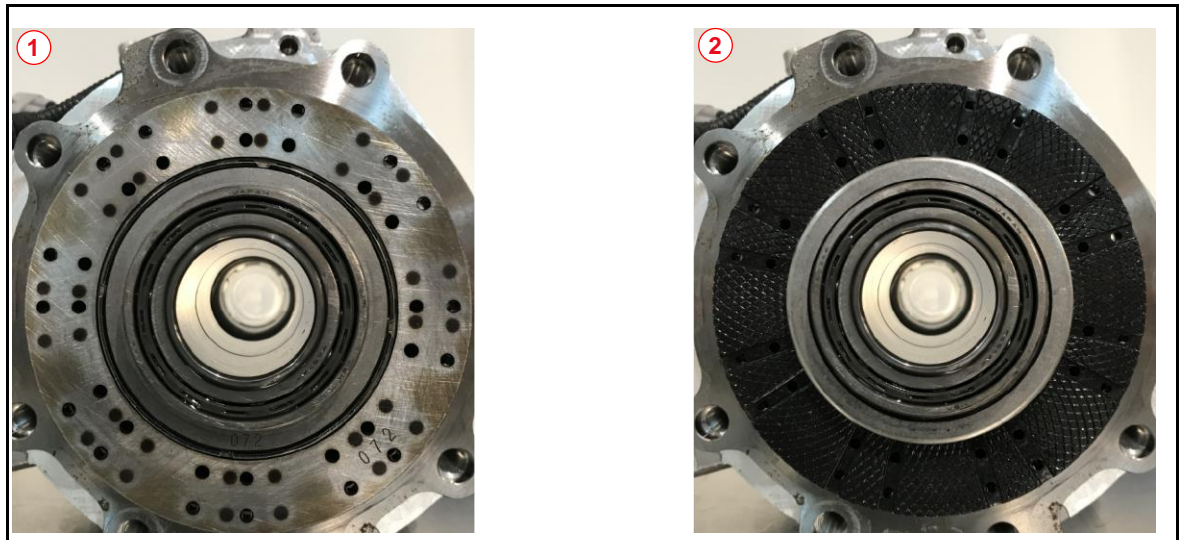
Figure 14. No Good vs OK Condition

1	No Good Condition
2	OK Condition

AFTER proper installation, the engraved mark should NOT be visible.
