Technical Service Bulletin

91 Concerns about the GPS or satellite radio reception (repair the coaxial cable)

91 20 94 2045106/6 August 13, 2020. Supersedes Technical Service Bulletin Group 91 number 18-16 dated October 19, 2018 for reasons listed below.

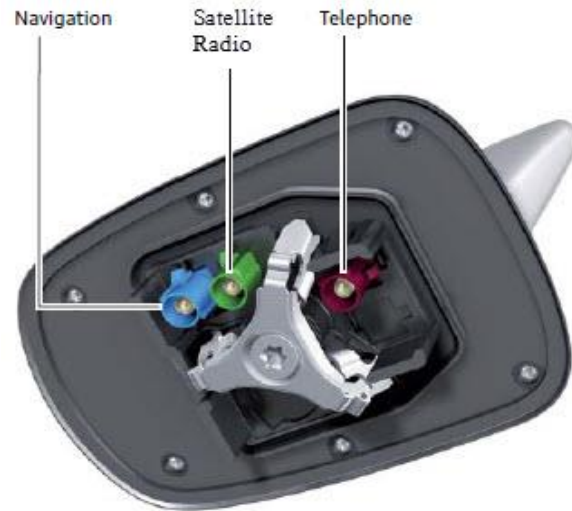
The correct circuit can be identified by the color on the antenna connector (Figure 1). Not all antenna connectors are laid out the same:

Figure 1. Identify the correct circuit by the color of the antenna connector. Blue: Navigation. Green: Satellite Radio. Connector placement on the antenna will change by vehicle options, reference the wiring diagram for your specific vehicle.

4. Replace the FAKRA connection at the shark fin antenna for the applicable circuit, see instructions below.

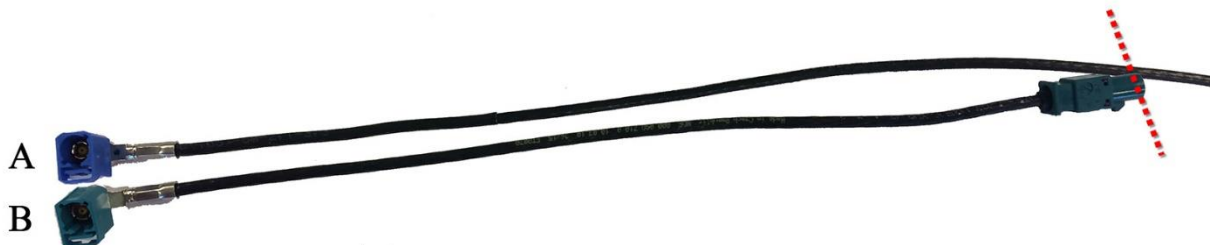
Figure 2. Measure the cut point on the vehicle's antenna coaxial wiring (A) based on the length of the replacement coaxial "Adapter Antenna Cable" (B). The removed length of cable from A should be equal to the length of cable B.

5. Follow instructions located in the repair manual to access the FAKRA connectors at the shark fin antenna. Only disconnect the FAKRA connector of the circuit associated with the customer's concern.
6. Remove a section of the vehicle's coaxial wiring for the applicable antenna circuit. Measure the length of coaxial wiring to be removed based on the Adapter Antenna Cable you are using (Figure 2). This will ensure that the removed section is the same length as the Adapter Antenna Cable (part number 000098710A or 000098650 (Q7 only)).

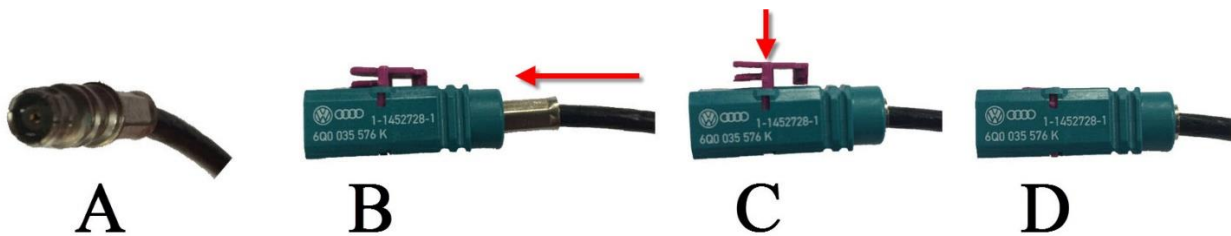
Figure 3. A: Coaxial wire with female replacement aerial connector end installed. B: Insert aerial connector end into connector housing until fully seated. C: With aerial connector fully seated in the connector housing, press down on the locking tab. D: Completed assembly.

- Identify the coaxial wiring type used in your application (RG174 or RTK031).
- Install the applicable replacement aerial connector on the vehicle side of the coaxial harness.
- For a visual example of the coaxial cable with a replacement aerial connector installed see Figure 3, item A.

8. Install the applicable connector housing onto the aerial connector installed in the previous step. Ensure the connector is fully seated onto the coaxial connector and the locking tab is pressed all the way down (Figure 3).

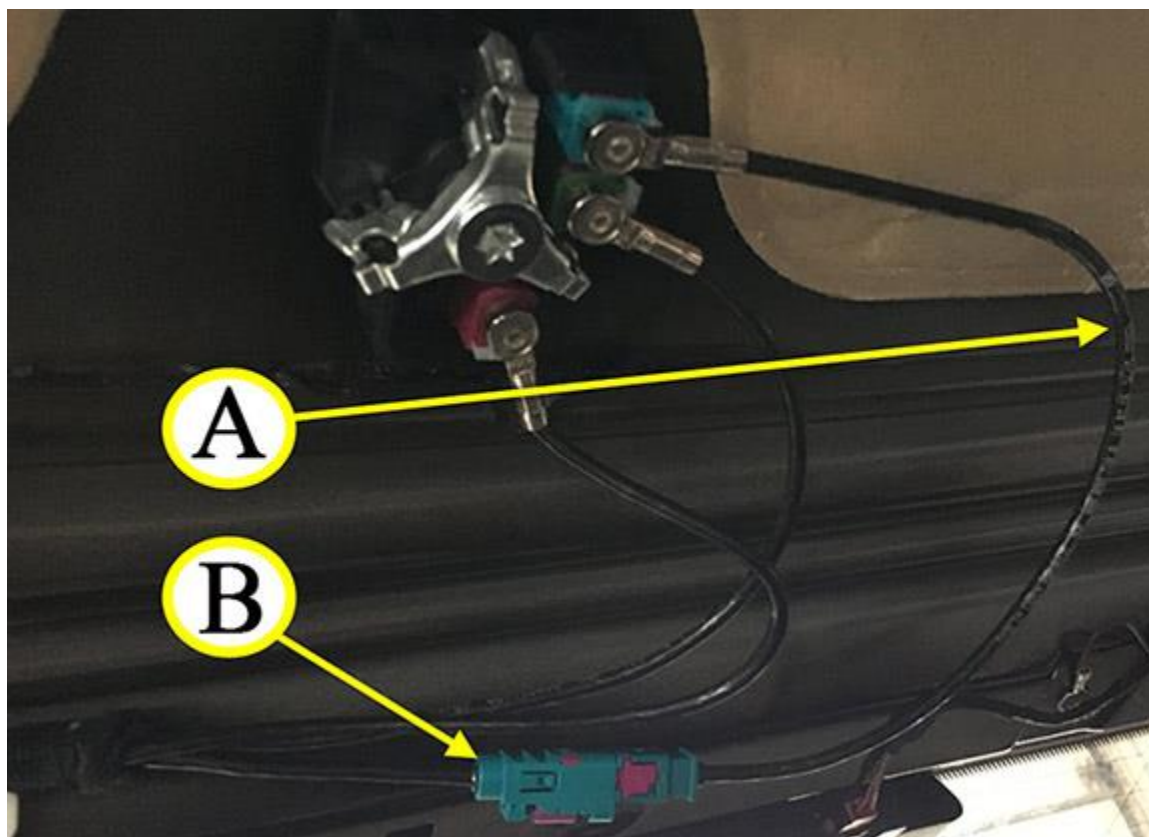
Figure 4. Install the Adapter Antenna Cable (A) onto the shark fin antenna and connect to the newly created FAKRA connection (B). Wrap a layer of cloth tape around FAKRA connection B to avoid any unwanted noises.

9. Install the applicable Adapter Antenna Cable onto the shark fin antenna and connect it to the newly installed FAKRA connection from the steps 7 and 8. Wrap the new FAKRA connection with cloth tape (part number 000979950) to avoid any unwanted noises.
