39-20-01 - Bevel Box Case Half Leak

Release date: 8/14/2020

Applicable Vehicles					
Model(s)	Year	Eng. Code	Trans. Code	VIN Range From	VIN Range To
Arteon	2019-2020	All	All	All	All
Atlas Cross Sport	2020	All	All	All	All
Atlas	2018-2020	All	All	All	All
Tiguan	2018-2020	All	All	All	All

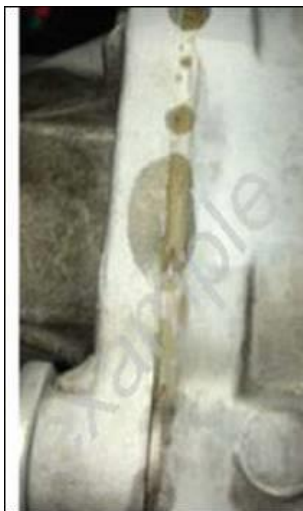
Figure 1.

Gear oil leak from the case halves of the bevel box due to currently used sealant type (Figure 1).

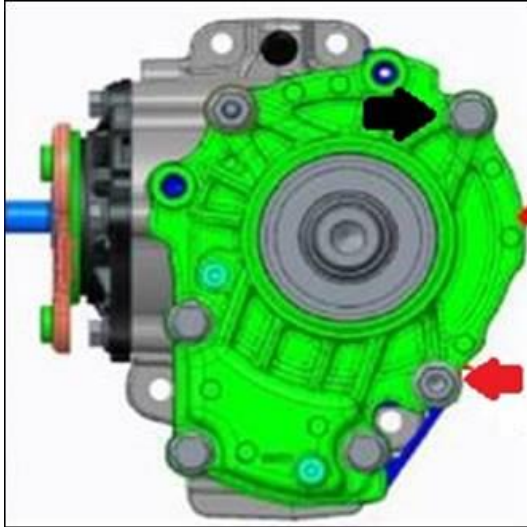
Figure 2.

Source of leak is between the case halves at the right side of the bevel box between the two bolts seen in Figure 2 (red and black arrows).
