## STAR ONLINE PUBLICATION

**Case Number:** S2023000034

**Symptom/Vehicle Issue:** Front Floor Wet. Water Leak From A Pillar Area

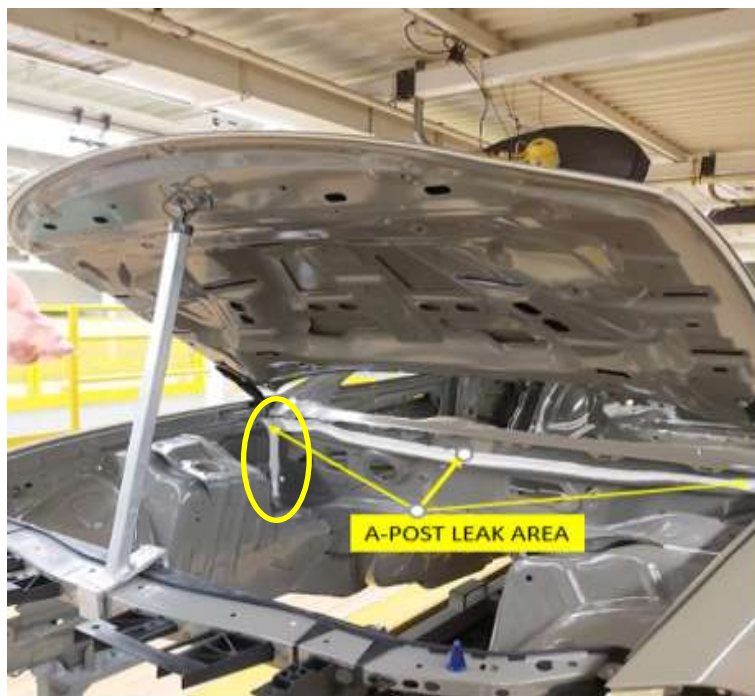
**Discussion:** As part of water leak testing, perform a visual inspection of seam sealer locations in the front bulkhead area (fig 1). Inspect the vertical and wiper cowl seams. Note the sealer is applied on inside of cabin and under hood area- inspect both.

Fig 1 Front Bulkhead

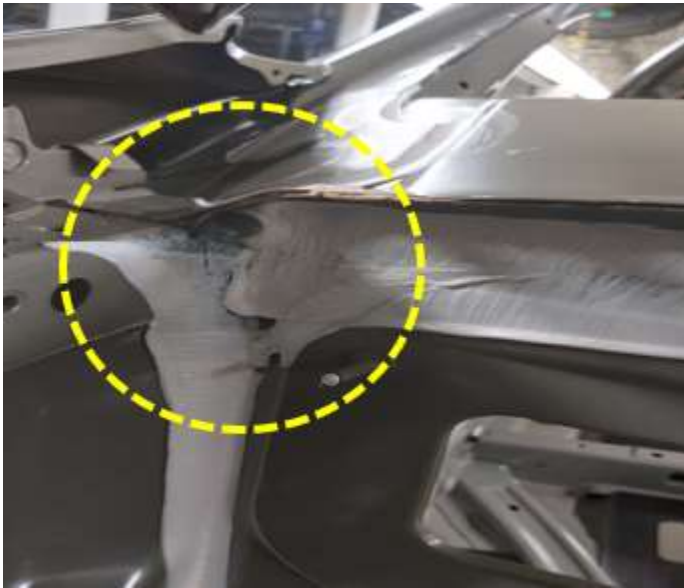
Fig 2 Sealer void

Inspect for missing sealer, skips, voids and air pockets (Fig 2). If found, use a seam sealer such as Kent Products Hitech clear p10200 or equivalent to seal the area. Follow products application and curing directions. Sealer can be applied with an applicator brush or popsicle stick (Fig 3 and 4).

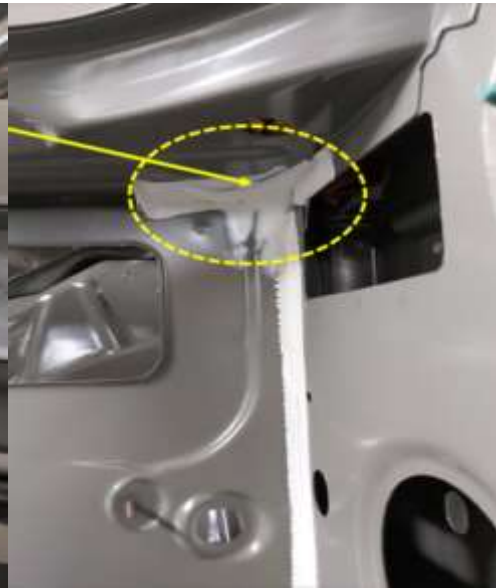
Fig 3 Repaired Seam

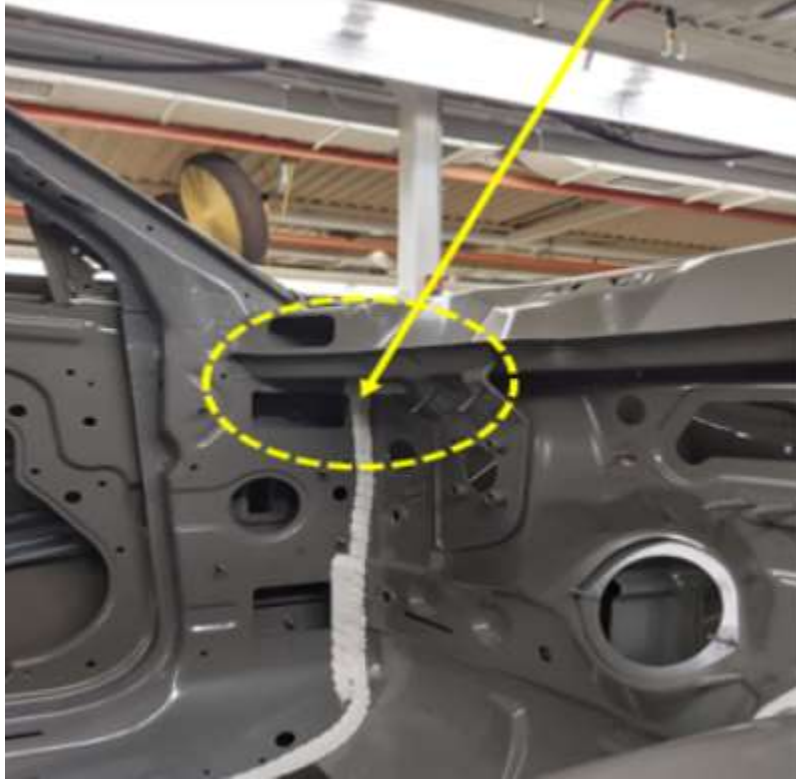
Fig 4 Cabin interior side of seams

**Verification:** Use open hose flow or a shower head to arc water on to the vehicle to test repaired areas. Allow water to flow on suspect area for minimum 10 minutes.
