NUMBER: 21-039-20

DATE: July 2, 2020

Transmission Case Oil Leak

This bulletin involves tightening the lower transmission bolts to updated torque specifications to possibly eliminate a leak at the case split line of the transmission.

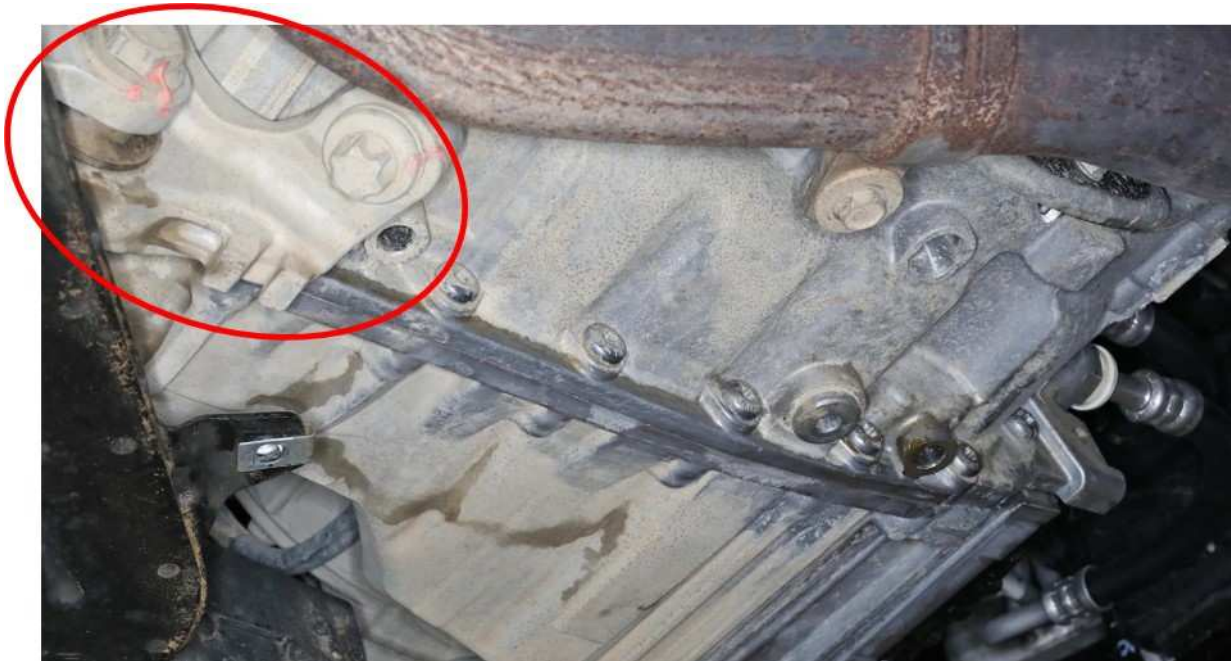
Fig. 3

(Reference Picture) Support Bracket to be Removed

1. Remove the cross under exhaust pipe for access (if necessary). Refer to the detailed service procedures available in DealerCONNECT> Service Library under: 11 - Exhaust System / Pipe, Exhaust Crossunder / Removal .
2. Remove the transmission mount bracket to gain access to bolts 1 & 2 (Fig. 3) .

4. Install the transmission mount bracket (Fig. 3) .
5. Install the cross under exhaust pipe (if removed). Refer to the detailed service procedures available in DealerCONNECT> Service Library under: 11 - Exhaust System / Pipe, Exhaust Crossunder / Install.
