NUMBER: 21-040-20

SUBJECT:

Transmission Case Oil Leak

This bulletin involves tightening the lower transmission bolts to updated torque specifications to possibly eliminate a leak at the case split line of the transmission.

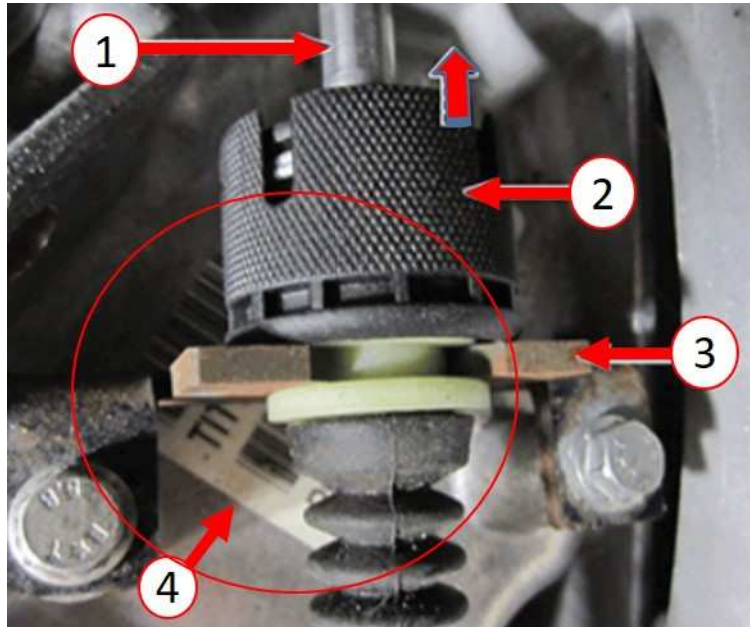
Fig. 1
(Reference Picture) for Transmission Tag Location

1. Inspect the transmission tag located under the shifter cable, for the plant code and build date (Fig. 1) .

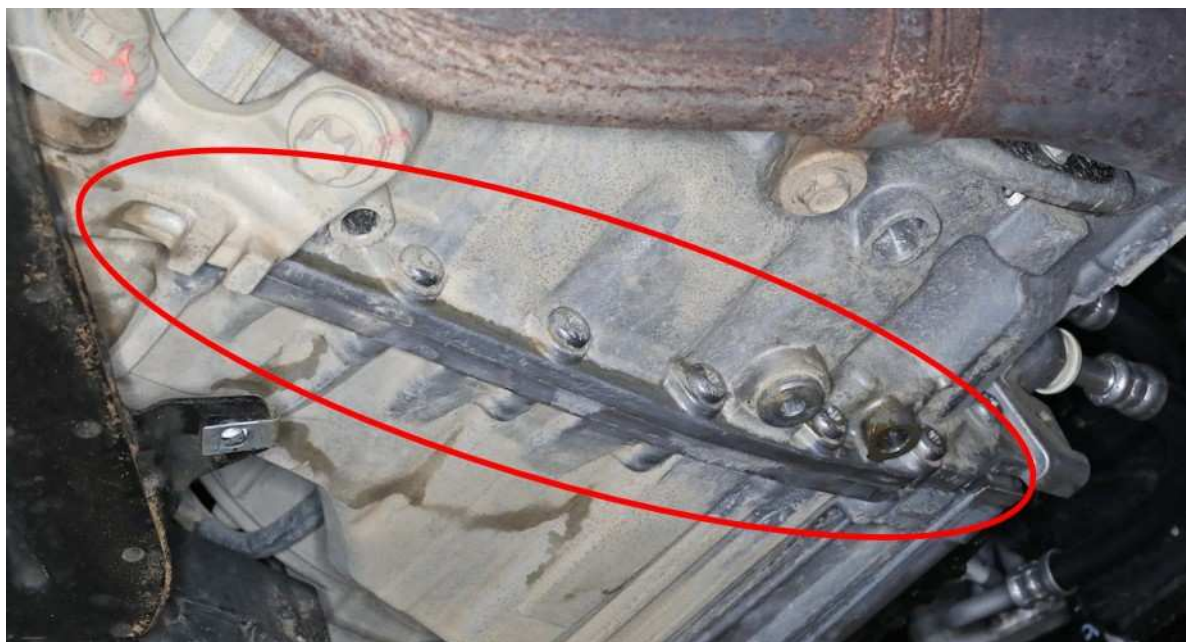
Fig. 2

Customers may notice (possibly transmission) fluid leaking on the ground from the left front of the vehicle.

(Reference Picture) Potential Leak Area at Case Split

7. Start the vehicle and verify the transmission fluid temperature is above 50 °C (122 °F).
8. Verify the transmission fluid level and it is not leaking at the repair area (Fig. 2) , if a leak is still detected further diagnosis should be performed.

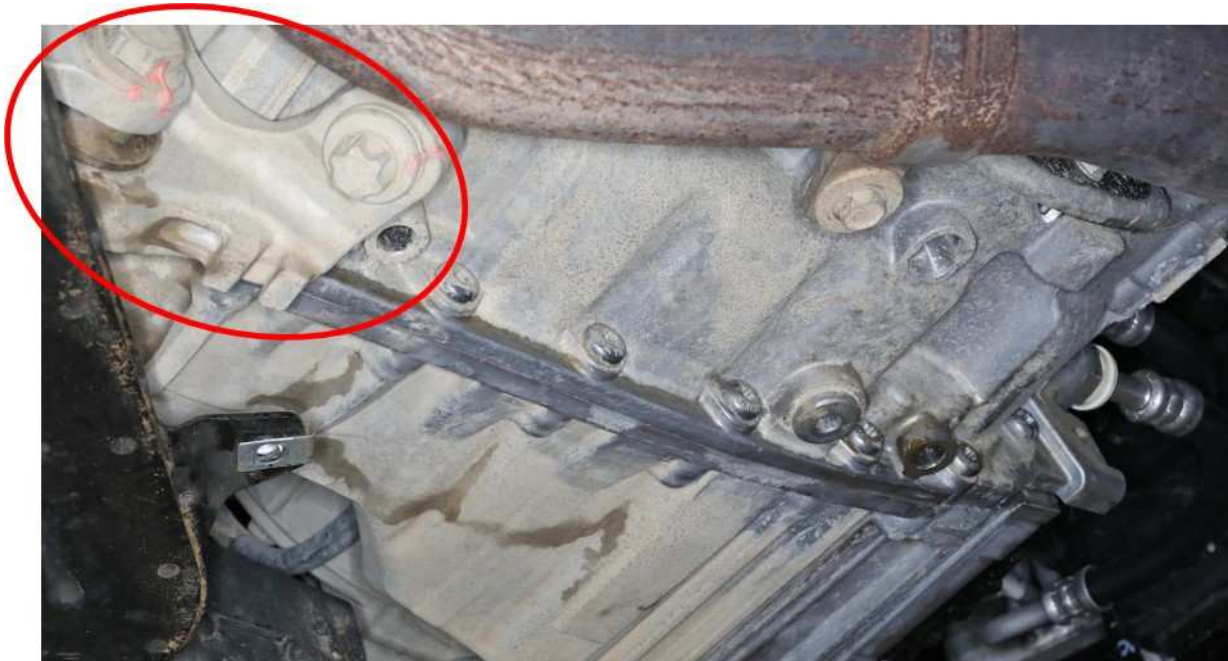
Fig. 3

(Reference Picture) Support Bracket to be Removed

1. Remove the cross under exhaust pipe for access (if necessary). Refer to the detailed service procedures available in DealerCONNECT> Service Library under: 11 - Exhaust System / Pipe, Exhaust Crossunder / Removal .
2. Remove the transmission mount bracket to gain access to bolts 1 & 2 (Fig. 3) .

4. Install the transmission mount bracket (Fig. 3) .
5. Install the cross under exhaust pipe (if removed). Refer to the detailed service procedures available in DealerCONNECT> Service Library under: 11 - Exhaust System / Pipe, Exhaust Crossunder / Install.

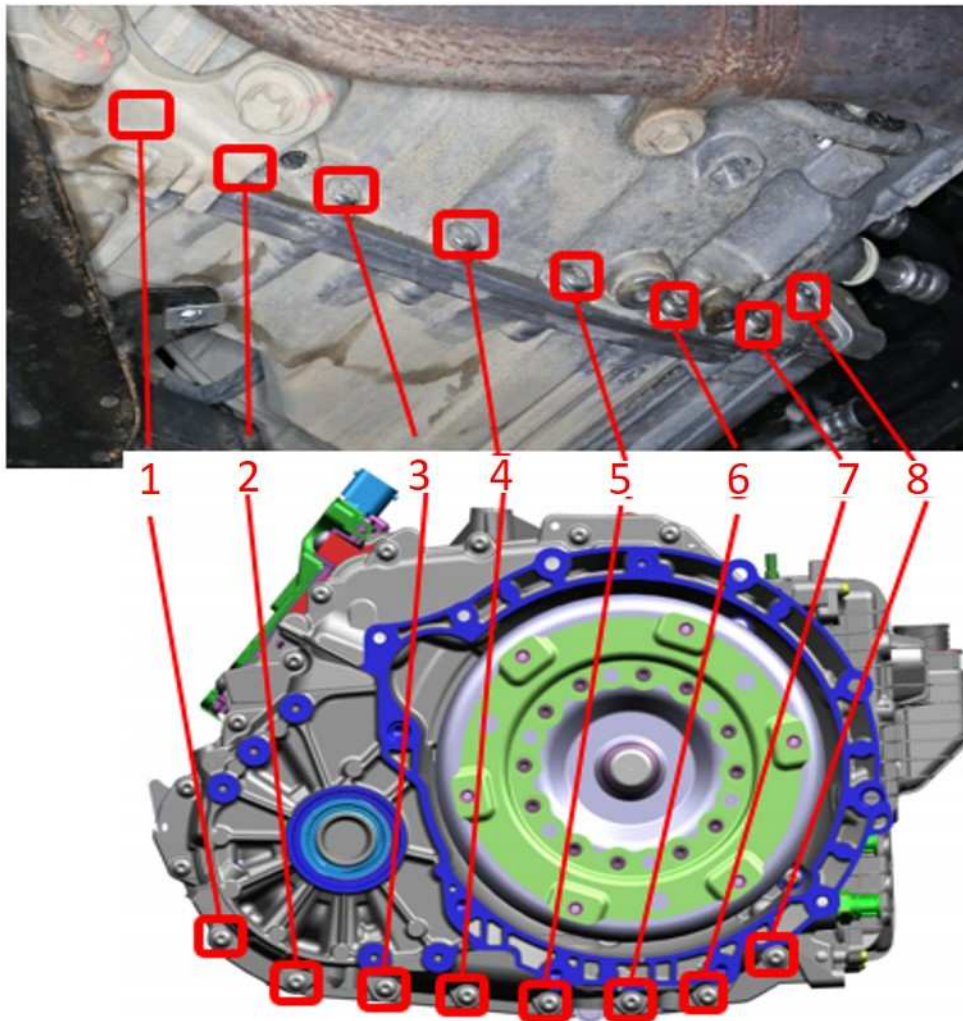
Fig. 4

(Reference Picture) Eight Bolts to be Torqued to Specifications at Potential Leak Area at the Case Split

3. Starting at bolt #8 and then working to bolt #1, torque bolts to 35 N·m (26 ft. lbs.) (Fig. 4) .

CAUTION! Do not rotate the bolts counter clockwise.
