**NUMBER:** 08-068-20

UGQ Radio Enhancements

This bulletin involves inspecting and if required, updating the radio software level to 34.21.

Jeep Compass

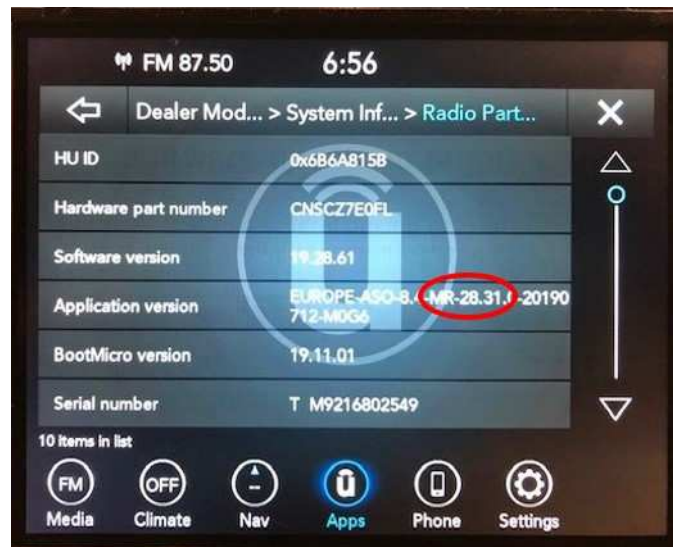
Fig. 1

1. Verify the radio software version. Radio must be in Dealer Mode to verify by following these steps:
  - a. Press and hold both lower corners of the display screen, until the Dealer Mode screen appears (approximately seven seconds). Release screen.
  - b. Select "Radio Part Information". The software version will be listed next to "Application Version" (Fig. 1) .

Radio Software Level Screen

2. Is the radio software level (Application Version) at or higher than 34.21?
  - YES >>> The radio software is already up to date. Normal diagnostics should be performed.
  - NO >>> Proceed to [Step 1](#) of the Repair Procedure.

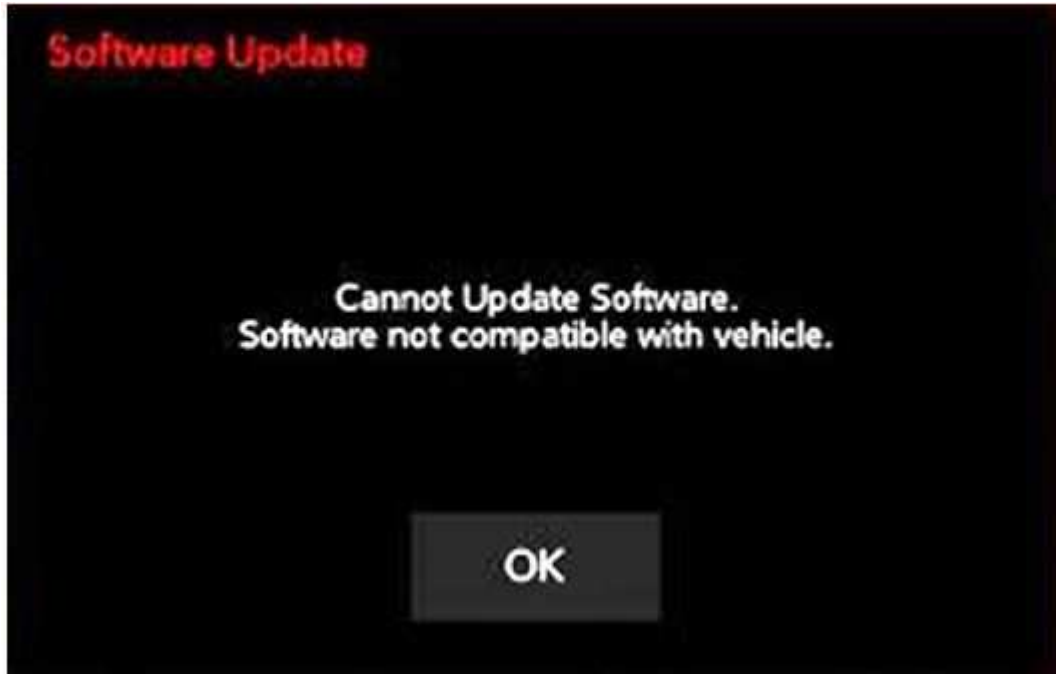
Fig. 5

Software Not Compatible Screen

10. If the screen in (Fig. 5) is displayed, the USB flash drive was not set up correctly. Use a top name brand USB flash drive, like Kingston, create a new USB flash drive and start the update again.

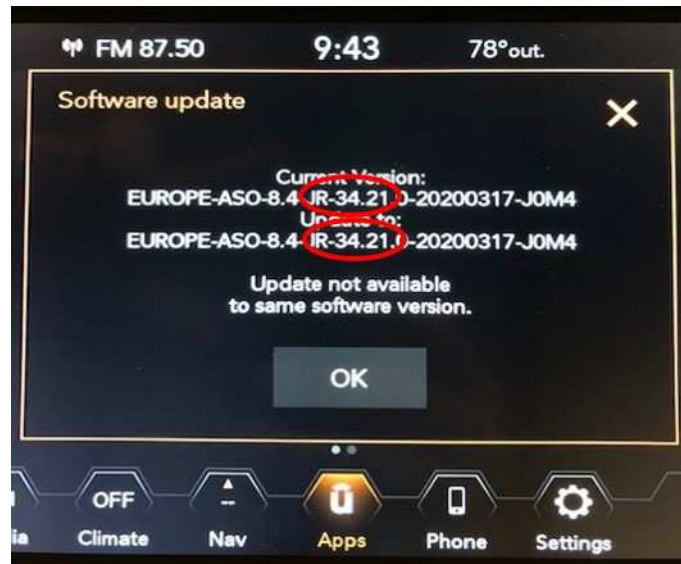
Fig. 6

Screen Displayed When Radio Software Level Is Up To Date

11. If the radio software is up to date, the screen in (Fig. 6) will be displayed. Press "OK" and remove the USB flash drive.

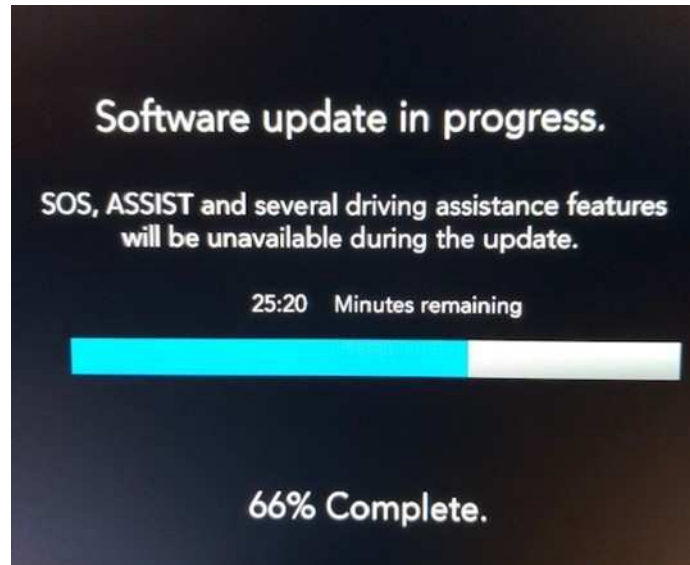
Fig. 9

Software Update In Progress

14. The radio will reboot and the update will begin. The update should only take 25 minutes, the timer on the screen may display the incorrect time remaining, (Fig. 9) .

**NOTE: The completion indicator may not reach 100%, even though the software update has been completed. Once the software update has finished, the radio and display screen will turn off.**

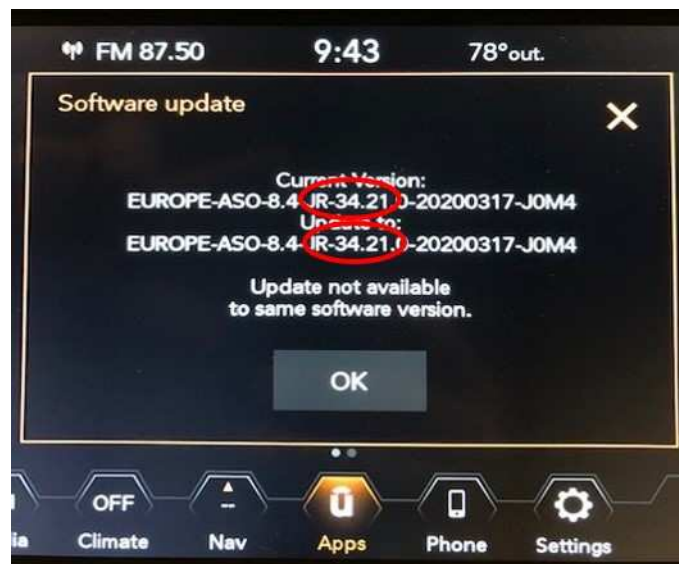
Fig. 10

Radio Software Has Been Updated

15. After the update has completed, the radio will shut down. With the USB flash drive still inserted in the USB port, cycle the ignition back to the run position. If the radio has been updated correctly, the screen in (Fig. 10) will be displayed. Press "OK" and remove the USB flash drive.
