NUMBER: 08-007-20 REV. A

GROUP: 08 - Electrical

DATE: July 17, 2020

UAQ and UCQ Radio Enhancements

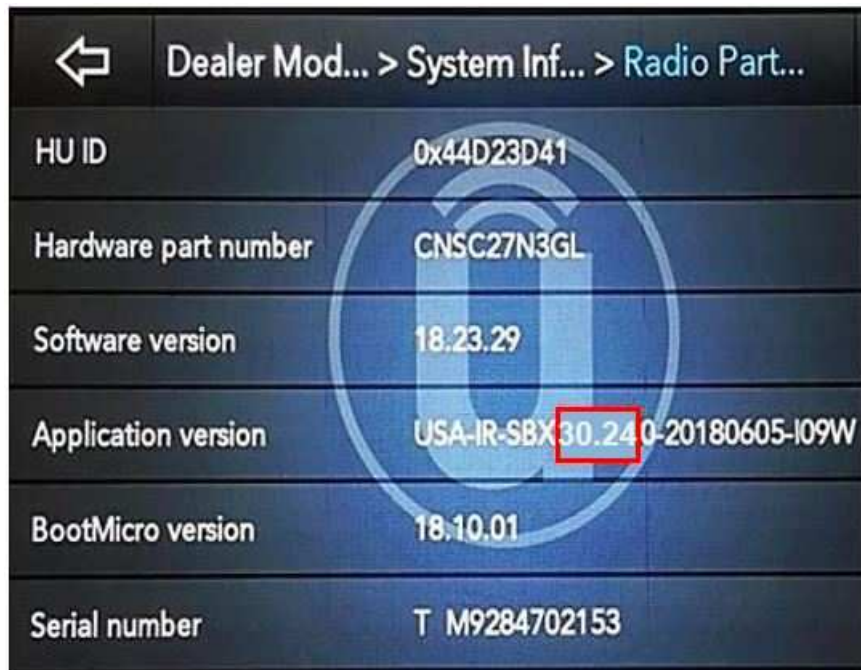
Fig. 1
Radio Software Level Screen

1. Verify the radio software version. Radio must be in Dealer Mode' to verify by following these steps:
 - Press and hold the two lower corners of the display screen simultaneously until the Dealer Mode screen appears (approximately seven seconds). Release buttons.
 - Select "Radio Part Information". The software version will be listed next to "Application Version" (Fig. 1) .
2. Is the current radio software level at or higher than?
 - ** UAQ radios - 34.2.**
 - UCQ - 30.24.

- YES >>> The radio software is already up to date. Normal diagnostic should be performed.
- NO >>> The radio software needs to be updated. Back out of Dealer Mode and proceed to [Step 1](#) of the Repair Procedure.

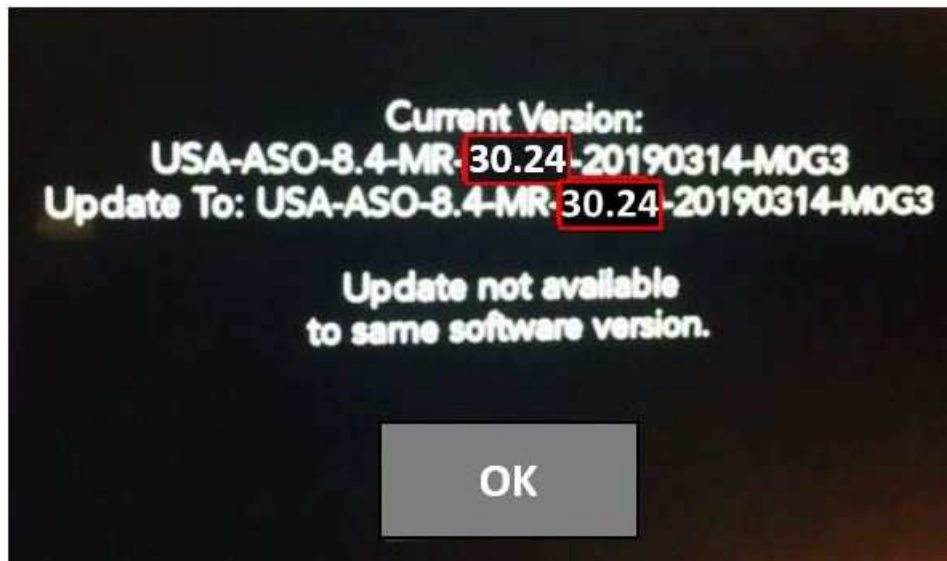
Fig. 5
Screen Displayed When Radio Software Is Up To Date

11. If the radio software is up to date, the “Current Version” and “Update To” will be the same (Fig. 5) . Press “OK” and remove the USB flash drive.

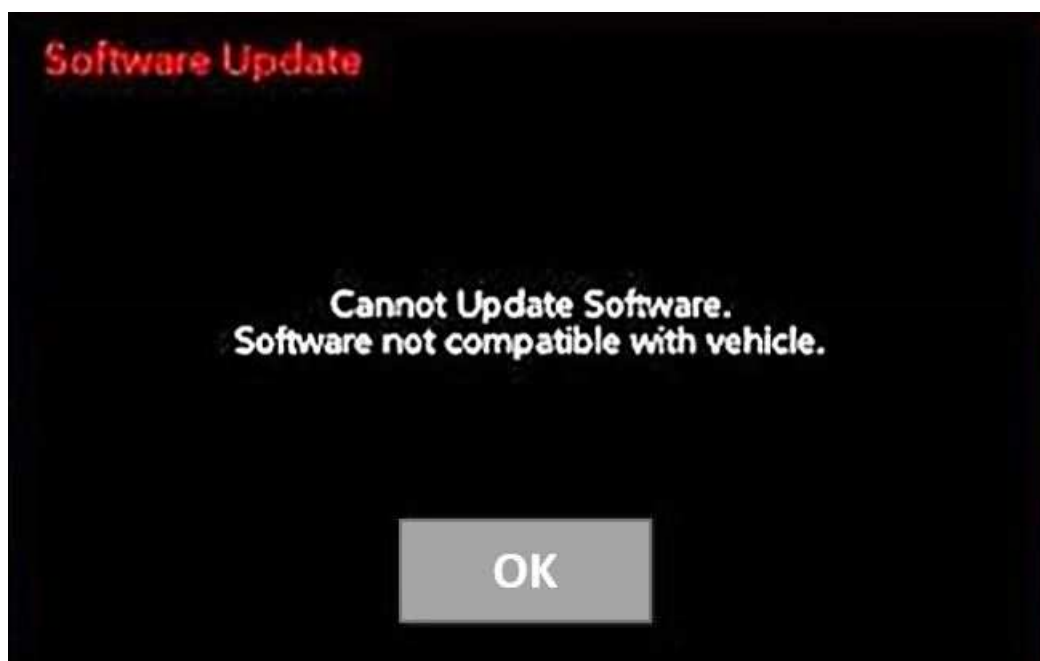
Fig. 6
Software not Compatible

12. If the screen in (Fig. 6) is displayed, the USB flash drive was not set up correctly. Use a top name brand USB and create a new flash drive and start the update again.
