NUMBER: 08-071-20

GROUP: 08 - Electrical

Interior Water Intrusion Through HVAC Air Inlet

2017 - 2018	(MP)	Jeep Compass
2017 - 2018	(M1)	Jeep Compass
2017 - 2018	(M4)	Jeep Compass
2018	(M6)	Jeep Compass

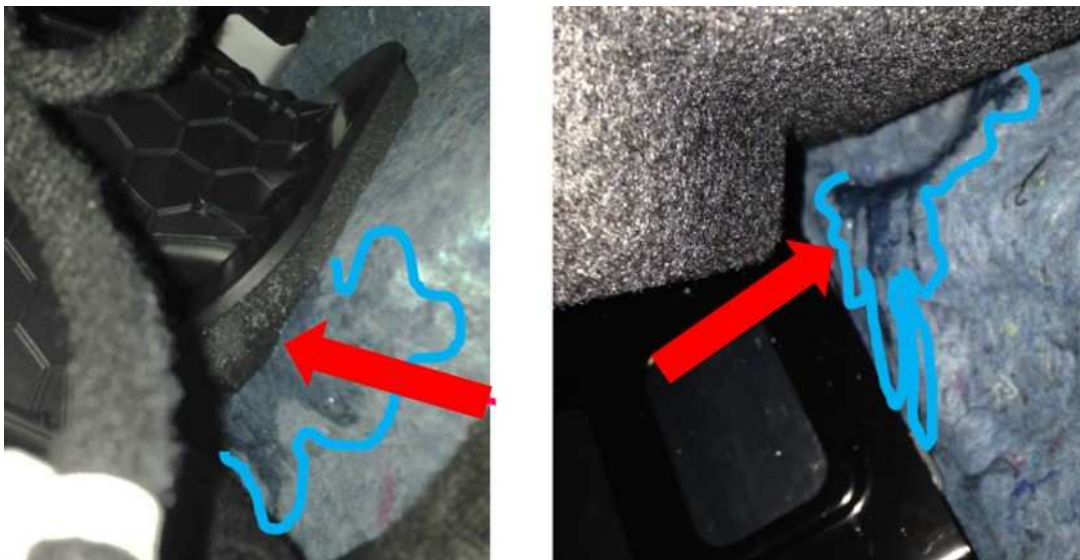
Fig. 1

4. Inspect the instrument panel insulator ([Fig. 1](#)) for dampness or water intrusion by performing the following steps:
 - Remove the glove box. Refer to the detailed service procedures available in DealerCONNECT/Service Library under: Service Info>23 - Body/Instrument Panel/Glove box, Instrument Panel/Removal.
 - Remove the floor console. Refer to the detailed service procedures available in DealerCONNECT/Service Library under: Service Info>23 - Body/Interior/Console, Floor/Removal.

Examples Areas Of A Wet Instrument Panel Insulator

5. Was the instrument panel insulator, or any of the carpets or mats damp or have an odor ([Fig. 1](#)) ?
 - YES>>> Dry the interior carpet and instrument panel insulator. Proceed to [Step 1](#) of the Drying Procedure.
 - NO>>> Proceed to [Step 1](#) of the Water Leak Repair Procedure.

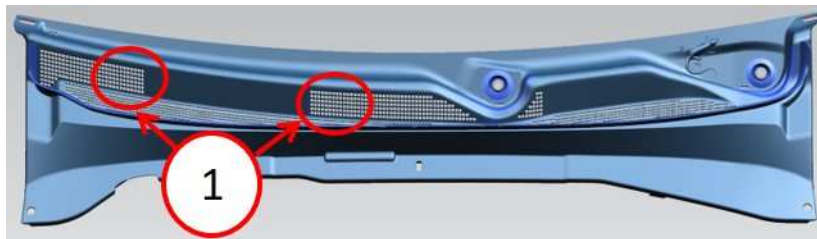
**Fig. 2**

1. Visually inspect the cowl panel cover ([Fig. 2](#)) . The revised cowl panel cover screen openings are noticeably smaller screened opening area ([Fig. 2](#)) .

Original Design Cowl Panel Cover (Replace If The Vehicle Has This Design Cowl Panel)

1 - Revised Cowl Panel Cover Does Not Have As Large Screened Openings

NOTE: Only replace the cowl panel cover if it is the original design cowl panel cover.

2. Does the cowl panel cover have the revised design ([Fig. 2](#)) ?
 - YES>>> **Remove the cowl panel cover.** Refer to the detailed service procedures available in DealerCONNECT/Service Library under: Service Info>23 - Body/Exterior/Cover, Cowl Panel/Removal. Proceed to [Step 3](#) of the Repair Procedure.
 - NO>>> **Remove and discard the cowl panel cover.** Refer to the detailed service procedures available in DealerCONNECT/Service Library under: Service Info>23 - Body/Exterior/Cover, Cowl Panel/Removal. Proceed to [Step 3](#) of the Repair Procedure.

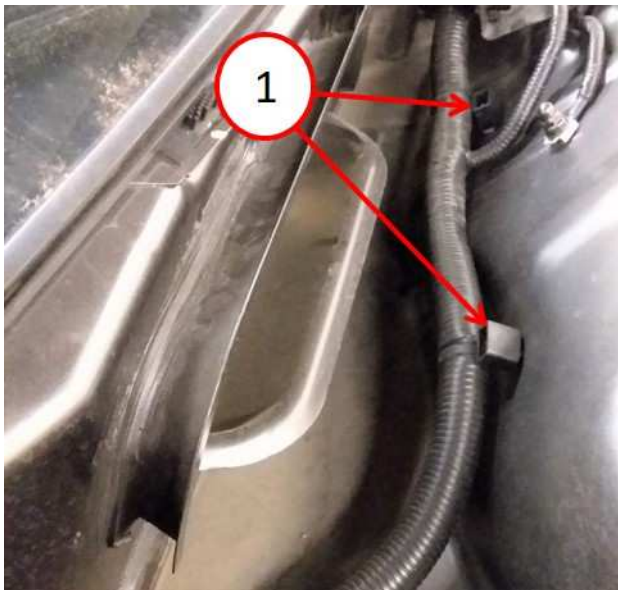
Fig. 3
Old Design Stud Clips

1 - Two Old Plenum Stud Clips To Remove And Discard

CAUTION! Both stud clips must be replaced. Failure to replace the clips may result in water intrusion through the HVAC air inlet.

3. Locate the headlamp wiring harness. Remove and discard the two stud clips that fasten the harness to the plenum (Fig. 3) .

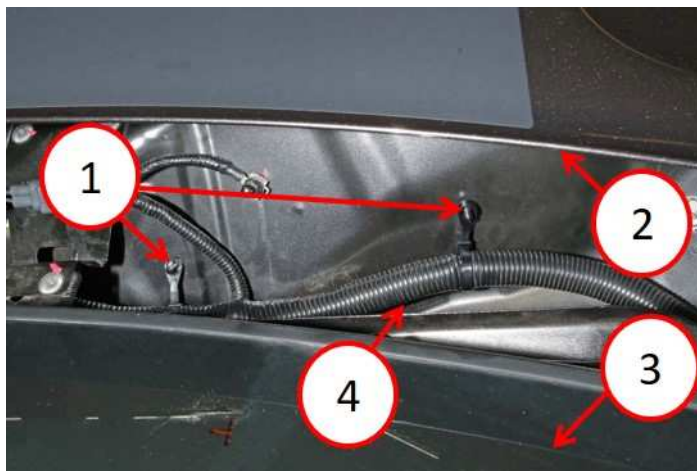
Fig. 4
New Stud Clips Installed on Headlamp Wiring Harness and Plenum Studs

- 1 - New Stud Clips on Plenum Studs
 - 2 - Vehicle Hood
 - 3 - Vehicle Windshield
 - 4 - New Headlamp Wiring Harness Routing (**Re-routing is accomplished when the new clips have been installed**)
-

4. Install two new stud clips onto the plenum studs and fasten the headlamp wiring harness (Fig. 4) .
