Headlamps fogged

Topic number	LI82.10-P-063239
Version	9
Function group	82.10 Exterior lights
Date	06-30-2020
Validity	BR 205 from modification year 18/1 and X166 facelift X 253 halogen W 166 SA code: 621, 622 R 172 and model series 117 facelift, halogen X 156 halogen and SA code 614, 615, 616,618,621,622
Reason for change	Validity adapted (BR205 from modification year 18/1)
Reason for block

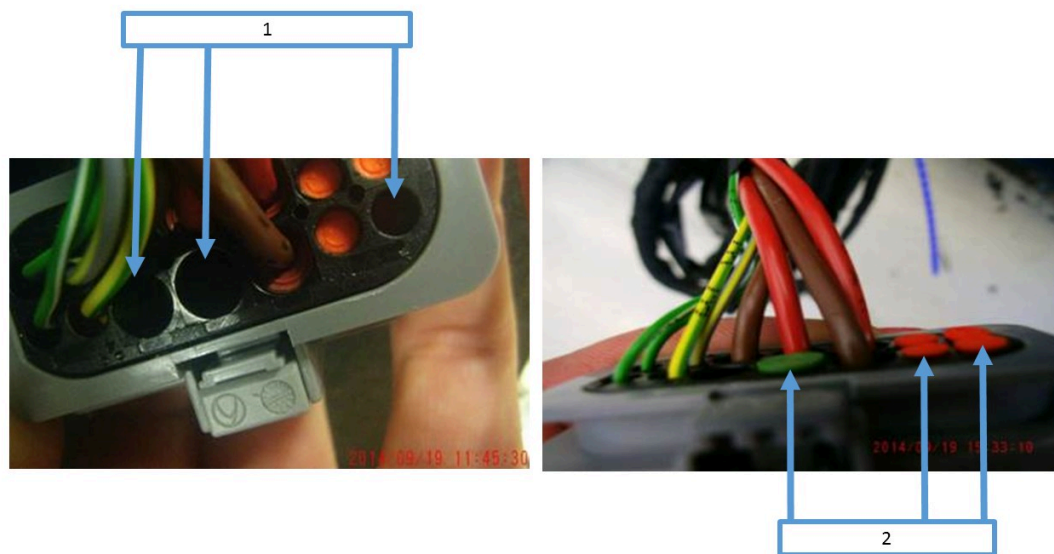
Bild 5.jpg:

Attachments	
File	Description
Bild 1.jpg	1) Service cover with membrane
Bild 5.jpg	1) Seals missing 2) Seals not correctly fitted
Bild 6.jpg	Transparent diaphragm correctly or incorrectly bonded.

1. The seals on the central connector must all be present [Picture 5 (1)] and correctly fitted [Picture 5 (2)].
2. The new transparent diaphragm must be correctly bonded [Picture 6].
3. Check headlamp housing for any external damage.
