RE: **UPDATE -Service Campaign 2019080019 Supplemental VINS added Bolt Replacement on the Steering Rack**  
MY12-17 166, 204, 205, 207, 212, 213, 217,218, 222, 253, 292 (C-Class, CLS-Class, E-Class, GL-Class, GLC-Class, GLE-Class, GLK-Class, GLS-Class, M-Class S-Class)

# Service Campaign Bulletin

Campaign No. 2019080019, November 2019

**Replace Steering Gear Bolts**

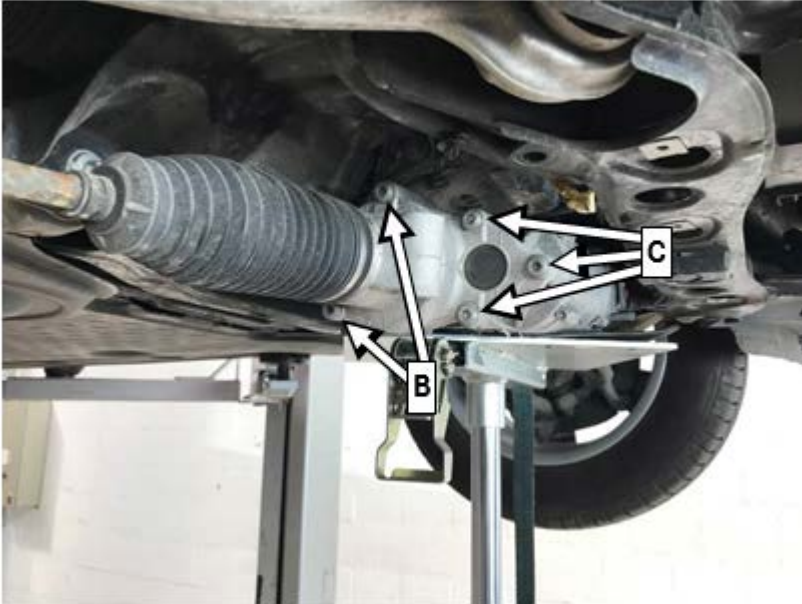
Figure 2

**i** If a **screw** should **break off** or have already broken off, **replace the electric power steering rack.**

4. Remove screws (B and C, Figure 2), making **absolutely sure** to do so **individually and one after the other**, replace with new steel screws and tighten with the specified torque incl. tightening angle.

**Nm** Power-pack screw on steering gear: **5 Nm and 90°** tightening angle.
