BULLETIN NUMBER:  
**IB16-J-002B**

**POSSIBLE CAUSES FOR ENGINE OIL DILUTED WITH DIESEL FUEL**

**AFFECTED VEHICLES**

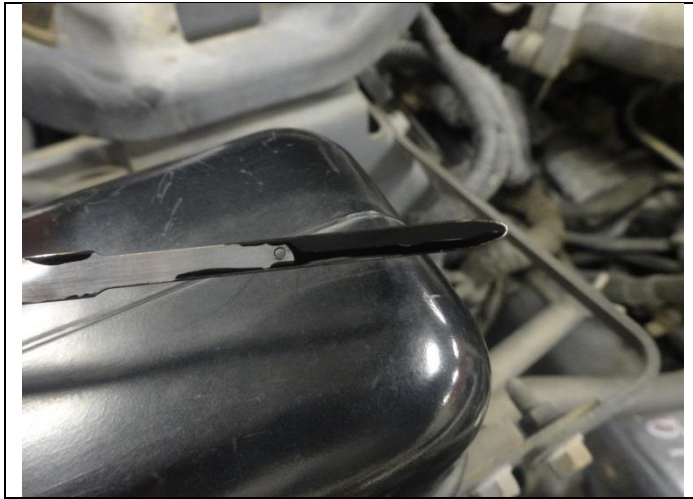
**Figure 1**

**1. Engine oil is overfilled during maintenance.**

Refer to Figure 1 for correct oil level on a dipstick.

When refilling the engine oil, refer to the Workshop Manual (WSM) for the oil capacity of the engine you are servicing. Fill the engine with about 80% of the oil capacity. Start the engine to allow the oil filter to fill. Turn the engine off and allow the oil to drain down for several minutes, then check the dipstick. Continue to add oil as necessary to bring the level up to the full mark on the dipstick.

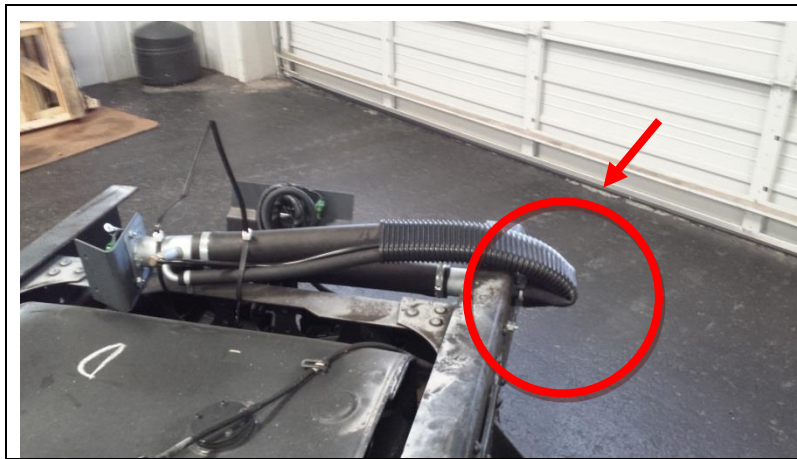
**Figure 2**

**2. Fuel tank fill and vent hoses are kinked during temporary transport or during vehicle upfit.**

If the fuel tank fill and vent hoses are kinked, a vacuum will build up inside the fuel tank while the engine is running. This condition may cause the fuel tank to contract, potentially blocking off the fuel return line at the bottom of the fuel tank. This, in turn, will increase fuel pressure in the fuel return line, causing the fuel pump seal to release fuel into the crankcase.

Refer to Figure 2 for an illustration of improperly installed and kinked fuel tank fill and vent hoses during transport.

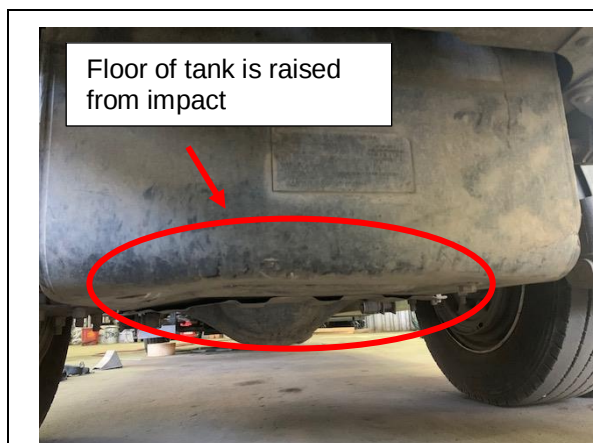
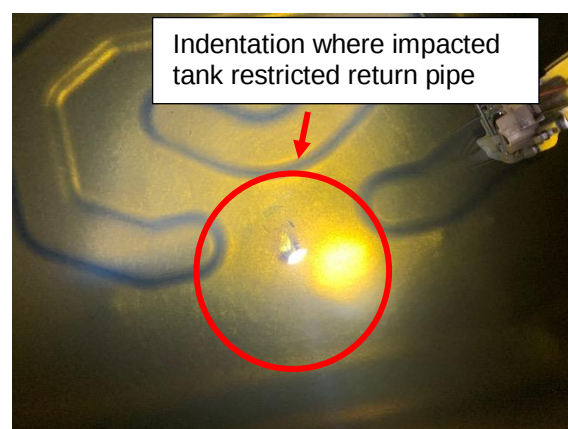
A restricted fuel return line between the engine and the fuel tank will increase fuel pressure in the fuel return line, causing the fuel pump seal to fail, releasing fuel into the crankcase. Check the upfit installation to ensure that a fuel return line has not been crushed or kinked.

Inspect the fuel tank for signs of physical damage, such as dents. (See Figures 3 and 4.) If the fuel tank has been dented or crushed, the fuel return line may be restricted from returning fuel into the tank, causing the fuel pump seal to fail releasing fuel into the crankcase.
