# Technical Service Bulletin

## 30 Transmission leak from service opening of the lower bellhousing

30 20 28 2053597/4 August 20, 2020. Supersedes Technical Service Bulletin Group 30 number 19-25 dated June 25, 2019 for reasons listed below.

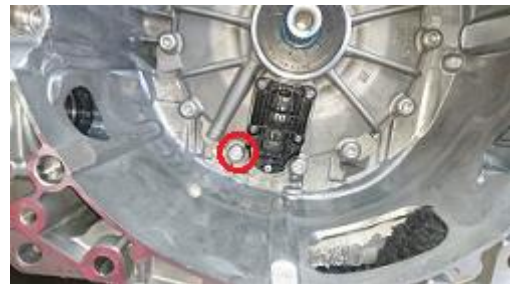
1. Remove the lower bolt of the cover on the passenger's side of the plastic cover (Figure 1 and Figure 2).

**Figure 1.** Bolt location.

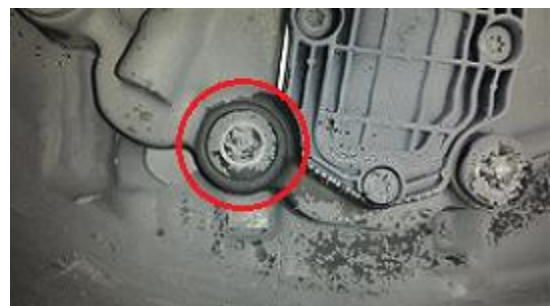
Leaking through the bolt holes of the clutch cover.

**Figure 2.** Leak location.

2. If there is oil residue in the bolt hole, continue with this TSB repair. If there is no oil residue in the bolt hole, create an Audi Technical Assistance Center contact with pictures of the leak and a diagnosis log attached. Then contact Audi Technical Assistance Center for diagnosis assistance.

1. Remove all bolts of the clutch cover (*Do not remove the dual clutch only the bolts are being replaced*).
2. Clean the bolt holes.
3. Install 12 new bolts for the clutch cover with the part number WHT 002 459 C:
  - Tightening torque: 12Nm + 90°.
  - The tightening sequence is a diagonal pattern as described in the repair manual.
4. Reinstall the dual mass flywheel into the transmission per the repair manual.
5. Reinstall the transmission into the vehicle per the repair manual.
6. Check and adjust the transmission ATF level.
7. Road test for proper operation.
